Internal degradation monitoring of power devices during power cycling test

Akihiko Watanabe^a, Masahiro Tsukuda^b and Ichiro Omura^a,

^a Kyushu Institute of Technology, 1-1 Sensui-cho, Tobata-ku, Kitakyushu, Japan

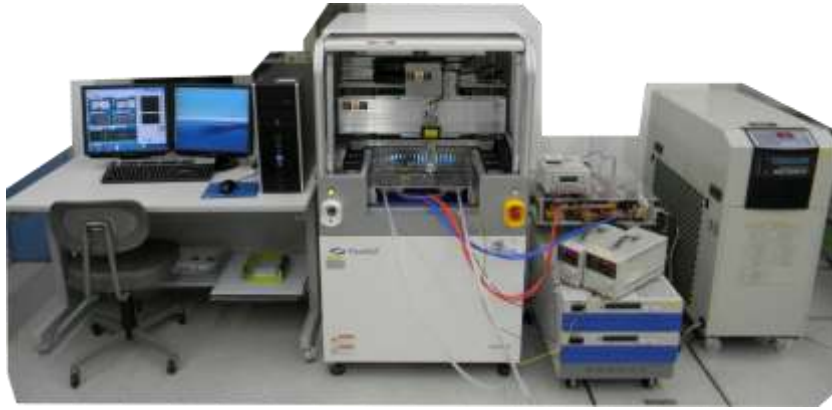
Figure 2 Internal degradation monitoring system

Required components to the real time monitoring of internal phenomena of DUT are (1) non-destructive inside imaging, (2) power stress control and (3) device cooling as shown in Figure 1 and 2.
