Restoration of seventeenth century water gardens at Bramham Park

Joseph Holden reports on his research into discovering how the original water features at Bramham Park worked and to suggest how they might be restored to their former glory.

Joseph Holden
University
of Leeds

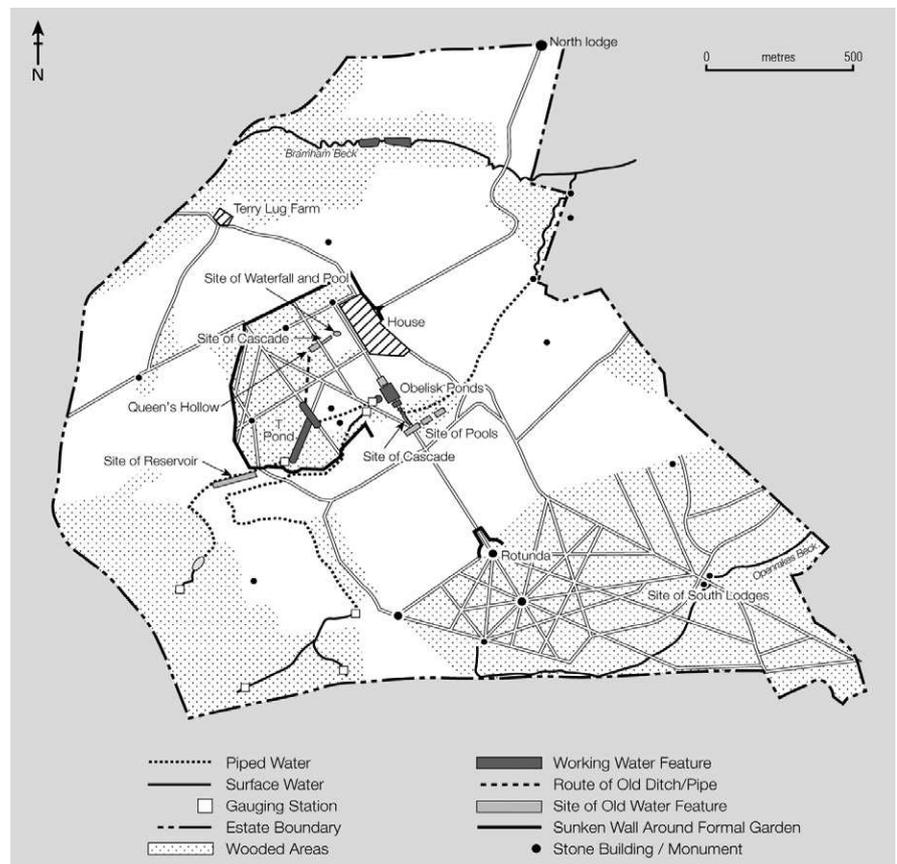
Figure 1 is a map of Bramham Park showing named working and defunct water features. In order to establish how water was supplied to the now dry Queen's Hollow and associated cascades and how other features were originally connected, ground penetrating radar

Figure 1. Map of main water features at Bramham

Since gravity was the only feasible mechanism for transporting water at the time this obstacle had to be overcome by contouring the water along an elaborate series of ditches and pipes for over 2 km around the valley edge (Figure 1) with a gradient of only 1:250.

linking water level to discharge. The discharge was also automatically recorded at four other sites (Figure 1) to allow determination of where there were leaks or inputs.

there are some losses between its supply springs and the ponds, repairing these leaks would still not be enough to feasibly allow restoration of the Obelisk cascades. This is because each of the two major cascade systems (Obelisk Pond and Queen's Hollow – see Figure 1) would need around 8-10 litres s⁻¹ to operate in a satisfactory way. For most of the year this would not be possible.

While the research discussed above has concentrated on water features in the formal gardens at Bramham, one of the best assets of Bramham is the landscape of the Park as a whole. Forming this landscape there is a range of plantations, rides, walks, buildings and stone monuments which are supplemented by water features such as fish ponds and stone arch bridges along Bramham Beck and Openrakes Beck (Figure 1).

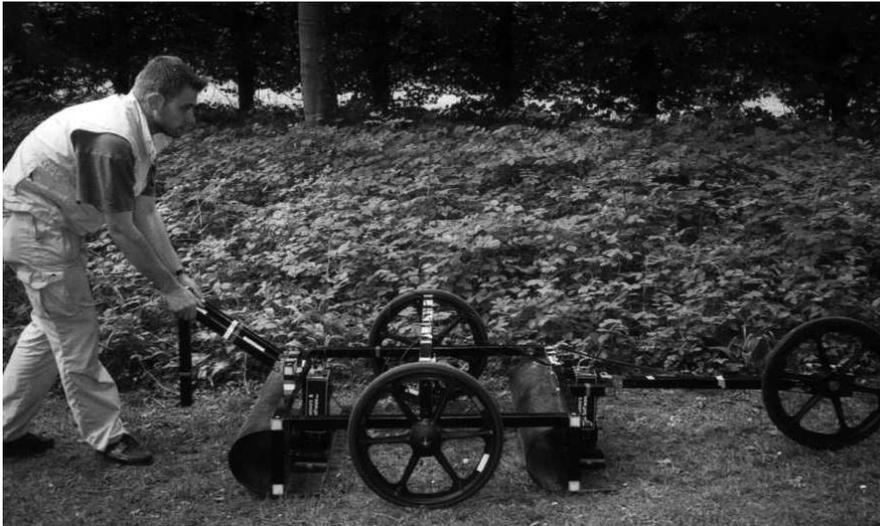
(GPR) was used (Figure 2).

This technique has been established at Leeds University for detecting underground pipes and water leaks for the water industry without the need for disturbing the ground.

Figure 2. Surveying the old water features at Bramham using GPR

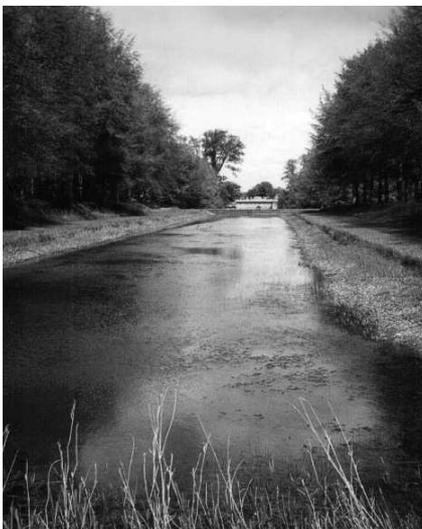
Water enters the T Pond via pipes leading from one of the springs. The GPR survey showed that the T Pond (Figure 3) originally overflowed into a pipe and ditch that sent water to the Queen's Hollow which it then delivered via a 30-step cascade to the mouth of a mythical beast. From here water poured down a further waterfall to a pool in a Parterre (Figure 4).

Figure 3. The T Pond

Many of the ponds (just like the great Yorkshire canals) were lined traditionally with puddled clay. However, some ponds, such as the T Pond, are leaking or are completely dry. Puddled clay requires relining every few decades and this will be the first step necessary at Bramham before any of the other restoration work can take place.

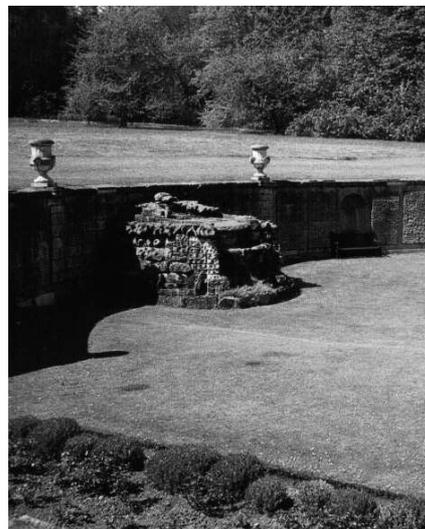
Figure 4. The old waterfall and pond in Parterre once supplied by water from another pond and 30-step cascade which in turn were fed by the T Pond

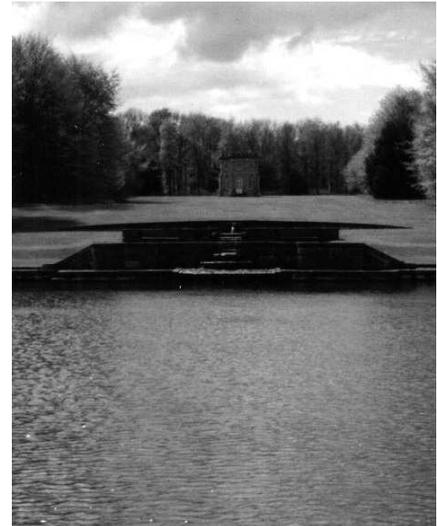
This system no longer works and maps suggest that it had ceased operation by the early nineteenth century. Cascades leading from the large Obelisk Pond system (Figures 5 and 6) are now covered with turf too and also probably stopped functioning during the nineteenth century.

Figure 5. The main Obelisk Pond

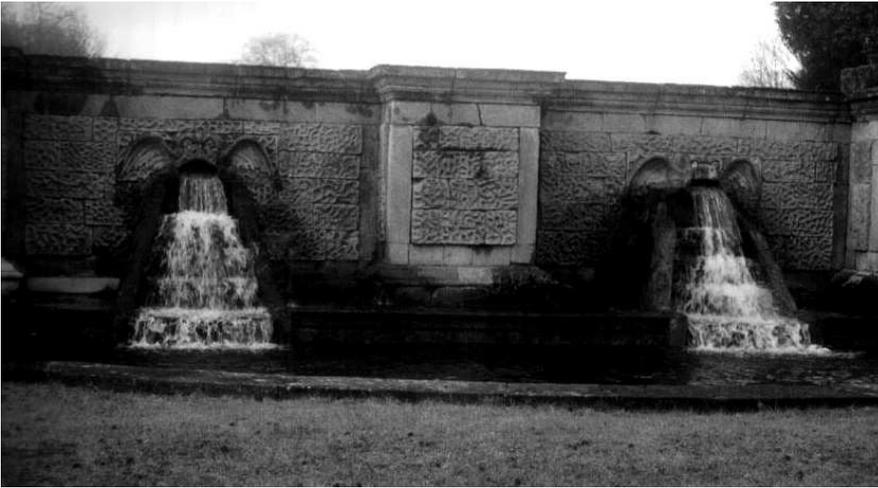
Figure 6. Dragon's mouths at the Obelisk Pond in January 2003 which once supplied water to a long flowing cascade (For most of the year the flow is much less than shown in the figure)

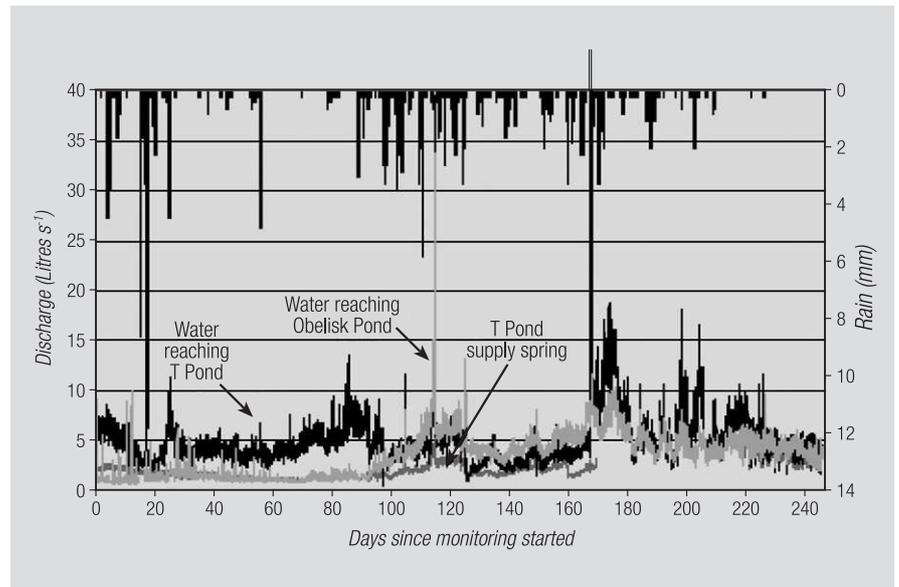
Figure 7 shows the discharge for the spring supplying water to the T Pond and the amount of water received at the T Pond. It is evident that there are large gains between the two sites. Because water is piped for most of the distance between the two sites, the extra inputs of water are restricted to hillslope runoff running down into the open stream

This shows that while piping the whole course of the system might seem useful in order to prevent sedimentation and remove the need for ditch maintenance, it would result in a large reduction in available water supply. This is because the spring water alone is not the main source of water.

Figure 7 also plots the amount of water reaching the Obelisk Pond system. While

Figure 7. 15-minute discharge and precipitation (vertical bars) for three sites at Bramham since July 15th 2002

However, if water reaching the T Pond was added to water reaching the Obelisk Ponds then restoration would be possible for one set of cascades but this would

only work during wet winter periods. Nevertheless, this could be achieved by re-routing water from the T Pond to the Obelisk Ponds.

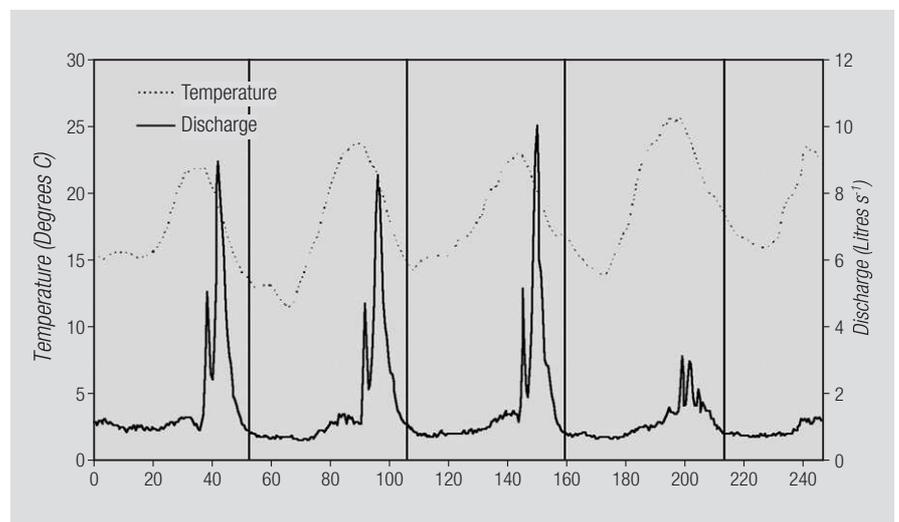
Figure 8 may provide some clues as to why there is insufficient water supplying the water features. This plot shows that there are daily fluctuations in discharge

from the springs.

This feature could be caused by instrument readings affected by temperature, groundwater tides resulting from lunar cycles, daily evaporation or groundwater abstraction.

The first three of these factors can be discounted since temperature and tidal cycles are not coincident with discharge fluctuations and the instruments have been carefully calibrated for temperature effects. It is likely that some form of abstraction is taking place which may be affecting supply to Bramham Park.

Figure 8. Daily discharge cycles for a spring at Bramham for a 4.5 day period during August 2002
