Femoral stem wear in cemented total hip replacement

H-Y Zhang^{1*}, L Blunt¹, X-Q Jiang¹, L Brown¹, S Barrans¹, and Y Zhao²

Abstract: The great success of cemented total hip replacement to treat patients with end-stage osteoarthritis and osteonecrosis has been well documented. However, its long-term survivorship has been compromised by progressive development of aseptic loosening, and few hip prostheses could survive beyond 25 years. Aseptic loosening is mainly attributed to bone resorption which is activated by an *in-vivo* macrophage response to particulate debris generated by wear of the hip prosthesis. Theoretically, wear can occur not only at the articulating head–cup interface but also at other load-bearing surfaces, such as the stem–cement interface. Recently, great progress has been made in reducing wear at the head–cup interface through the introduction of new materials and improved manufacture; consequently femoral stem wear is considered to be playing an increasingly significant role in the overall wear of cemented total hip replacement. In this review article, the clinical incidences of femoral stem wear are comprehensively introduced, and its significance is highligh

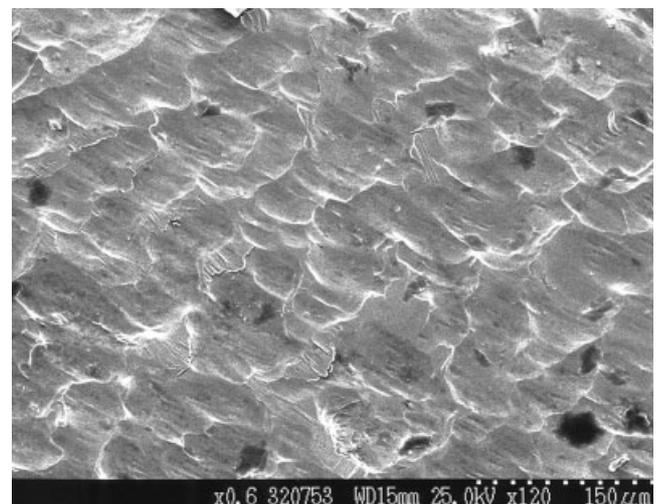
Fig. 1 Fretting wear on an explanted polished Exeter femoral stem measured by SEM

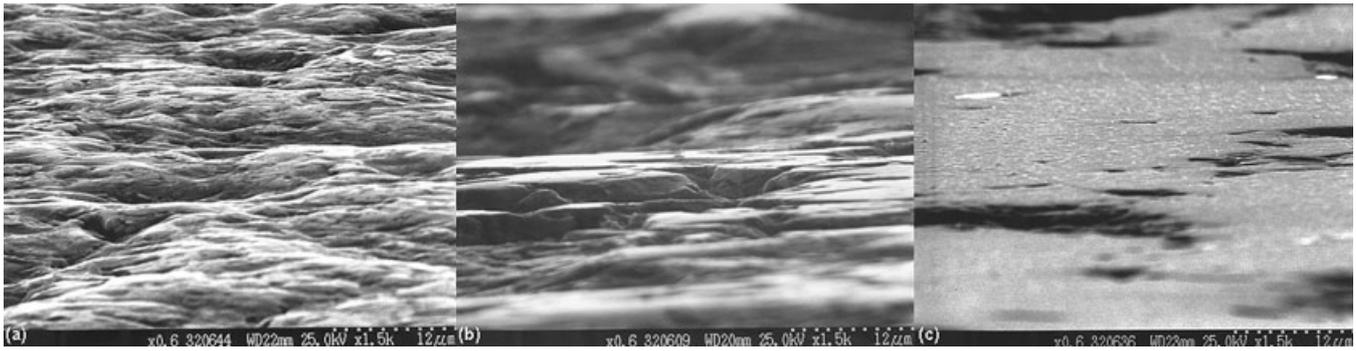
Fig. 2 Grazing-incidence SEM images showing increasing degrees of polishing wear on matt-surfaced stems: (a) an unworn area; (b) an area of slight polishing wear; (c) an area of marked polishing wear

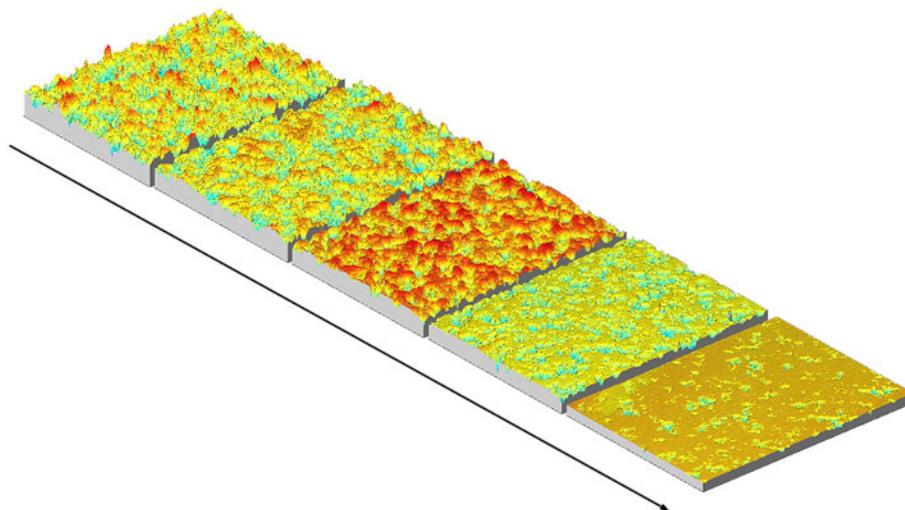
Fig. 3 The axonometric plots showing progressive stages of abrasive wear on an Exeter matt-surfaced stem. The asperities present on the unworn surface are removed during the wear

generally accepted. However, the exact surface level that produced fretting wear or abrasive wear was not clear. Subsequently, clinical data on femoral stem wear continued to be published. In 2005, Jones *et al.* [30] reported abrasive wear on the proximal matt surface of the Bridge hip stem, and they also detected the presence of titanium debris embedded within the cement mantle. Another significant contribution to this area was ascribed to Brown [31], who had developed a semi-quantitative method to calculate volume loss during the wear of matt femoral stems. By comparing this result with that calculated from a mathematical truncation model, it was confirmed that the wear mechanism for matt femoral stems was abrasive wear rather than classic fretting wear, at least until a fully polished surface was attained, by which point it was considered that classic fretting wear would predominate (Fig. 3).

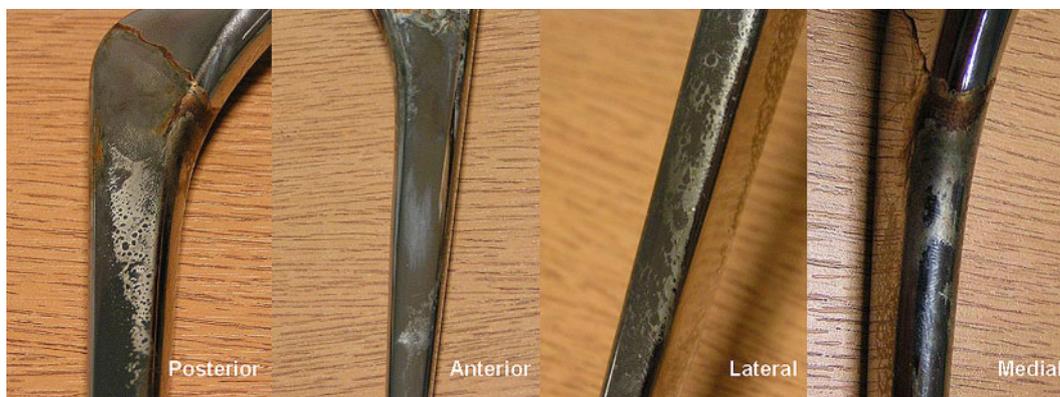
Fig. 4 Fretting wear generated on the surface of an Exeter polished femoral stem through an *in-vitro* wear simulation

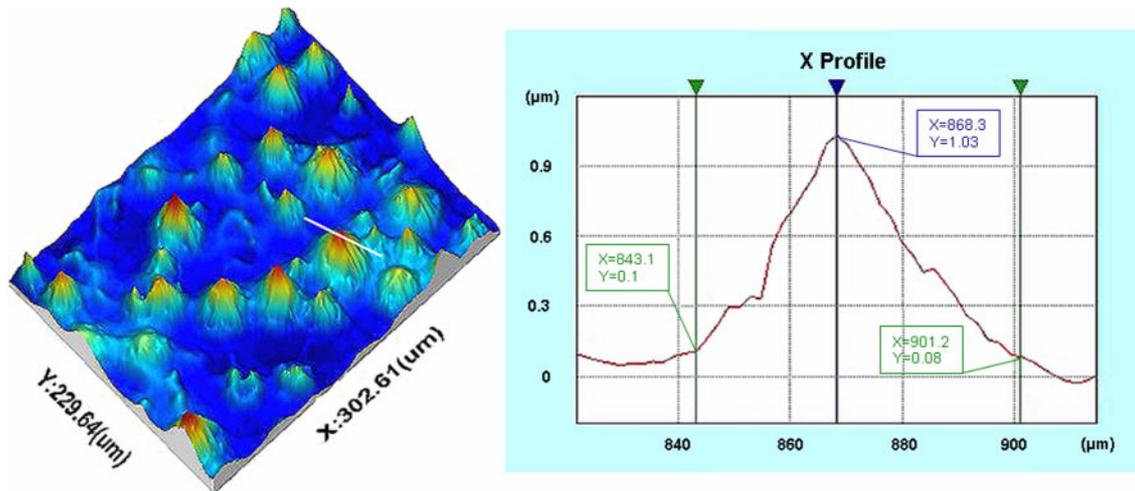
Fig. 5 Shrinkage peaks formed on the bone cement surface during polymerization. The two-dimensional profile of the peaks indicates that they are about $50\ \mu\text{m}$ in width and $1\ \mu\text{m}$ in height

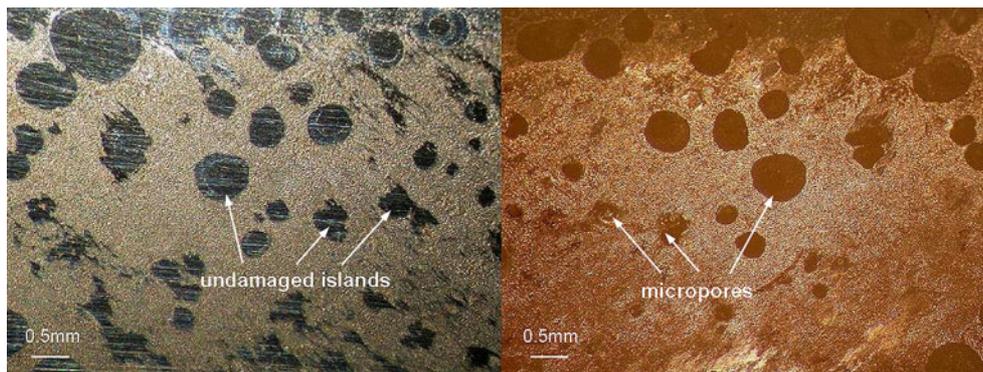
Fig. 6 Optical micrograph showing the 'undamaged islands' surrounded by fretting wear on the femoral stem surface and the corresponding micropores in the bone cement surface. The boundaries of the 'undamaged islands' match well with the micropores

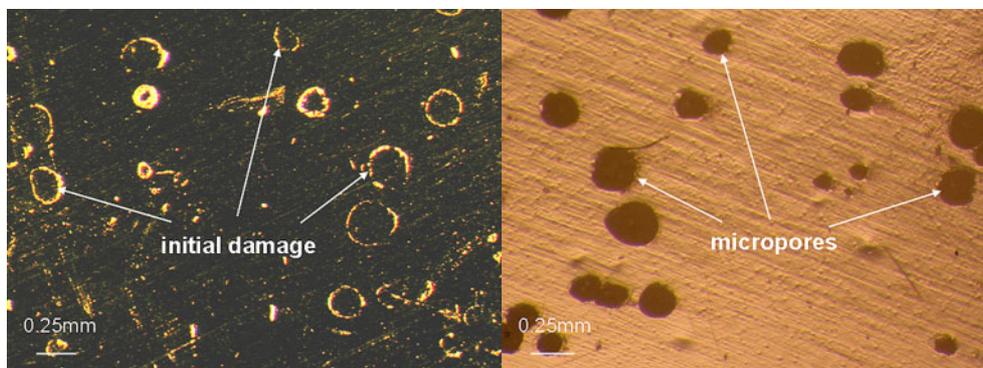
Fig. 7 Optical micrograph showing the initial damage on the femoral stem surface and the corresponding micropores in the bone cement surface. The boundaries of the initial damage match well with the micropores

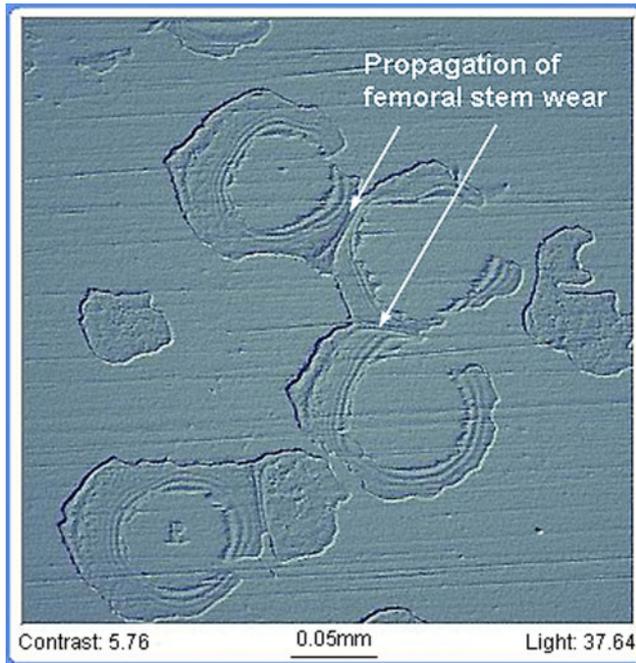
Fig. 8 An interferometric micrograph showing the propagation of femoral stem wear into a large area from the sites contacting the micropores in the cement surface
