FLOODING AND PHYSICAL PLANNING IN URBAN AREAS IN WEST AFRICA: SITUATIONAL ANALYSIS OF ACCRA, GHANA

Noah Kofi KARLEY

Abstract

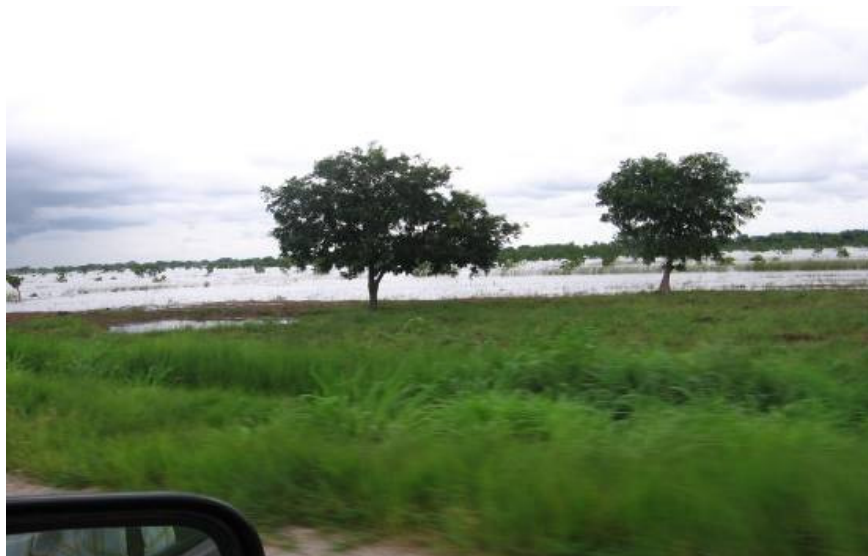
PLATE 1 : SUBMERGED FARMS IN NORTHERN GHANA, 2007

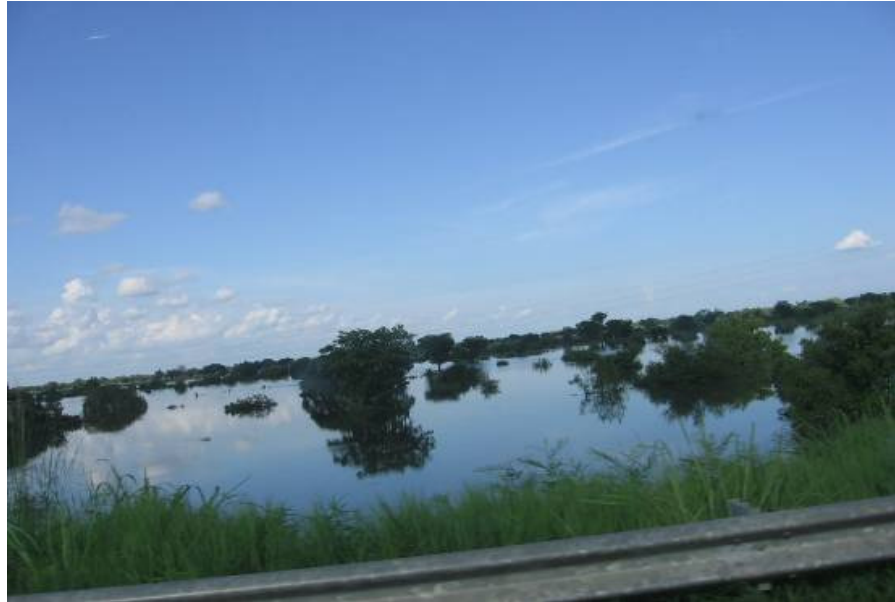
PLATE 2: SUBMERGED FARMS IN NORTHERN GHANA, 2007 (SOURCE: PHOTOGRAPHS TAKEN BY RESEARCHER)

area is hit by floods when there is severe rainfall. In 2007, when the water from the dam reached very high levels the flood gate of the Bagre dam in the east of the country, was opened. This released water at a force of 900m³ per second into the White Volta River, which flows into Ghana and caused severe flooding. This affected the whole country and the northern regions in particular. The photographs Plates 1 and 2 show some of the affected areas with farms completely submerged.

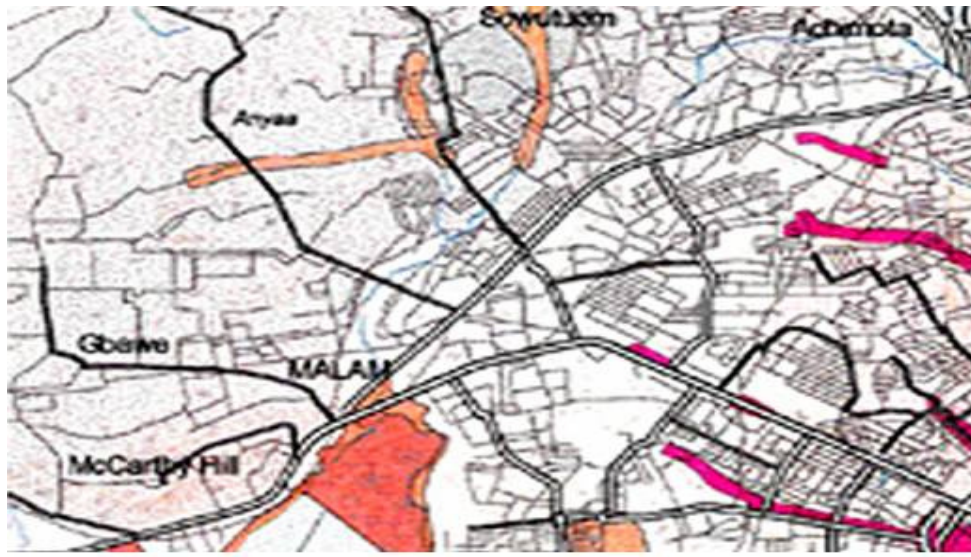
Sowutuom

FIGURE 2 - MAP SHOWING THE SOWUTUOM COMMUNITY AND LAFA RIVER

According to the experts from the T&CPD (2008) one of the main causes of recent flooding in communities (Figure 2) situated around the Lafa River is the construction of a secondary drain system. The system was designed to service a tertiary one that had no access into the primary drain, the Lafa stream. Thus, storm waters collected by the secondary drain are discharged into houses in the surrounding area. Also, it is observed that the community situated at the southern part of the area (called Dansoman SNNIT flats) was developed on the bed of the Lafa River. This makes it extremely difficult to construct any meaningful drainage system to serve houses within the community. Thus the initial drains constructed are always inundated when the storm waters from up stream are discharged into this vast plain. The topographical reading of the area indicates that it is only about one foot above sea level.

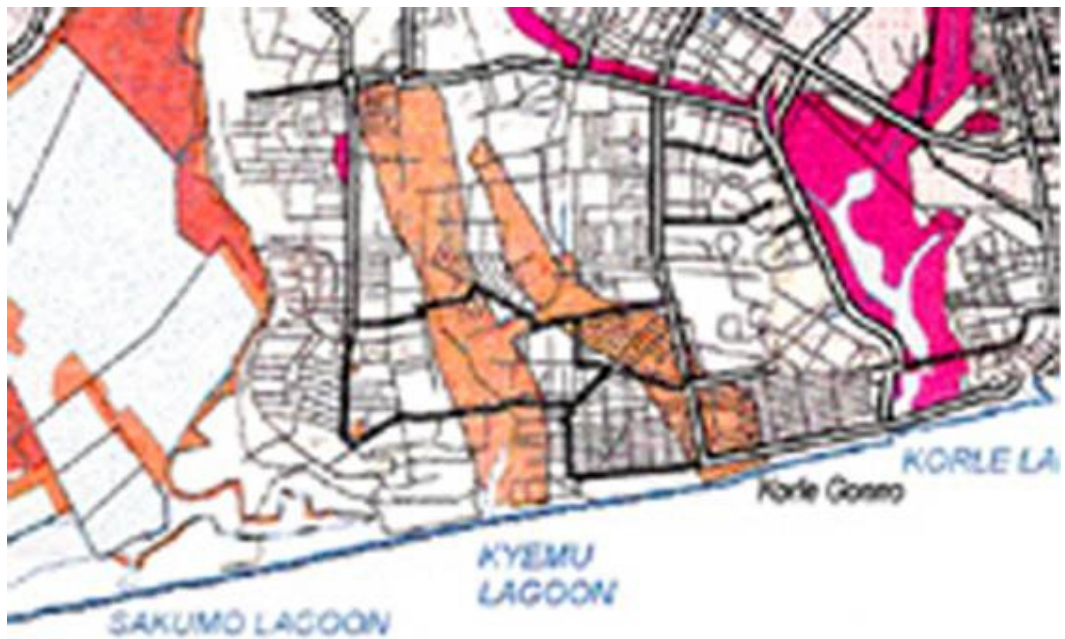
Kyemu

FIGURE 3 - MAP SHOWING THE KYEMU LAGOON AND THE MAMPONG AREA

The Khemu stream stretches from the area called Russia through part of Sukura, New Mampobi, Old Dansoman and finally into the Khemu Lagoon (Figure 3) at Chorkor. Heavy siltation, coupled with an

estimated three quarters of the Lagoon basin encroached on by residential developments, blocks the main stream. Occasional bars at the estuary also compound the problem.

The Mampong River takes its source from Sukura and its environs and finally discharges its water into the Khemu West stream. There are undersized culverts on the Banana Inn-Mamprobi road as well as service lines running across the cross section of this culvert. Thus, storm waters transporting garbage blocks the undersized culverts thereby flooding all houses located upstream.

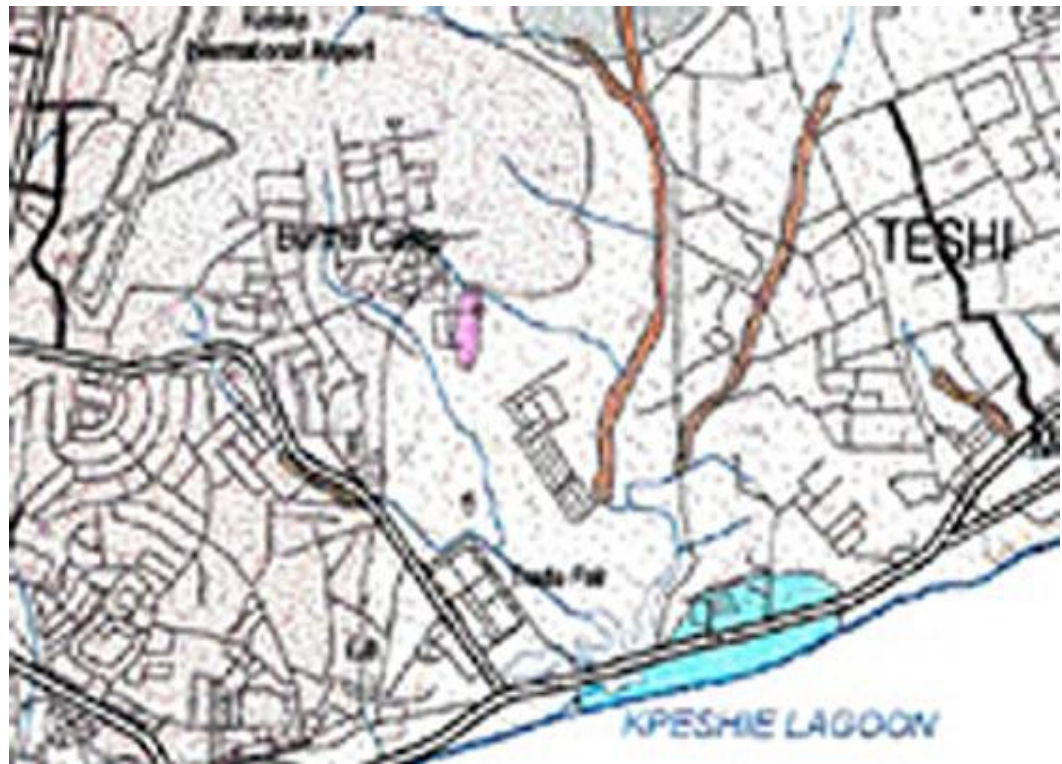
Figure 4 - Map showing Naaplajor, Teshie communities and Kpeshie Lagoon

The Naaplajor community is located at the northern part of Teshie but on a tributary of the Kpeshie stream (Figure 4). According to experts from the T&CPD (2008), the main flooding problem of this small community is inadequate bridge across the stream. Two lives were lost here in the past four years, through flooding. Also, the Sango System is another water course with three major portions of the basin requiring major attention. The problem of all communities affected by the system is that of the lack of larger access way of storm water. The worst affected of the three communities is Coco Beach which is at the extreme end of the stream. Recent dredging undertaken at this point of the stream seemed not enough to contain the storm waters.

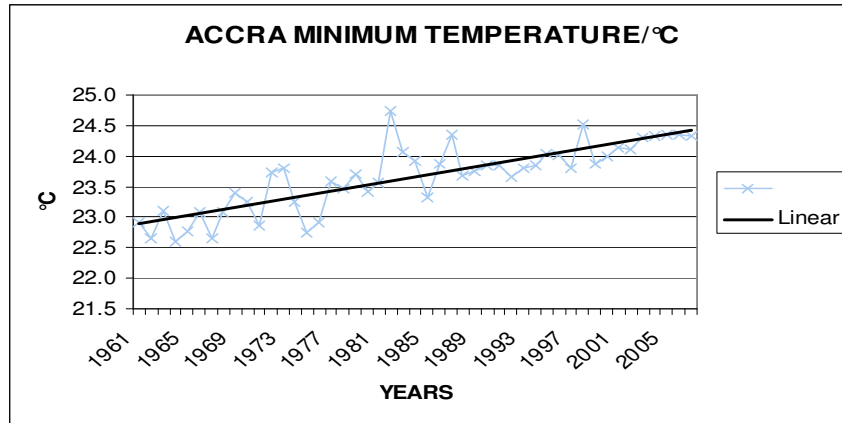
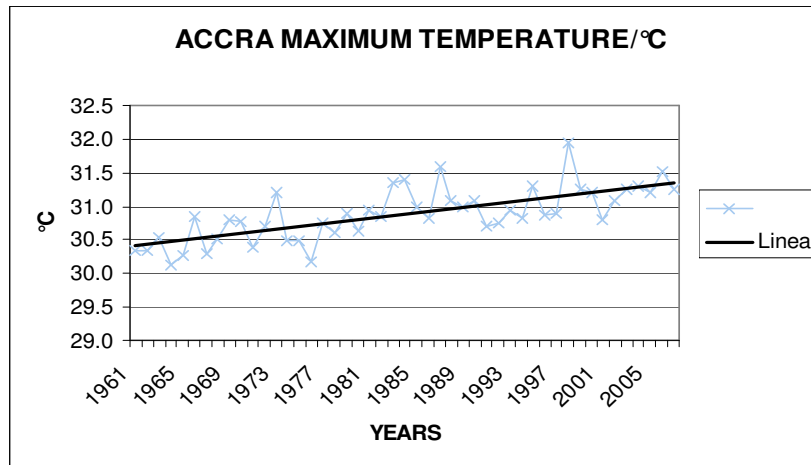
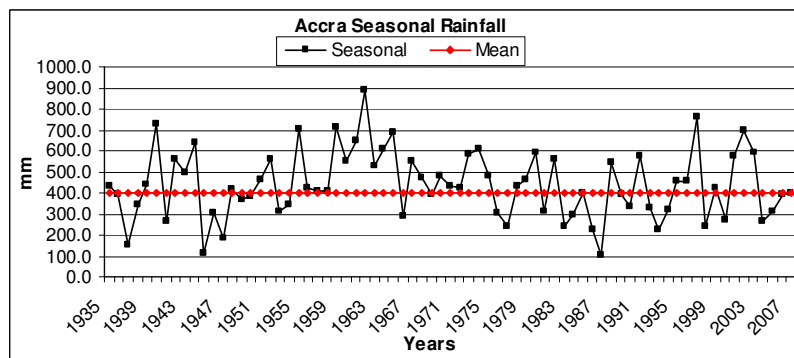
FIGURE 5 - (1): ACCRA MINIMUM TEMPERATURE, 1961 TO 2005, (2): ACCRA MAXIMUM TEMPERATURE, 1961 TO 2005, (3): ACCRA SEASONAL RAINFALL 1935 TO 2007

Source: Data provided by Meteorological service department, Legon Accra station

Many parts of the world have experienced devastating flooding throughout the last few years, which have affected thousands of people and cost millions of dollars. The perception is that changing rainfall pattern is caused by climate change. This is probably not the case in the case of Accra, Ghana. For example, the average temperature data for Accra collected over 1961 to 2005 shows an increasing trend in the minimum and maximum temperatures over the period as shown in Figures 5.1 & 5.2 respectively. But, this is not the case for seasonal rainfall (measured - June, July and August) over the period between 1935 and 2007 as shown in Figure 5.3, which depicts a relatively flat mean trend over the period. However, unlike previous years, it is observed that in Accra the rains started early in April 2008 ahead of the usual June, July and August rain period.
