Remote Sensing and Field Assessment of Tsunami Effects on Coastal Pond Aquaculture in Northern Sumatra

S. P. Kam, S. C. Liew, Z. A. Muchlisin and P. Chen

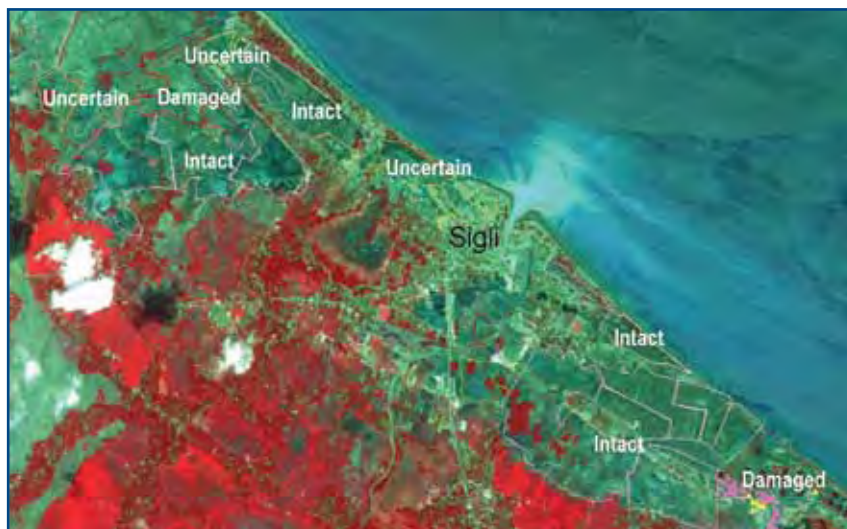
Fig. 4 shows a subset of the pond damage assessment map produced for the stretch of coastal area in the vicinity of Sigli town in Pidie. Delineated polygons of aquaculture

pond clusters, annotated with “intact”, “damaged” and “uncertain” classes, are superimposed on the post-tsunami SPOT-5 image.

Figure 4. Part of a post-tsunami SPOT-5 image near Sigi overlaid with polygons of damage classes. SPOT image © CNES 2005.

Also evident are other features of the coastal zone that would provide useful spatial information including the spatial pattern of human settlements and land use, coastal forests, infrastructure networks, providing sufficient detail to be directly used as a base map

for various reconstruction planning purposes. Large-format prints were made of the image map, comprising the mosaic of post-tsunami SPOT-5 scenes covering the entire 700 km stretch of coast as backdrop, overlaid with the delineated polygons of aquaculture ponds and annotated with names of main towns and river mouths. The prints were brought back to Aceh for carrying out the field assessment and are available for other uses as well.
