Failure Analysis and Recovery of a 50mm Highly Elastic Intermetallic NiTi Ball Bearing for an ISS Application

NASA, Glenn Research Center

43nd Aerospace Mechanisms Symposium

May 4th, 2016

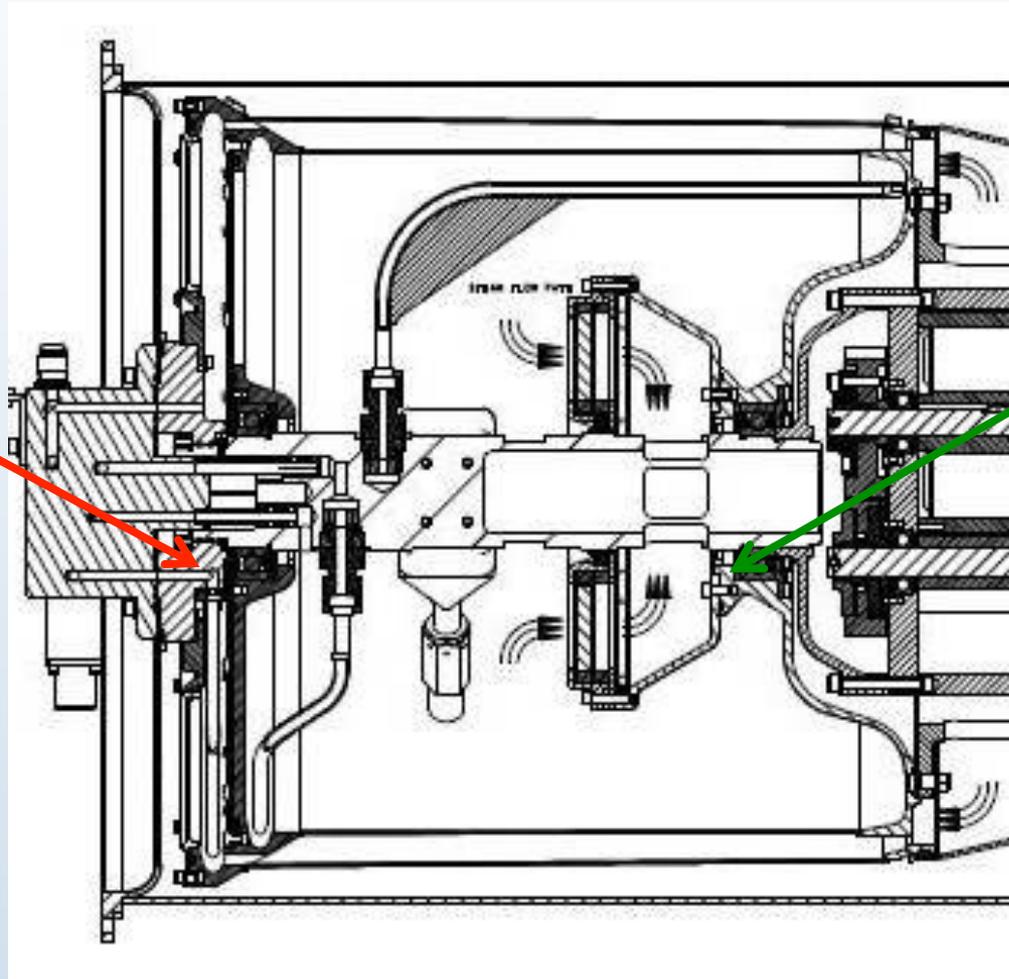
Bearing Test: 2014 at MSFC in DA Ground Test Unit

Rear hub bearing is pressed into this bore. It failed from an inner race crack after 200+ hours of operation. Wear debris noted before audible bearing noise.

Front motor-side bearing is pressed into this bore. It did not fail at all.

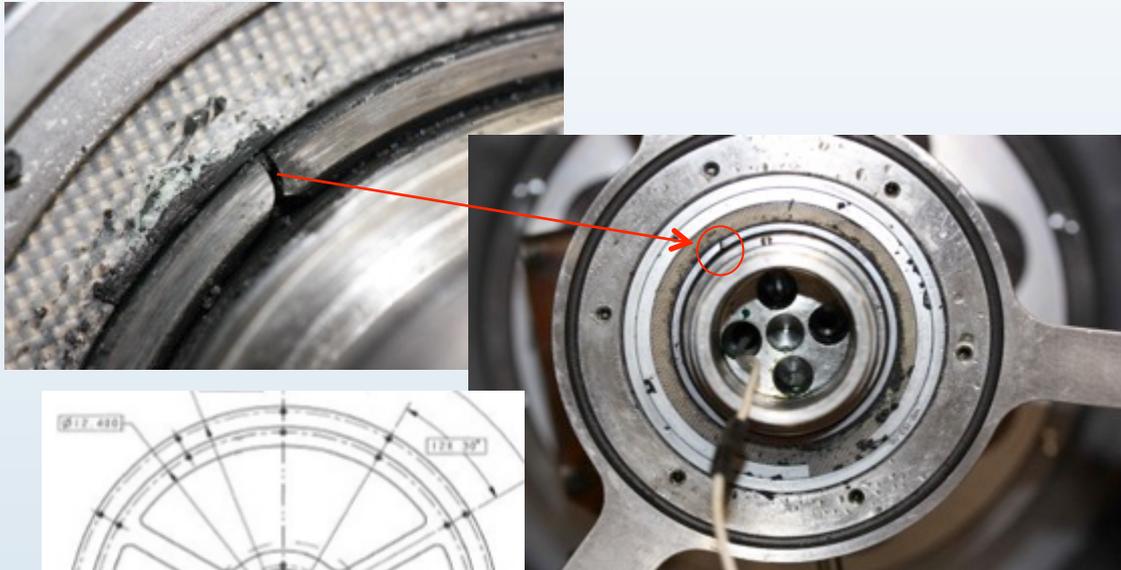
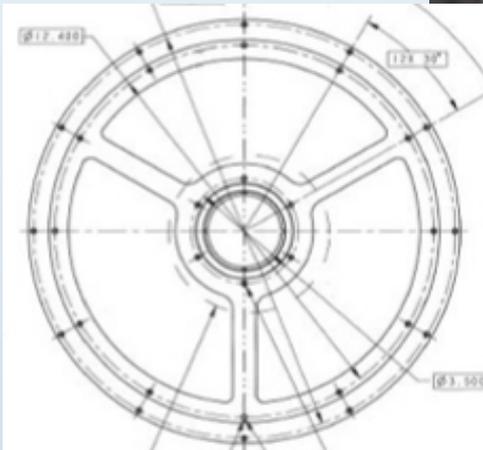
*Hub Side
(Cracked inner race)*

DA Post Test bearing Photos: Prior to removal

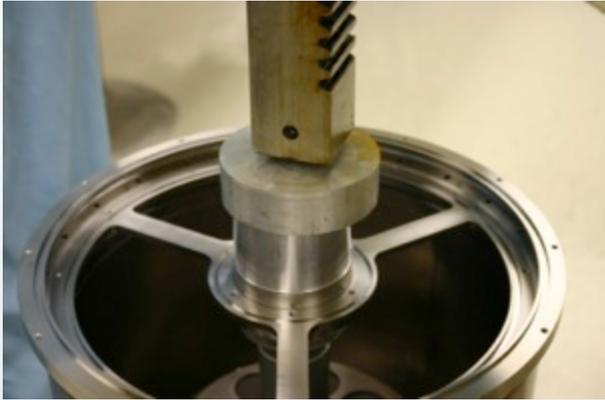
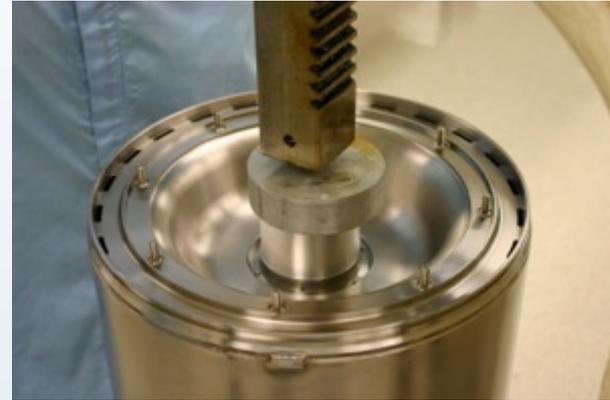
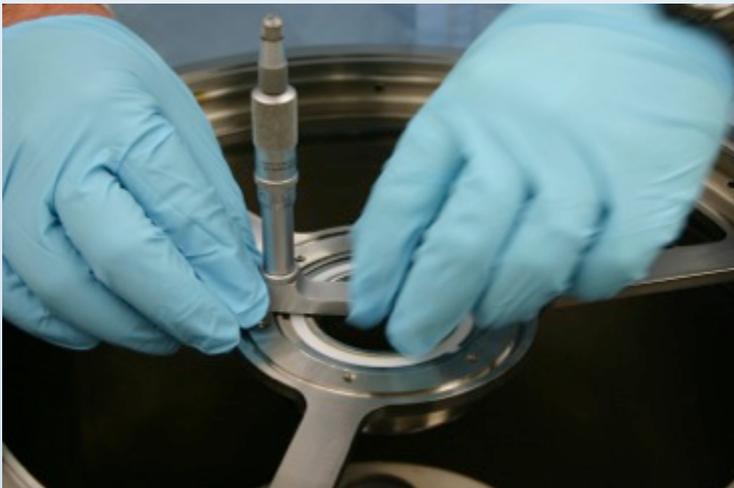
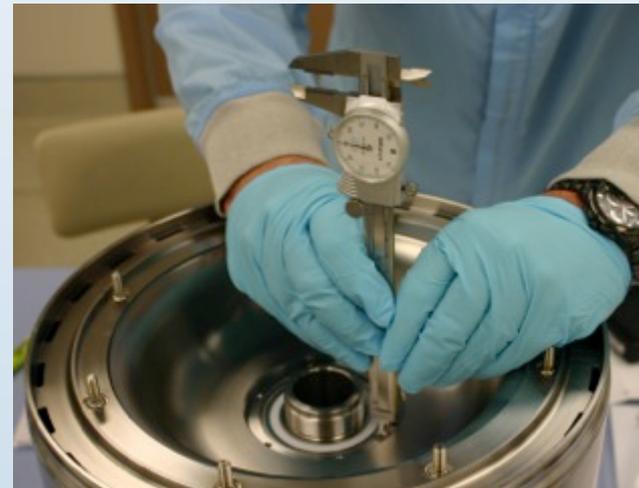
DA bearing Installation: Bearing OD Pressing

BEARINGS ARE PRESSED WITH TOOLING DESIGNED TO APPLY PRESSURE ON BOTH THE INNER AND OUTER RACES.

EACH BEARING IS INSPECTED TO ENSURE PROPER SEATING.

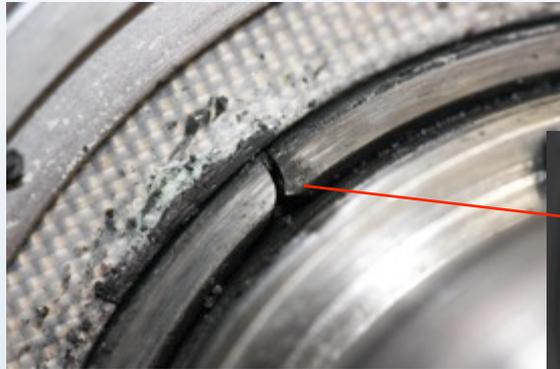
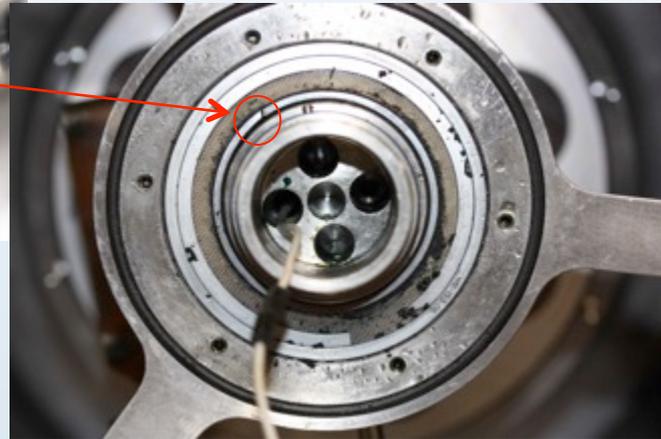
*Hub Side
(Cracked inner race)*

**Outer Race: 0.0011"
interference fit in bore.**

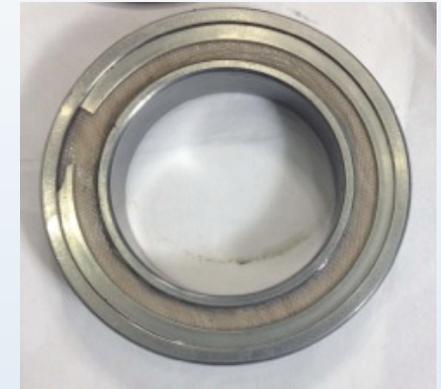
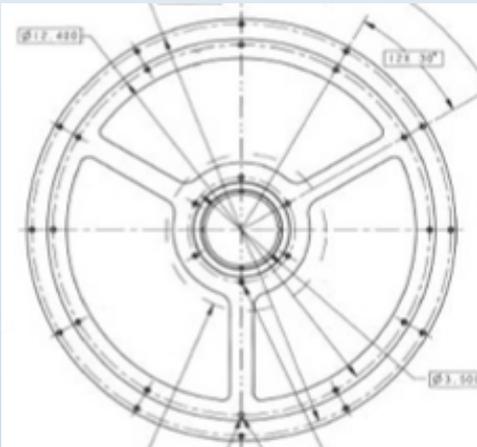
*Motor-Side
(As new condition)*

**Outer Race: 0.0007"
interference fit in bore.**

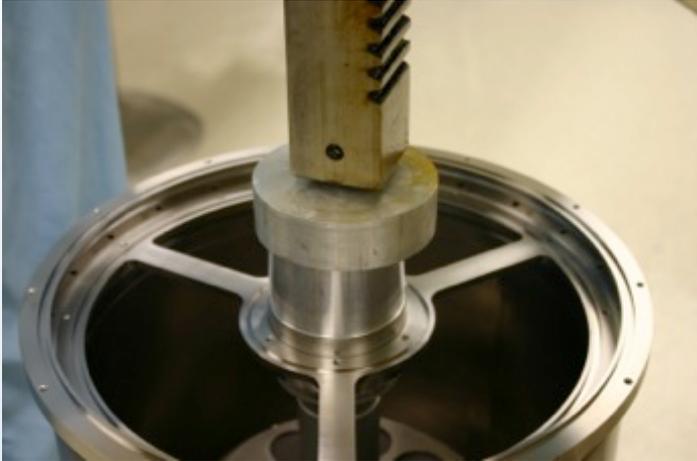
*Hub
Side*

- Bearing bore has three attachment points (spokes) with low axial rigidity and high radial rigidity.
- Heavy interference fit of a bearing race results in tri-lobe shape of outer race.
- Low axial stiffness of structure results in some loss of spring preload and possibly dynamic motion during operation.

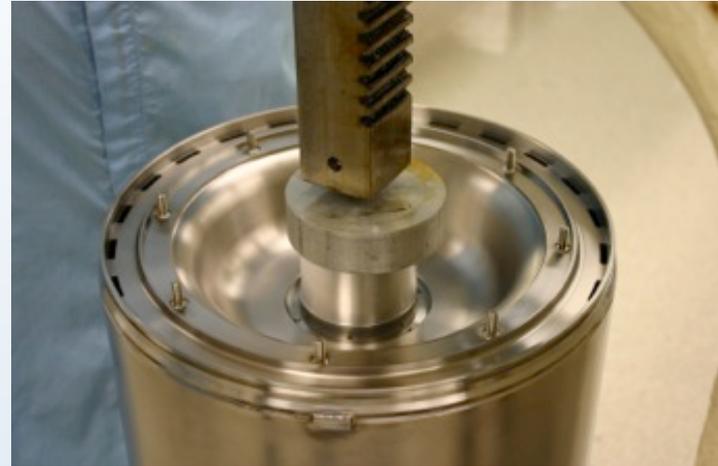
*Motor
Side*

- Bearing bore is axis-symmetric with high axial and radial rigidity.
- Heavy interference fit of a bearing race retains round shape of outer race.
- Elastic compression of outer race will reduce internal clearance between balls and races.

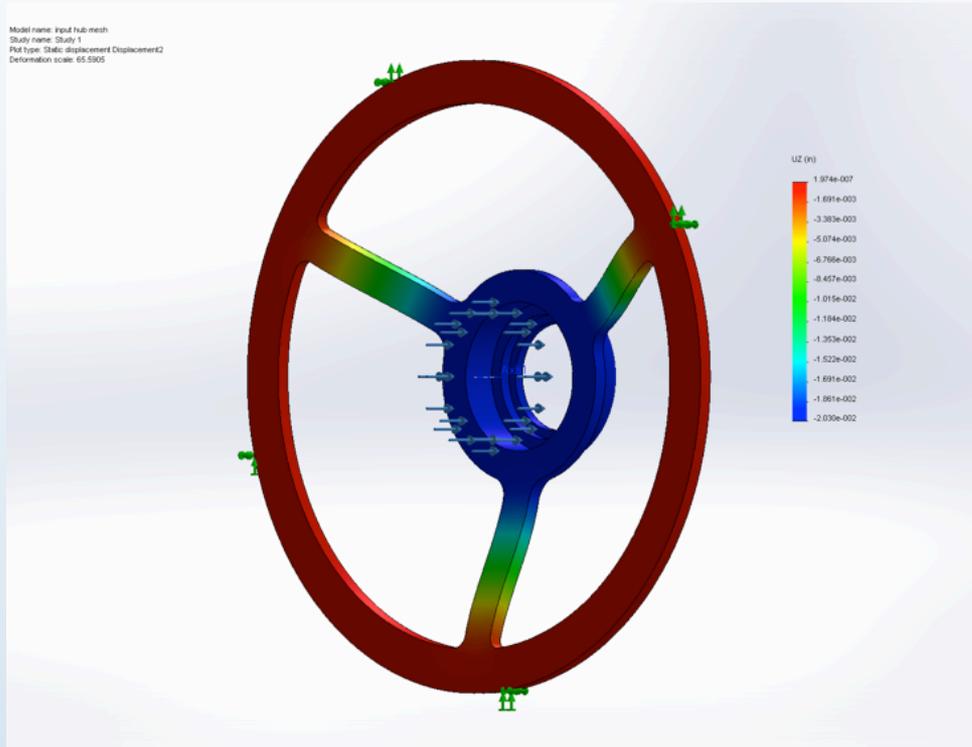
Hub Side Structure: Deformed

Axial Load Results in spoke deflection:

- **Reduction in axial spring preload force of about 10% (35 vs. 40 lbs).**
- **Hub bore retains original round shape.**

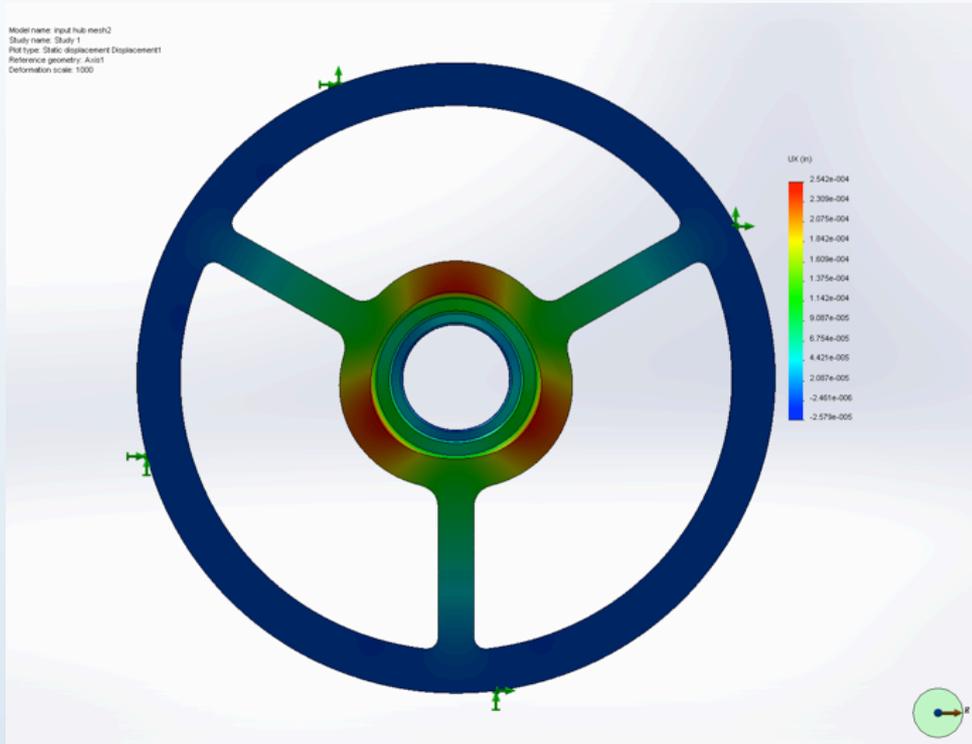
Deformation due to 0.0011" interference fit between bearing OD and hub bore.

- ***Spokes present hard points that deform bearing outer race.***
- ***Heavy interference (tight) fit reduces internal clearance.***
- ***Bearing outer race is not circular in installed condition.***

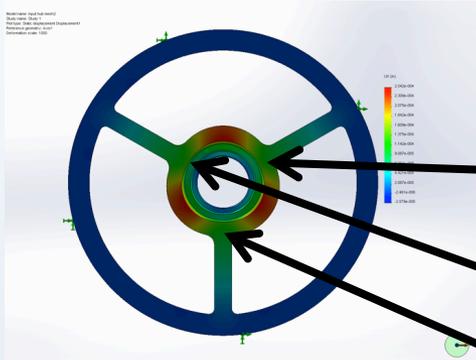
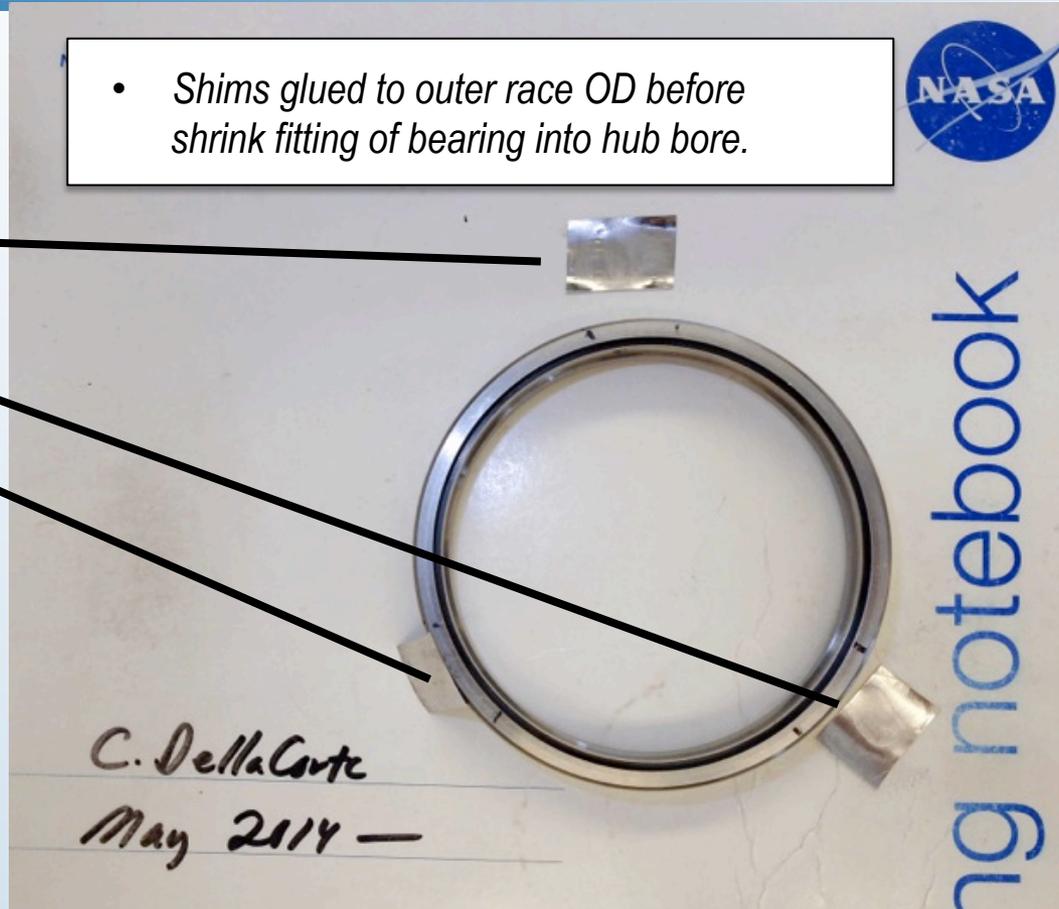
Modeled fit

- 0.001" thick shims
- 120 degrees apart
- 0.75" wide to ~match spokes
- Simulates 0.0011" interference.
- Motor side bearing interference fit set to 0.0003"

- Shims glued to outer race OD before shrink fitting of bearing into hub bore.

- Shims deform bearing outer race.
- Shims reduce internal bearing clearance, creating higher ball-race loads.
- Not an exact reproduction of application but similar.

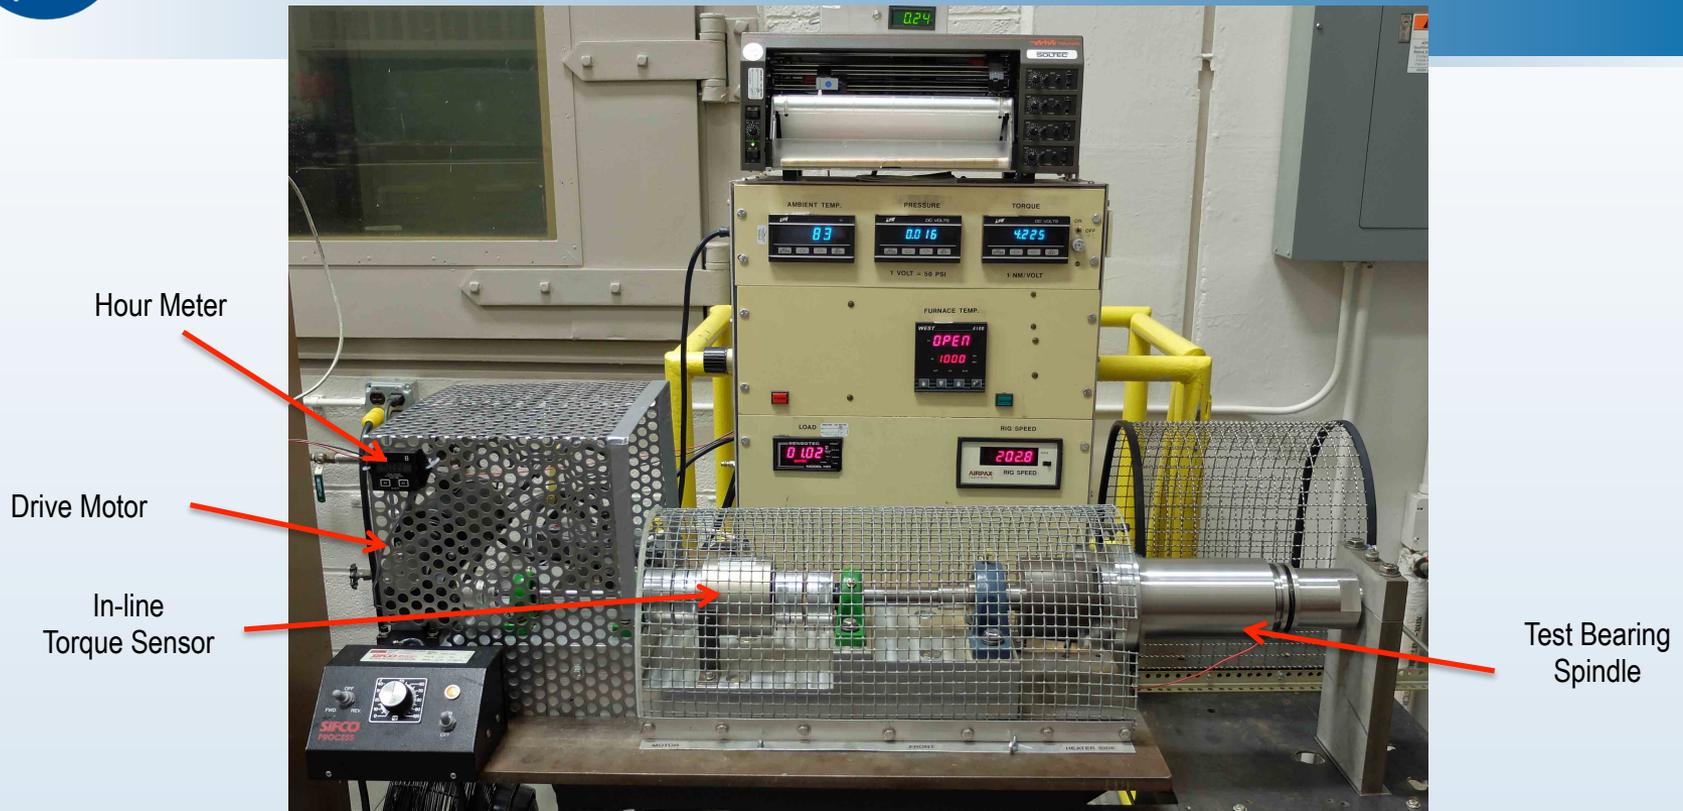
Bearing Test: Shimmed Outer Race

- ***Right bearing has shimmed outer race. Left bearing properly fit.***
- ***Inner races have clearance fit on stationary shaft.***
- ***200 rpm, 40 pound preload.***
- ***Monitor torque, inspect bearings at intervals or when audible noise observed.***
- ***Recall: 2014 ground test failure occurred in ~200 hours.***

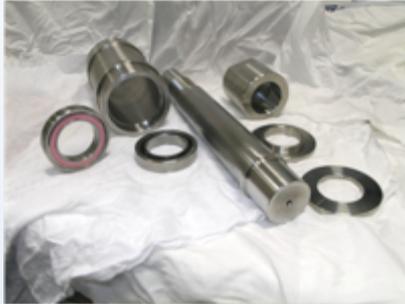
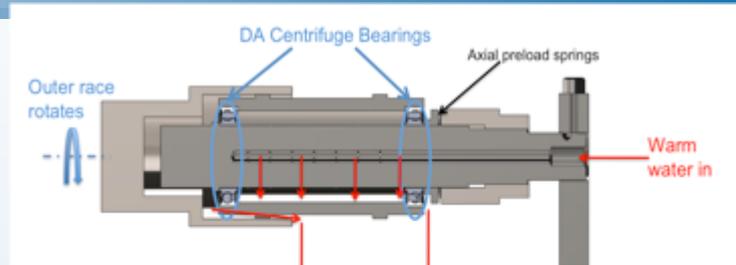
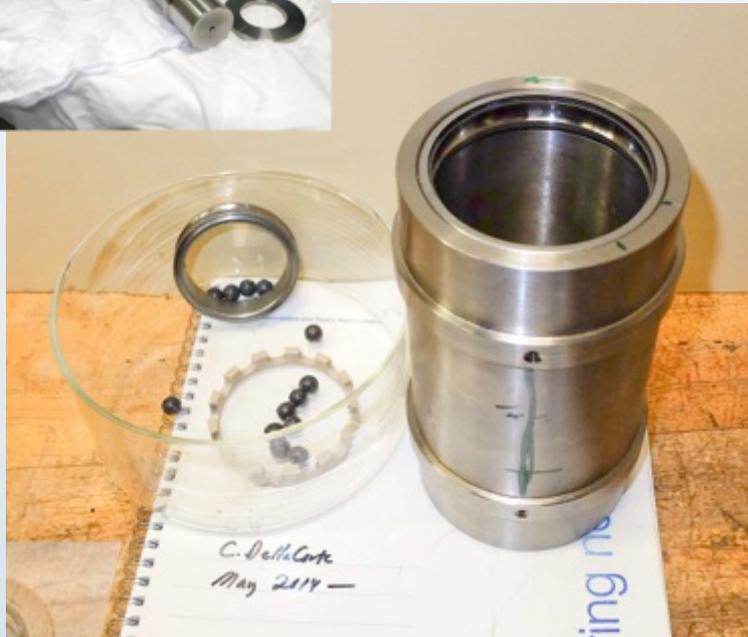
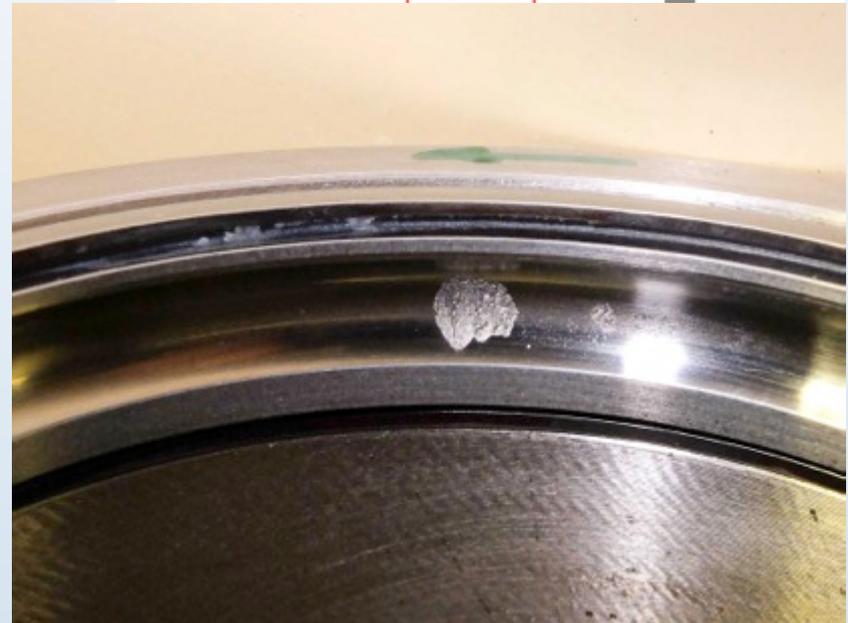
DA Centrifuge Bearing Test Rig
Spindle Components

- ***Test began normally, low torque, smooth operation.***
- ***Nothing happening after 100 hours. Still quiet at 150 hours.***
- ***At 157 hours, rig making noise. Shimmed bearing had uneven torque (hard spot).***
- ***Inspection revealed that shimmed bearing was failed, motor side bearing was fine.***

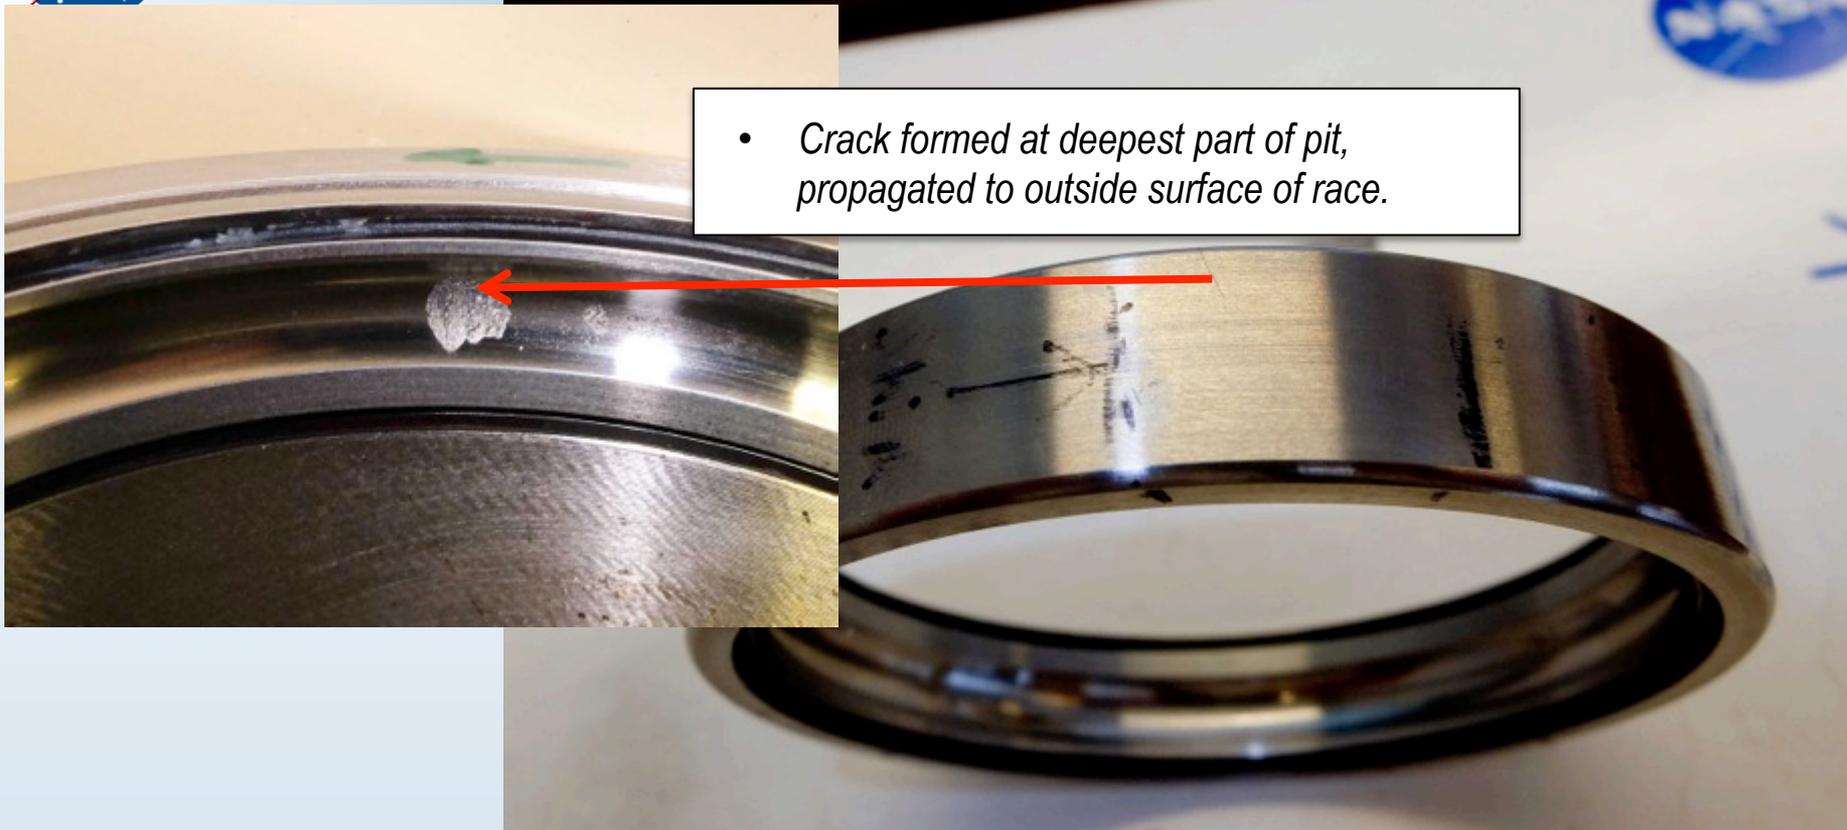
Shimmed Bearing: Post Mortem inspection

• *Crack formed at deepest part of pit, propagated to outside surface of race.*

- ***Grease highly discolored and forced out of shield***
- ***Inner and outer race fatigue pits.***
- ***Deepest outer race pits progress to form race cracks.***
- ***Race cracks appear to form as secondary damage.***
- ***Test provides a possible rationale for bearing failure in DA ground unit.***

- **Bearing failure in 2014 was attributed to incorrect (overly tight) fit into a non-symmetric hub.**
- **Brittle nature and the low elastic modulus of NiTi were contributing factors in the early failure.**
- **The failure mode was reproduced using shims to distort the outer race shape and minimize clearance.**
- **A follow on successful 10,000 hour test campaign using proper fits corroborates the design and the failure analyses.**

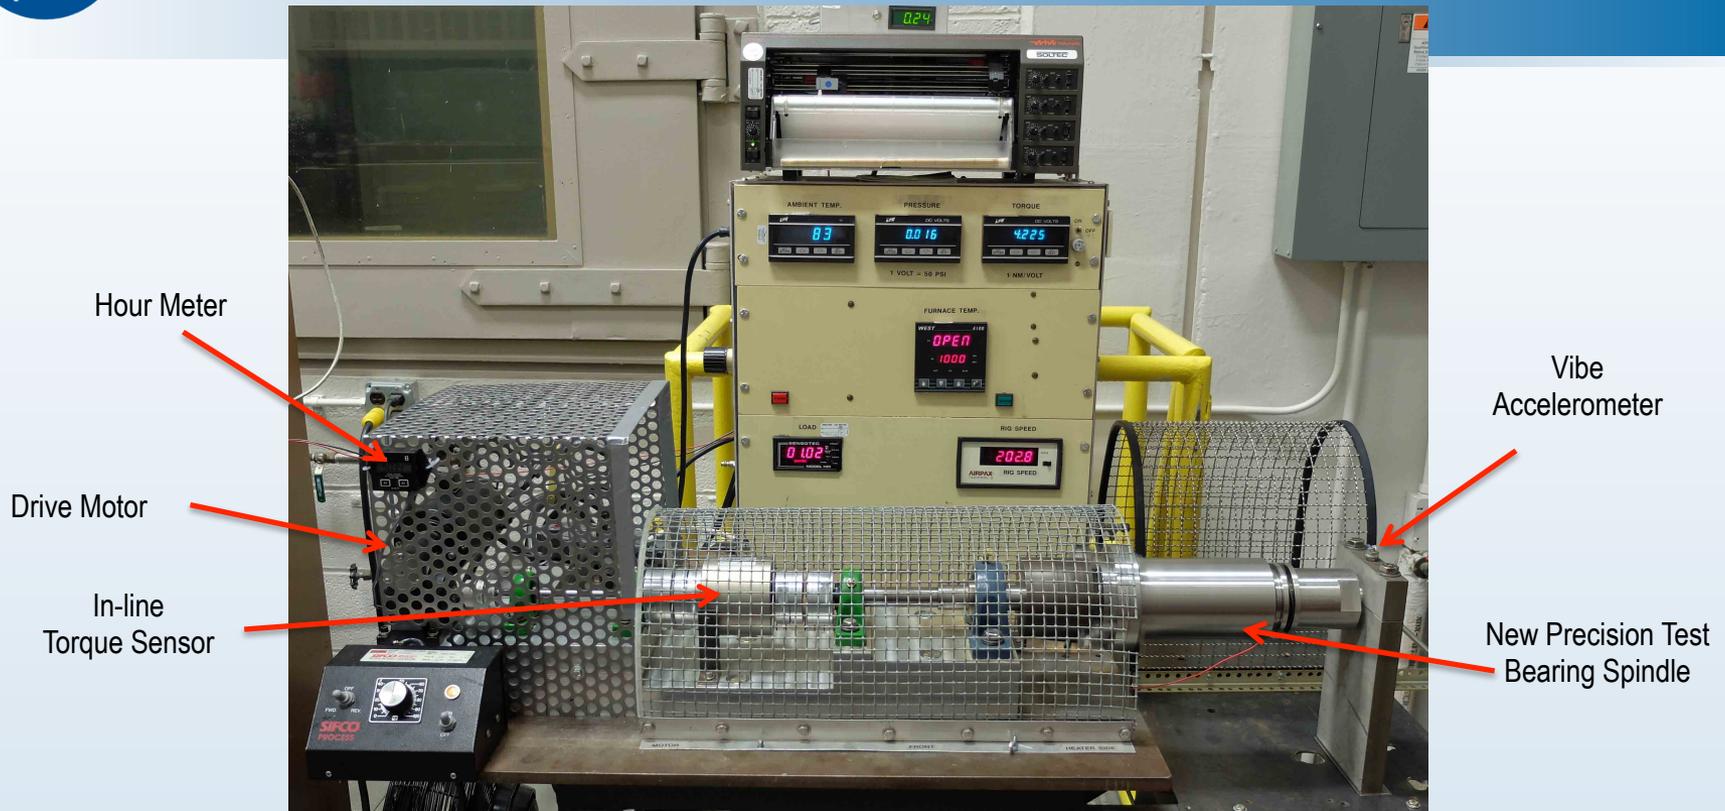
Bearing Life Test: Proper (Catalogue) Fits

- *Long-term (5000+ hour) tests begun on new flight bearings to verify life.*
- *New rig shaft and sleeve made with “to print” flight-like dimensions and DA fits.*
- *Bearing bore dimensions, concentricity and square verified with CMM.*
- *Outer race is a line to 0.0003” interference fit. Inner race has 0.0003” clearance.*
- *Accelerometer with hourly vibe spectrum data capture used for health monitoring.*
- *Interim bearing inspections at 1100, 5000 and 10,000 hours.*

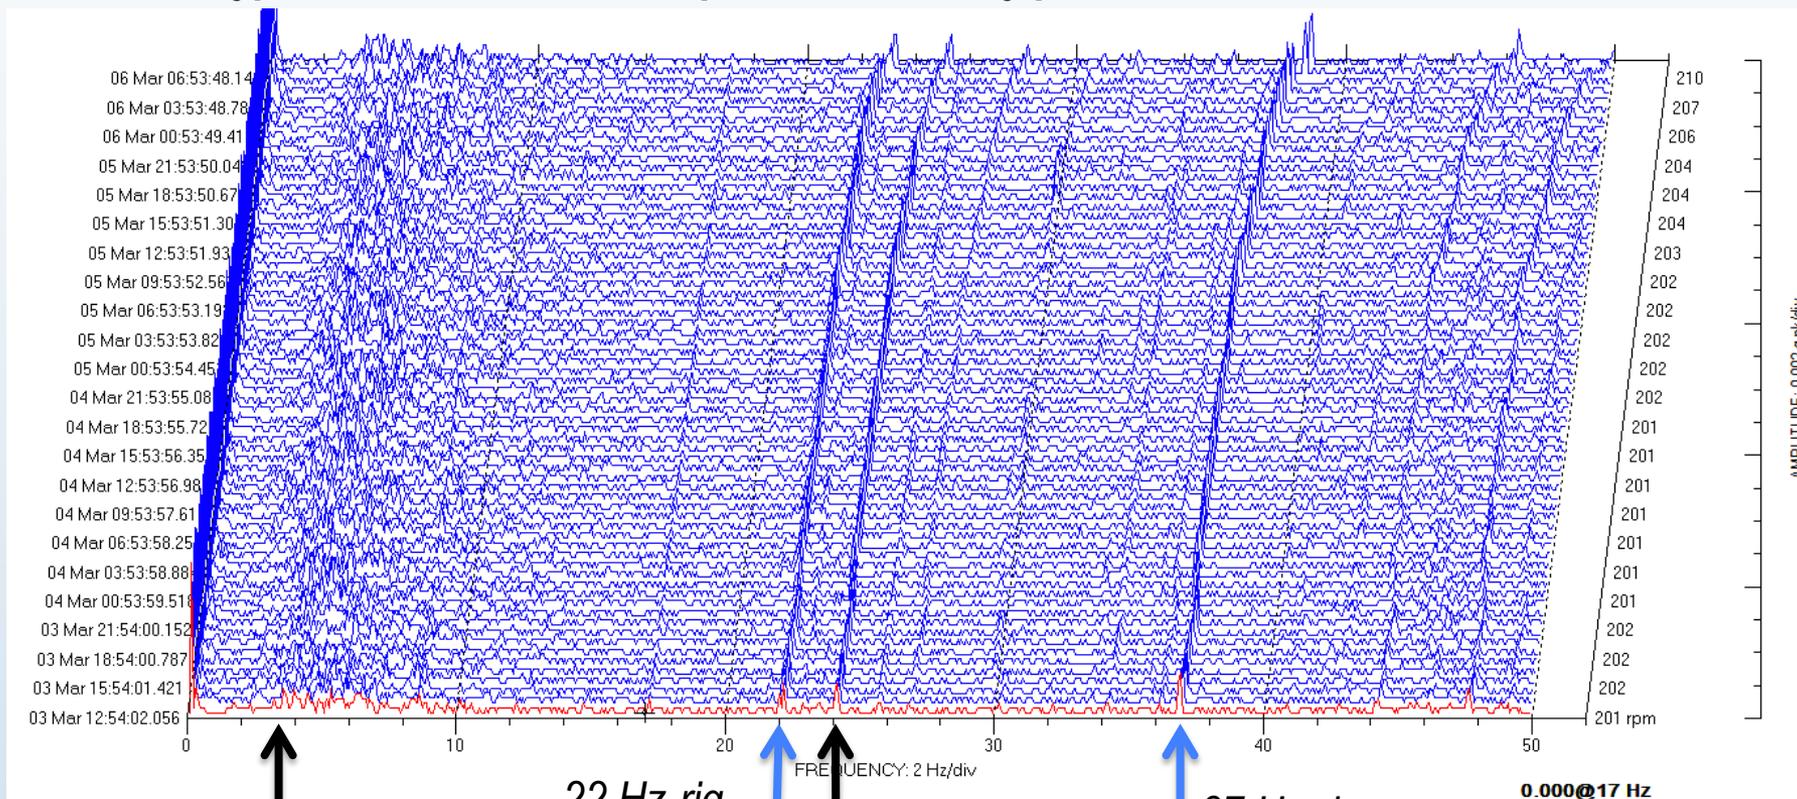
Bearing Life Test: Vibration plot at 1100 hours

- *Typical vibration cascade plot for three day period shown below:*

3.2 Hz-shaft
rpm

22 Hz-rig
support brg

24 Hz-ball pass
frequency

37 Hz-rig
support brg

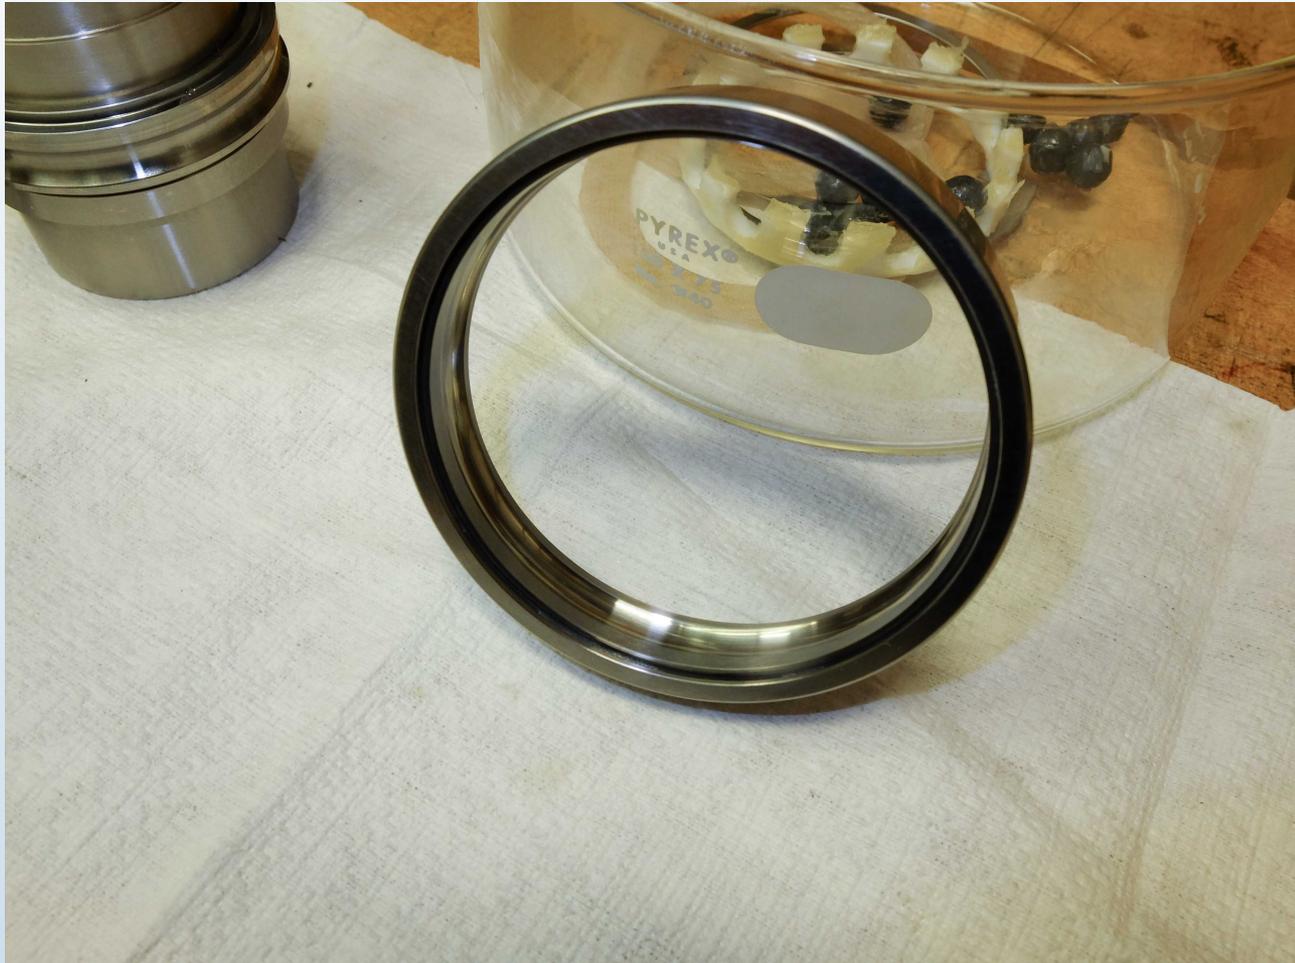
Bearing Life Test: Inspection at 1100 hours

- *Lubricant grease looks new, no visible wear or damage on races.*

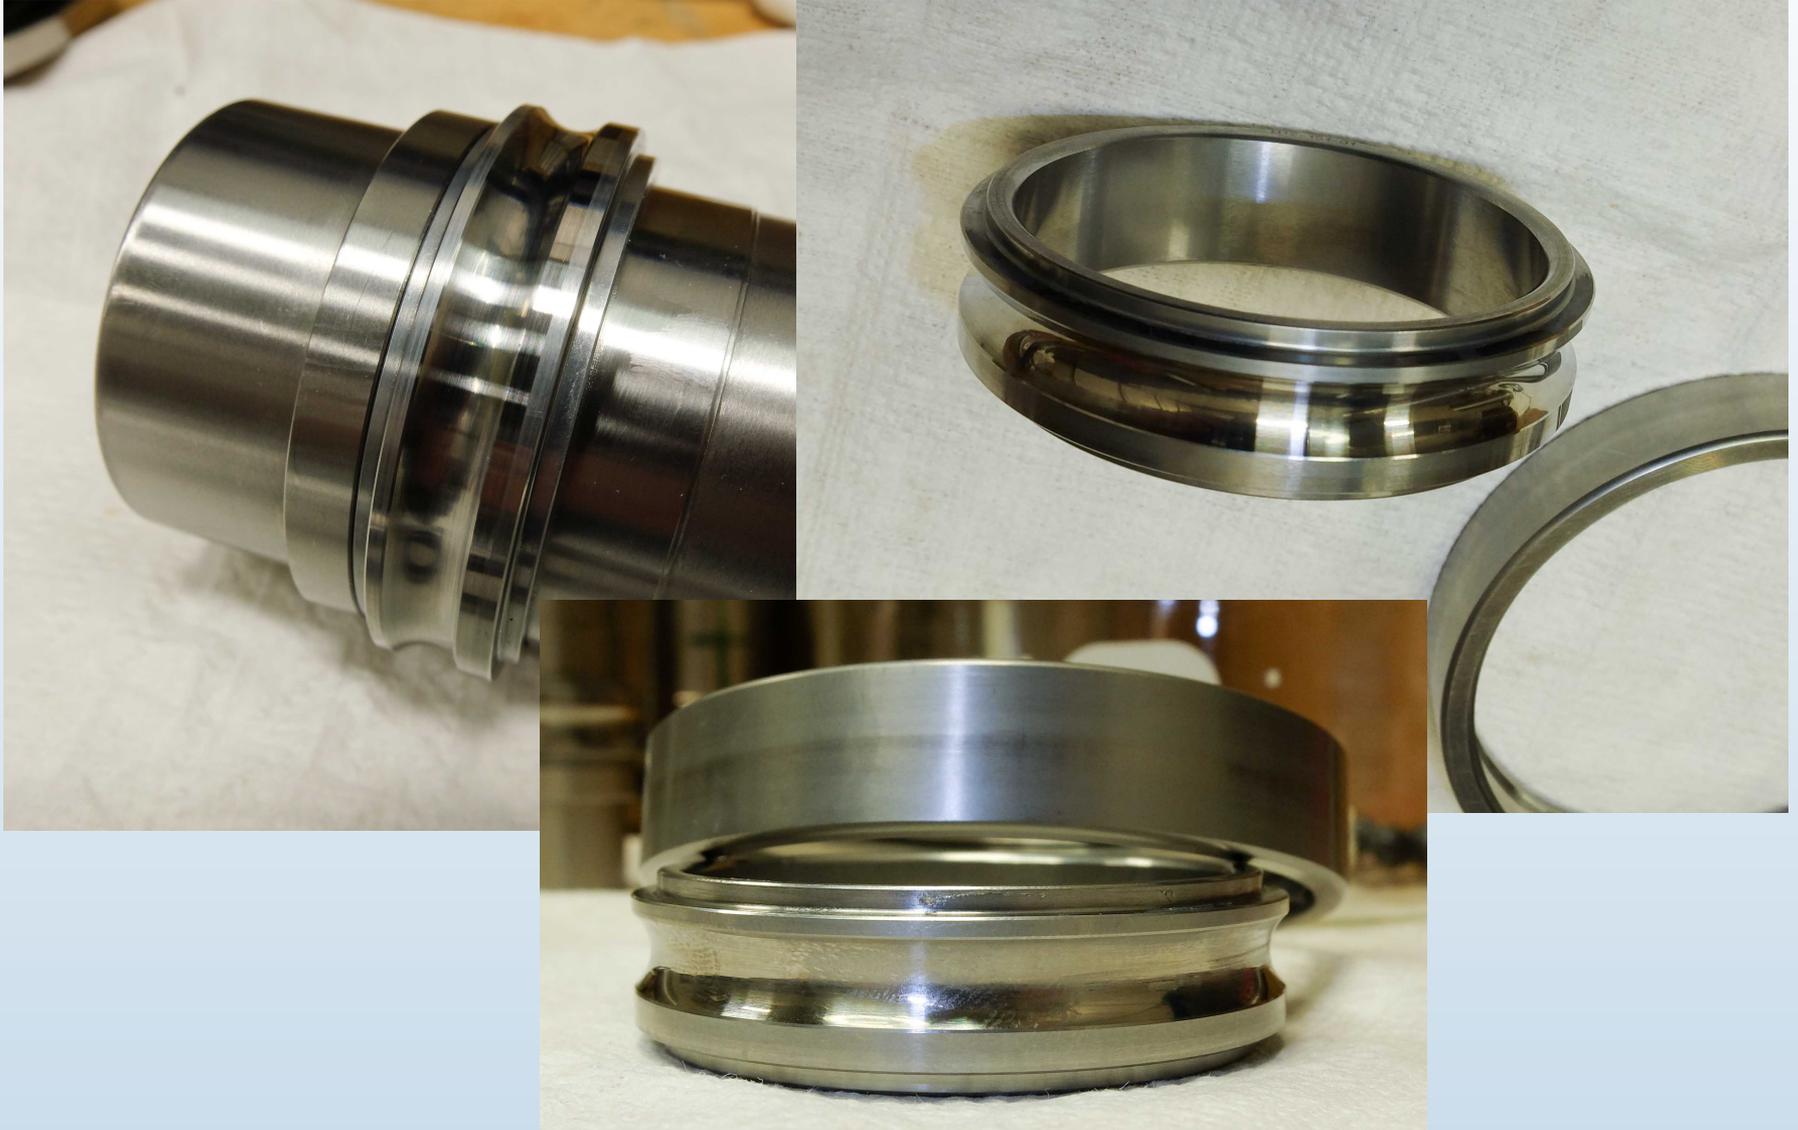
Bearing Life Test: Inspection at 1100 hours

- *Inner race surfaces shiny and without any apparent wear or other signs of contact damage.*

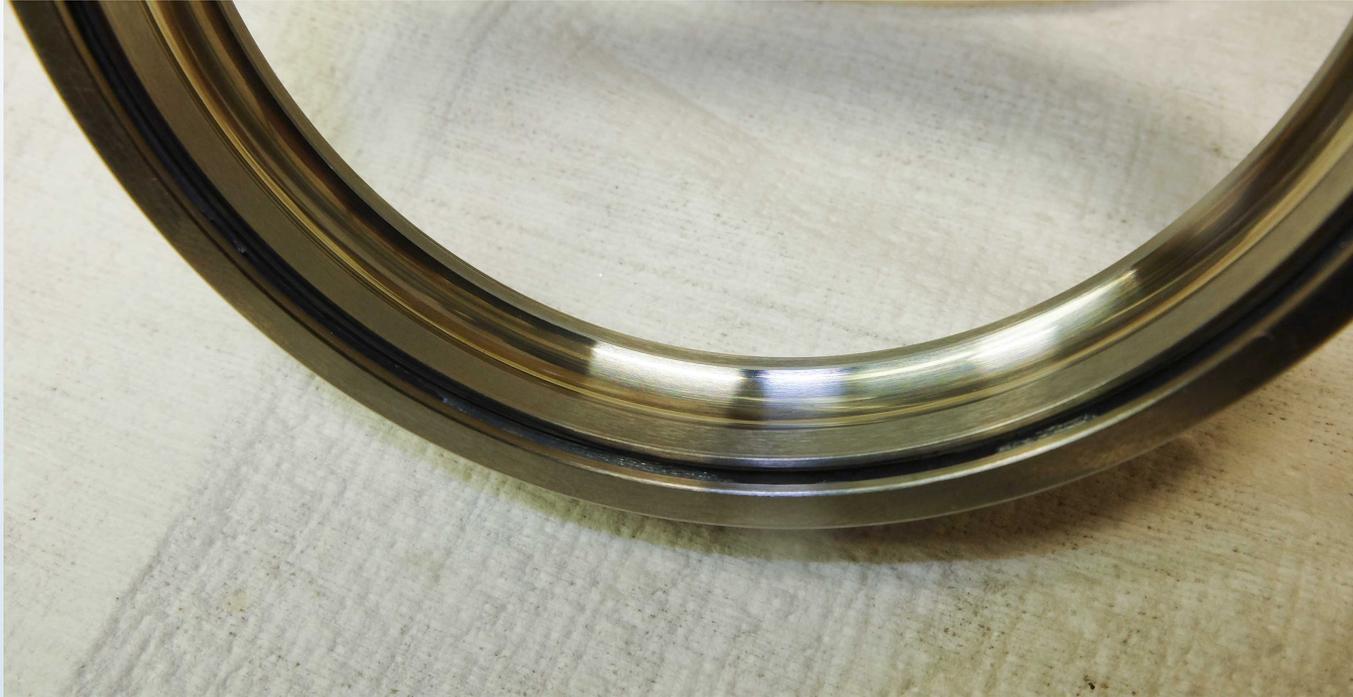
Bearing Life Test: Inspection at 1100 hours

- *Outer race looks fine too.*

- *Bearings were cleaned, visually inspected, re-greased and re-started.*
- *Health monitoring (torque and vibration) used to indicate failure.*

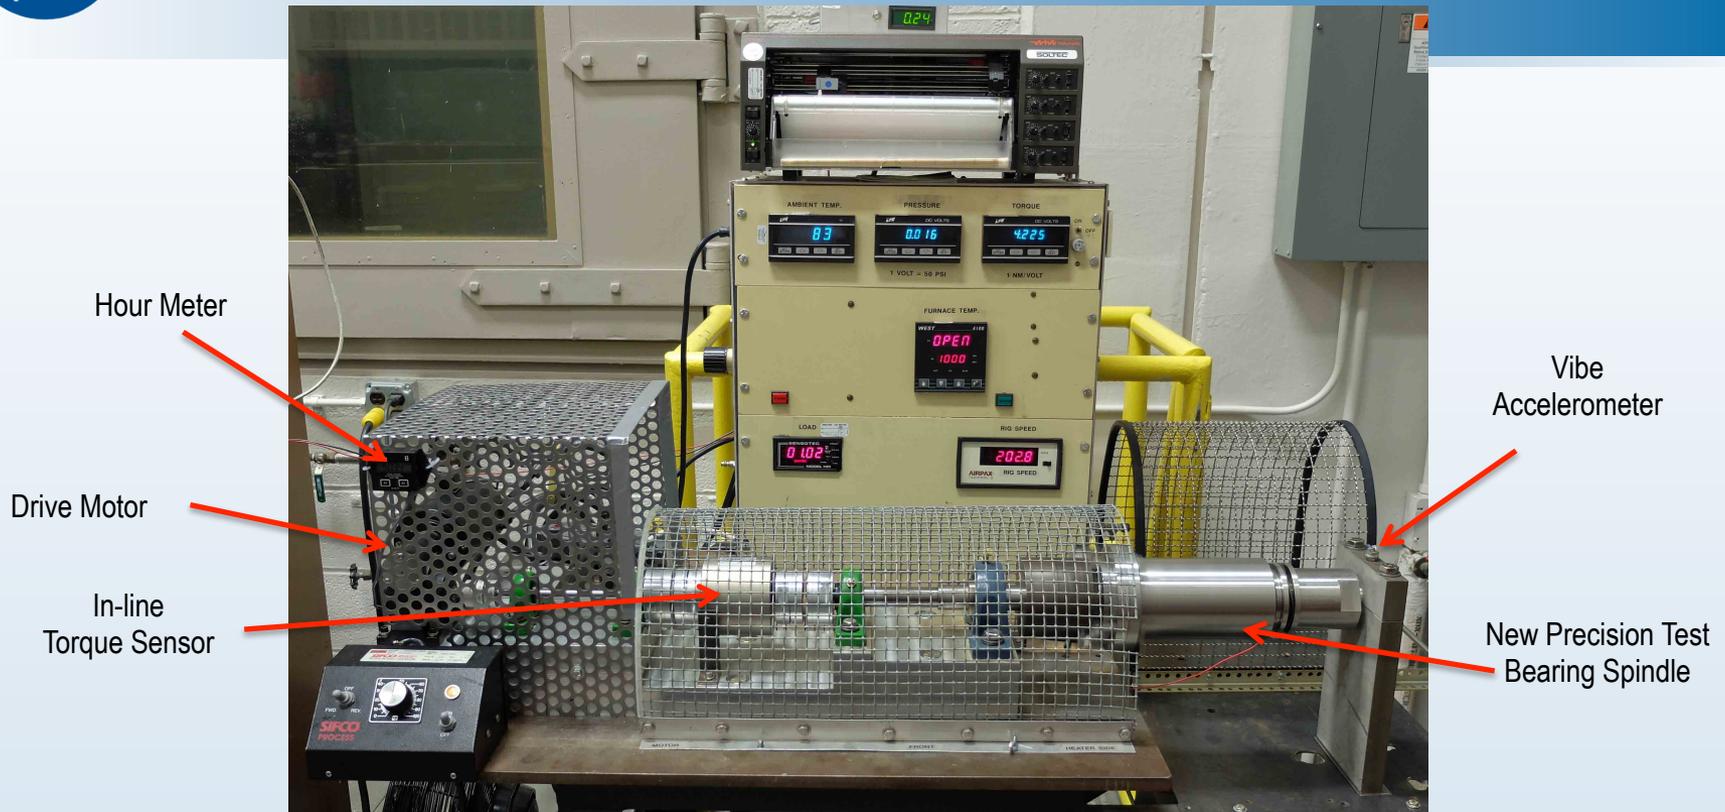
Bearing Life Test: continues

- ***Bearings were cleaned, visually inspected, re-greased and re-started.***
- ***Accelerometer with hourly vibe spectrum data capture used for health monitoring.***
- ***Tests continued (24/7) until vibration changes or 5000 hours reached.***
- ***5000 hour inspection revealed no changes. Tests concluded at 10,000 hour point (05/02/16).***
