## JAMES WEBB SPACE TELESCOPE (JWST) INTEGRATED SCIENCE INSTRUMENTS MODULE (ISIM) CRYO-VACUUM (CV) TEST CAMPAIGN SUMMARY

### ABSTRACT

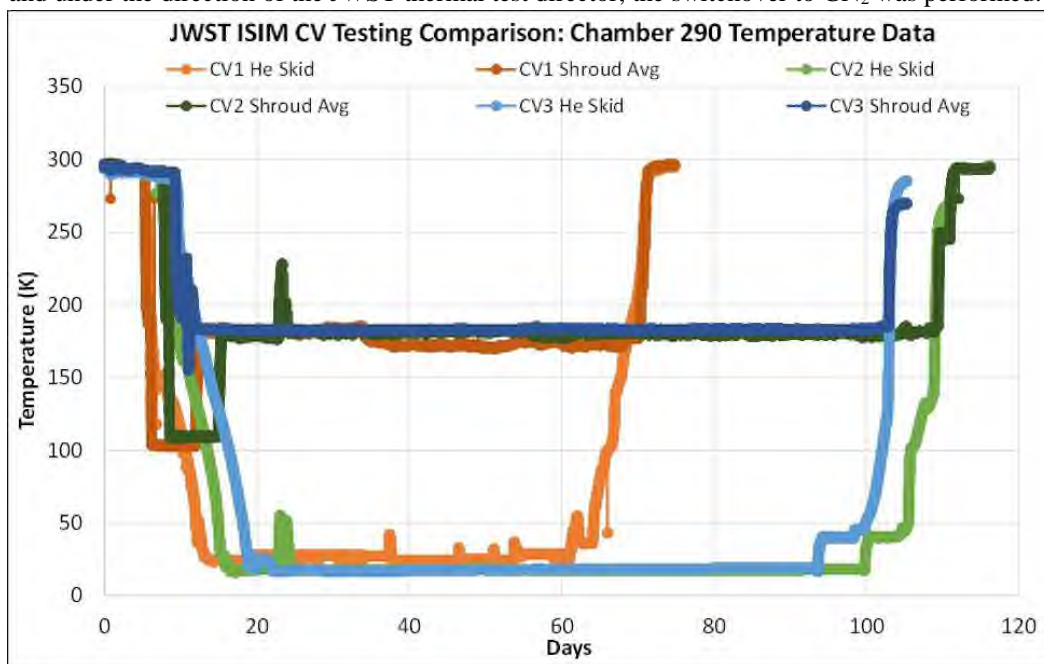
*Figure 7. ISIM CV Facility N<sub>2</sub> and He Shroud Temperature Results*

The nitrogen and helium shroud systems proved capable of maintaining required nominal operating temperatures. The nitrogen shroud operated at  $182\text{K} \pm 4\text{K}$  ( $-91^\circ\text{C} \pm 4^\circ\text{C}$ ) during every test at steady state GN<sub>2</sub> conditions, while the helium shroud achieved  $24\text{K} \pm 1\text{K}$  ( $-249^\circ\text{C} \pm 1^\circ\text{C}$ ) for the same test duration (Figure 7). The steady state temperatures reported here neglect the temperature fluctuations that resulted from facility-related issues, such as helium skid compressor shutdowns or power outages that would result in temperature spikes. Despite several efforts to locate a known leak in the nitrogen shroud prior to ISIM testing, these efforts were unsuccessful. As a result, during the steady state portions of the CV test campaign, the nitrogen shroud operated in GN<sub>2</sub> mode, to prevent the cold leak in the shroud to worsen in a flooded LN<sub>2</sub> shroud situation. To facilitate the initial cool-down stage of the test, however, the nitrogen shroud was flooded with LN<sub>2</sub>. Upon achieving a helium shroud temperature around 50K ( $-223^\circ\text{C}$ ) and under the direction of the JWST thermal test director, the switchover to GN<sub>2</sub> was performed.

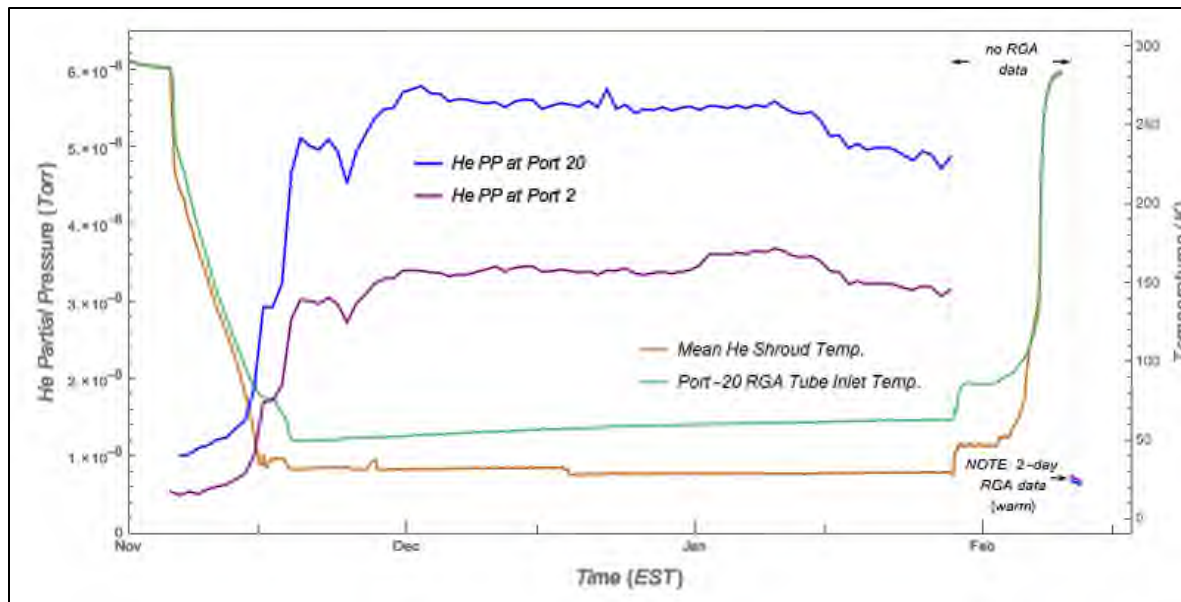
Figure 10. Average daily helium partial pressure measured at Ports 2 and 20 in relation to the mean helium shroud temperature and the inlet temperature of the Port 20 sampling tube.

Average daily helium partial pressures, covering most of the CV3 test campaign, are presented in Figure 10 and show evidence of a helium cold-leak within the helium-shroud or STMS enclosures. The inverse relationship between partial pressure and temperature may be the result of actual cold-leaks in addition to the effects of thermal transpiration on partial pressure measurements at each RGA. While it is difficult to quantify thermomolecular pressure increases over actual cold-volume values, due to the latter effect, they are presumed, from ideal theory, to be equivalent for corresponding RGA measurements. Therefore, pressure *differences* between Port 2 RGA and Port 20 RGA values are taken as physical and the result of leaks. One may wish to advance a caveat after considering warm partial pressure measurements at the beginning and end of CV3. Port 2 and Port 20 RGA values were nearly identical over the two days in February just prior to the helium skid being shut down and evacuated while the values are noticeably different for comparable conditions early in the test – comparable within cleanliness changes over months in vacuum.

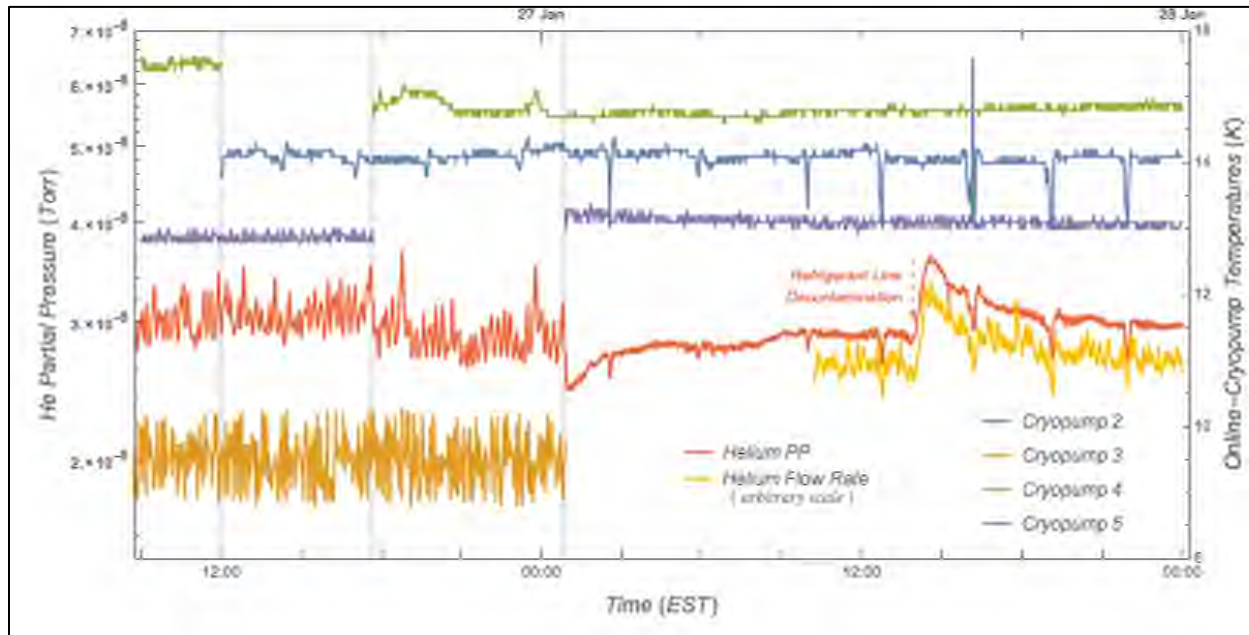
Figure 11. Plot of cryopump temperatures and Helium partial pressure during a period of various online cryopump combinations (trios) and initiation of cryocooler refrigerant line decontamination (exterior surface). Also shown is the flow rate profile from a Helium leak detector – plumbed in parallel with a mechanical pump and, together, backing the main chamber turbopump – during decontamination

Full verification of the MIRI cooler leak-rate requirement was again beyond reach in CV3. Helium partial pressure levels as seen, for example, in Figure 11 correlate to flow rates on the order of  $2 \times 10^{-4}$  sccs, as measured with a helium leak detector plumbed in the fore-line of the chamber turbopump. The corresponding flow rate profile, on an arbitrary scale, is also shown in Figure 11 for a period before and during decontamination of the RLDA and connected hardware. This correlation was verified through a procedure involving the rapid release of a known amount of helium, accumulated from a standard leak, into the SES chamber and observed with continuous measurements by both RGAs and the helium leak detector.

While steady-state pumping of helium is accomplished by the chamber turbopump, the chamber cryopumps can have significant effects on the partial pressure of helium. Whereas steady cooler leaks above requirements would have been obscured by the background rate, sudden changes at requirement level had the potential to be observed, as was the case during decontamination of the RLDA. That potential depended on which trio of cryopumps was on-line at any one time. Large fluctuations in partial pressure, as seen to the left in Figure XX, surely obscured changes that could be seen at more quiet times. This was clearly were not measurement noise since concurrent profiles from the two RGAs and leak detector match fluctuations perfectly, each to the other. Notice how features in the coldhead temperature profile for Cryopump 2 clearly match changes in the helium background when Cryopump 3 is off-line and are obscured when on-line. Cryopump 3 is an older  $\text{\Oerlikon-Leybold COOLVAC 60k BL-V LN2}$ , with dual GM refrigerators, while Cryopumps 2, 4, and 5 are newer  $\text{PHPK/CVI TorrMaster TM1200}$  pumps, with single GM refrigerators. None of these features has been investigated further for causes; however, one can clearly follow the hours-long progression to helium saturation of the cryoadsorption arrays of Cryopump 5, after it was brought back on line following regeneration.

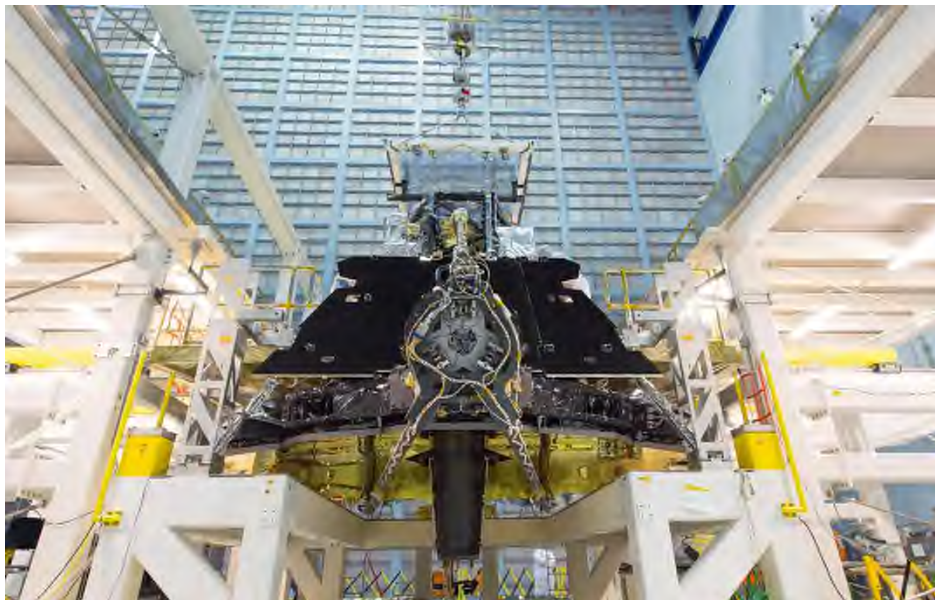
*Figure 10. Fully integrated OTIS (OTE + ISIM) in the NASA GSFC Class 10,000 cleanroom*

Successful completion of the JWST ISIM CV test campaign in March 2016 demonstrated that the procedures and operational capabilities of the SES are sufficient for a technically challenging program as marked by JWST ISIM-level requirements verification with all four SIs will be performed. The ISIM hardware is currently at the next level of integration with the OTE (Figure 10).
