# Demonstration Project using Railroad Flatcars for Low-Volume Road Bridges

Sponsored by the  
Iowa Department of Transportation  
Highway Division and the  
Iowa Highway Research Board

Iowa DOT Project TR-444

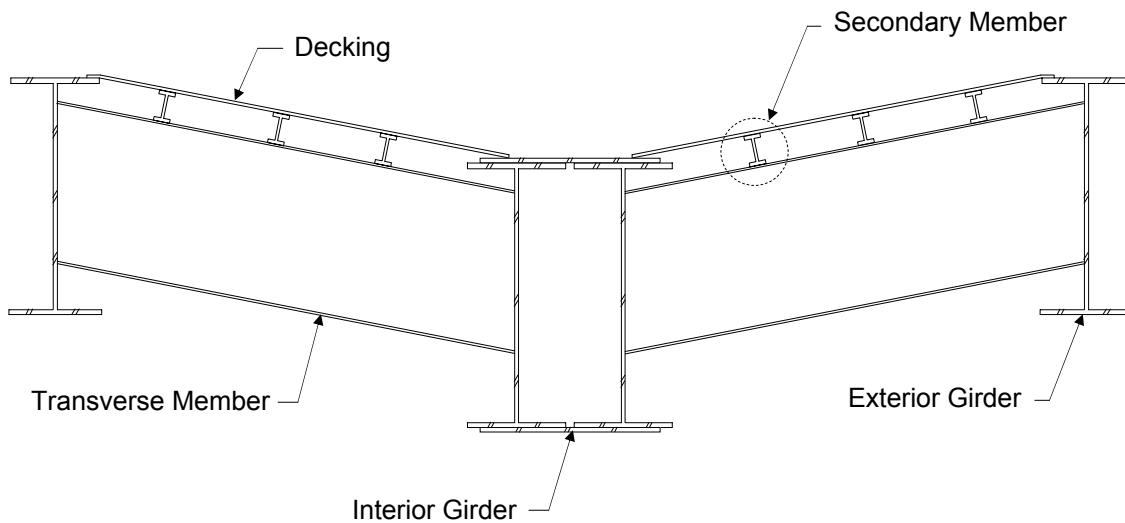
Figure 2.1. Identification of RRFC structural members.

Through inspection of the RRFCs, it was found that although the configuration of the elements in RRFCs may be different, the structural functions of the elements in each configuration remain the same. Therefore, the structural elements of RRFCs can be put into four categories: decking, girders, secondary members, and transverse members. As illustrated in Figure 2.1, the decking is the top plating on each RRFC; girders and secondary members are oriented longitudinally in the RRFC. Girders are the largest members in the RRFC, and thus, will support most of the loads since they will be supported at the piers and/or abutments. Each typical RRFC has three girders – two exterior and one interior. The transverse members are connected orthogonally to longitudinal members, and transfer loads from the secondary members to the girders. Secondary members are the remaining longitudinal members that typically transfer load from the decking to the transverse members.

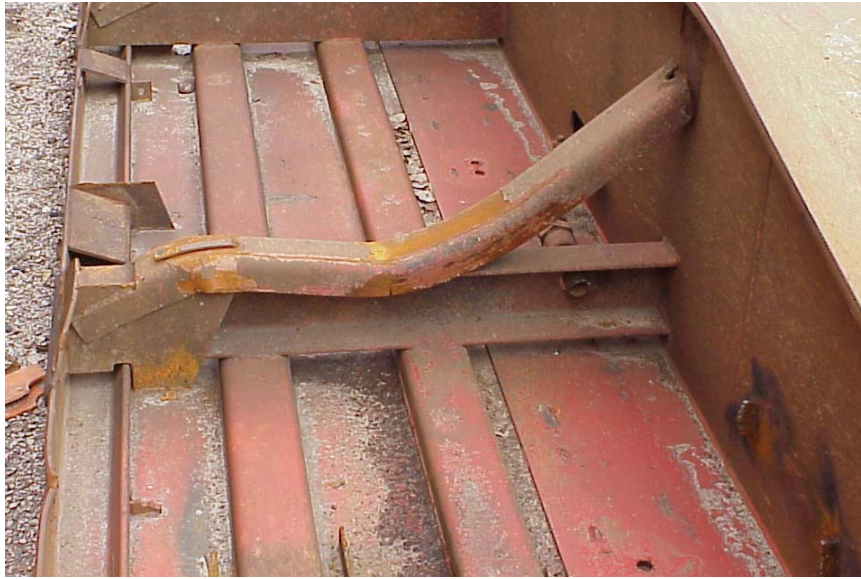
Figure 2.8. The deformed transverse member in AF4.

Both remaining flatcars (AF2 and AF3) had welded connections, and therefore, the camber and straightness of members were next inspected. Visual observations and camber measurements clearly identified a severely deformed exterior girder in AF2; therefore, it was rejected. Although AF4 had already been eliminated, it should be noted that one of its transverse members was severely deformed as illustrated in Figure 2.8, and as a result, load distributing capabilities of the RRFC were limited. An attempt was made to replace the damaged AF4 with an identical substitute, but the Erman Corporation reported that AF4 was not readily available and that it would be difficult finding replacements. AF3 proved to have “straight” members, was verified to be readily available, and the maximum variation in camber among the flatcars was approximately 1 in. Considering 1 in. camber variation to be manageable, all selection criteria were met and AF3, the 89-ft (Type A) RRFC, was selected for use in the WCB.

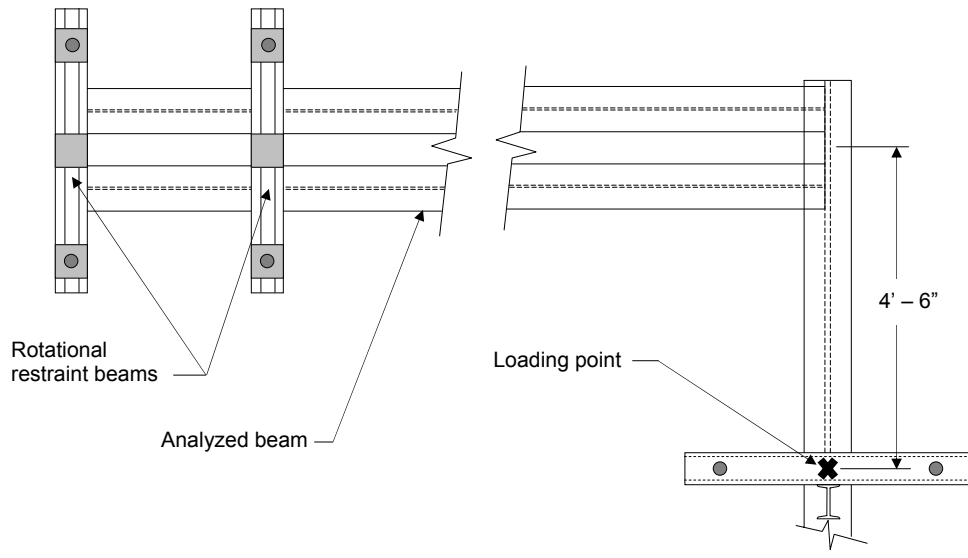
The FEA previously noted was performed on one of the W-shapes in the LCS; this W-shape is identified in Figure 5.6a. The modeled W-shape and the location of the strain gages on the flanges of that W-shape are presented in Figure 5.6b. The W-shape was modeled with the element *Shell63* in ANSYS. This element has six degrees of freedom at each node – translations and rotations about the nodal x, y, and z axes; the element is defined by 4 nodes, an element thickness, and material properties. As will be discussed in Chapter 6, the largest measured horizontal, vertical, and rotational displacements during the entire Ultimate Load Torsion Test were 1.67 in., 0.47 in., and 8.6 degrees, respectively. For each FEA, these displacements were applied to the rotating end of the LCS as boundary conditions to accurately reflect loading in the Ultimate Load Torsion Test.

a. Top view of analyzed W-shape

b. Isometric view indicating strain gage locations

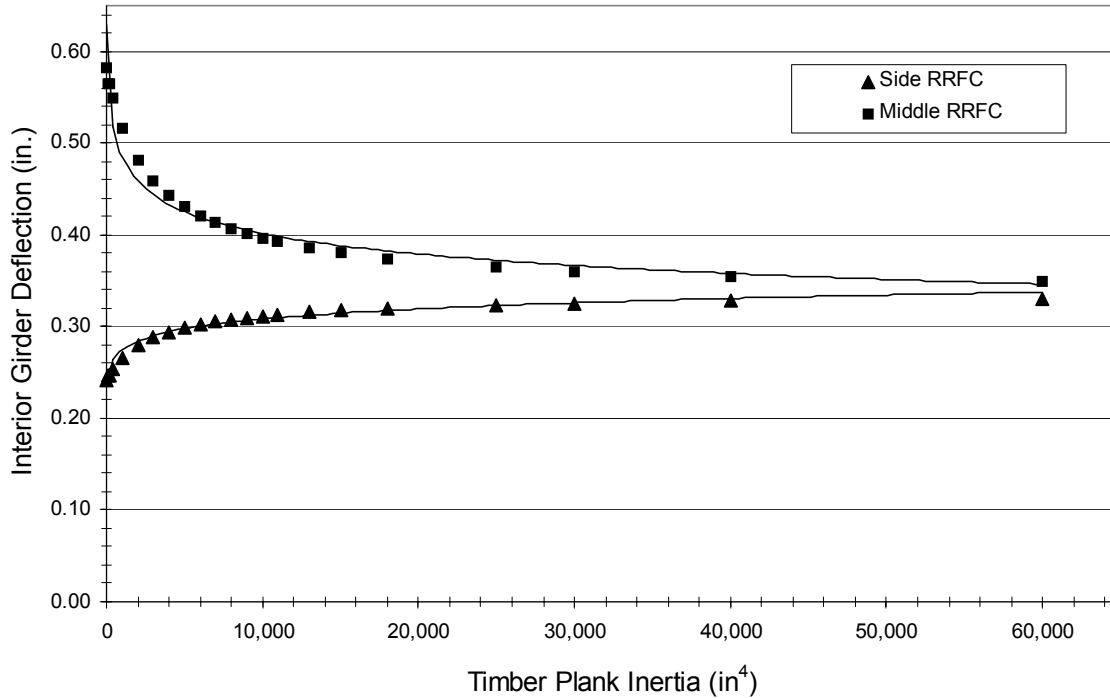
Figure 5.20. Relationship between timber plank inertia and interior girder deflections.

For a transversely centered truck on the WCB, Figure 5.20 illustrates the relationship between the timber plank inertia and interior girder displacements on the center and side RRFCs. This plot was created by varying the timber plank inertia in the model for the given loading condition, and then plotting the girder displacements versus timber plank inertia from each analysis. Note that as the timber plank inertia is increased, deflection is less for the interior girder in the middle flatcar while the deflection increases for the interior girder in the side flatcars. Since girder displacement is directly related to loading on the member,

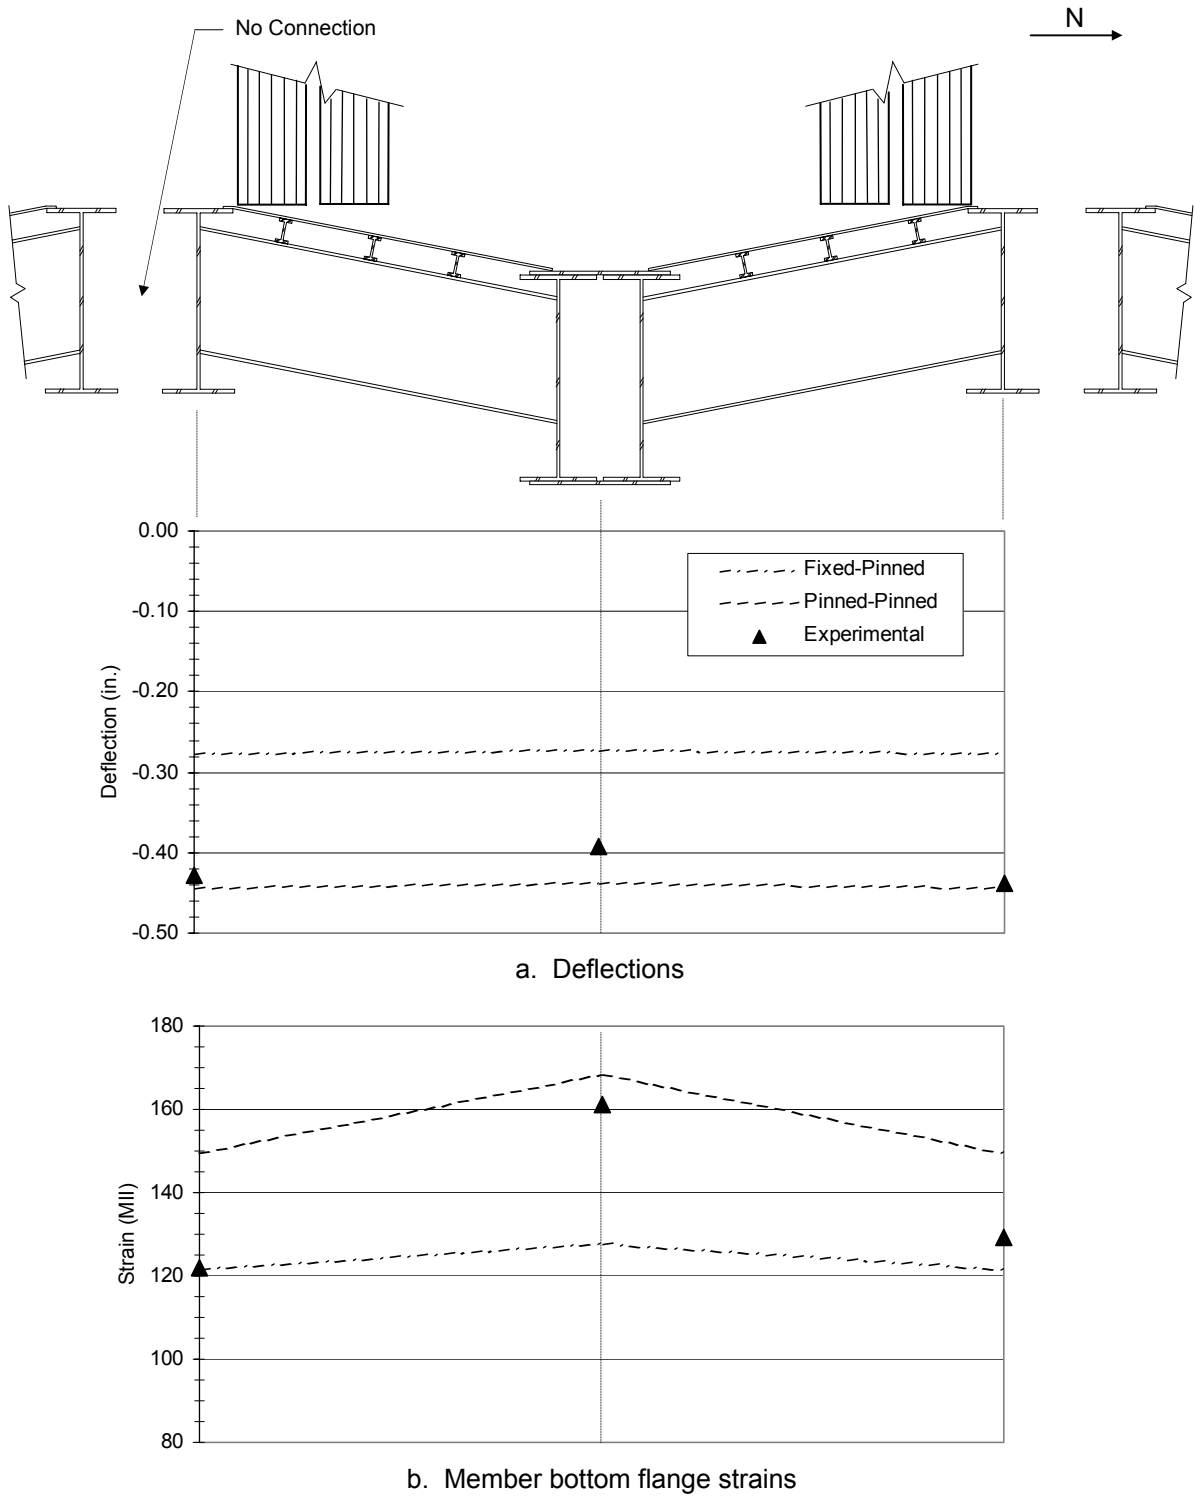
Figure 6.4. Comparison of BCB LT1 Test 1 midspan deflections and strains.

In Figures 6.4 – 6.6, the maximum midspan displacements and strains that were measured in all three tests of LT1 are presented along with theoretical results. These displacements and strains occurred when the centerline of the tandem axle was at the midspan of the bridge. As can be seen in each figure, girder displacement patterns are as
