# Tree-Ring Reconstruction of Debris-Flow Events Leading to Overbank Sedimentation on the Illgraben Cone (Valais Alps, Switzerland)

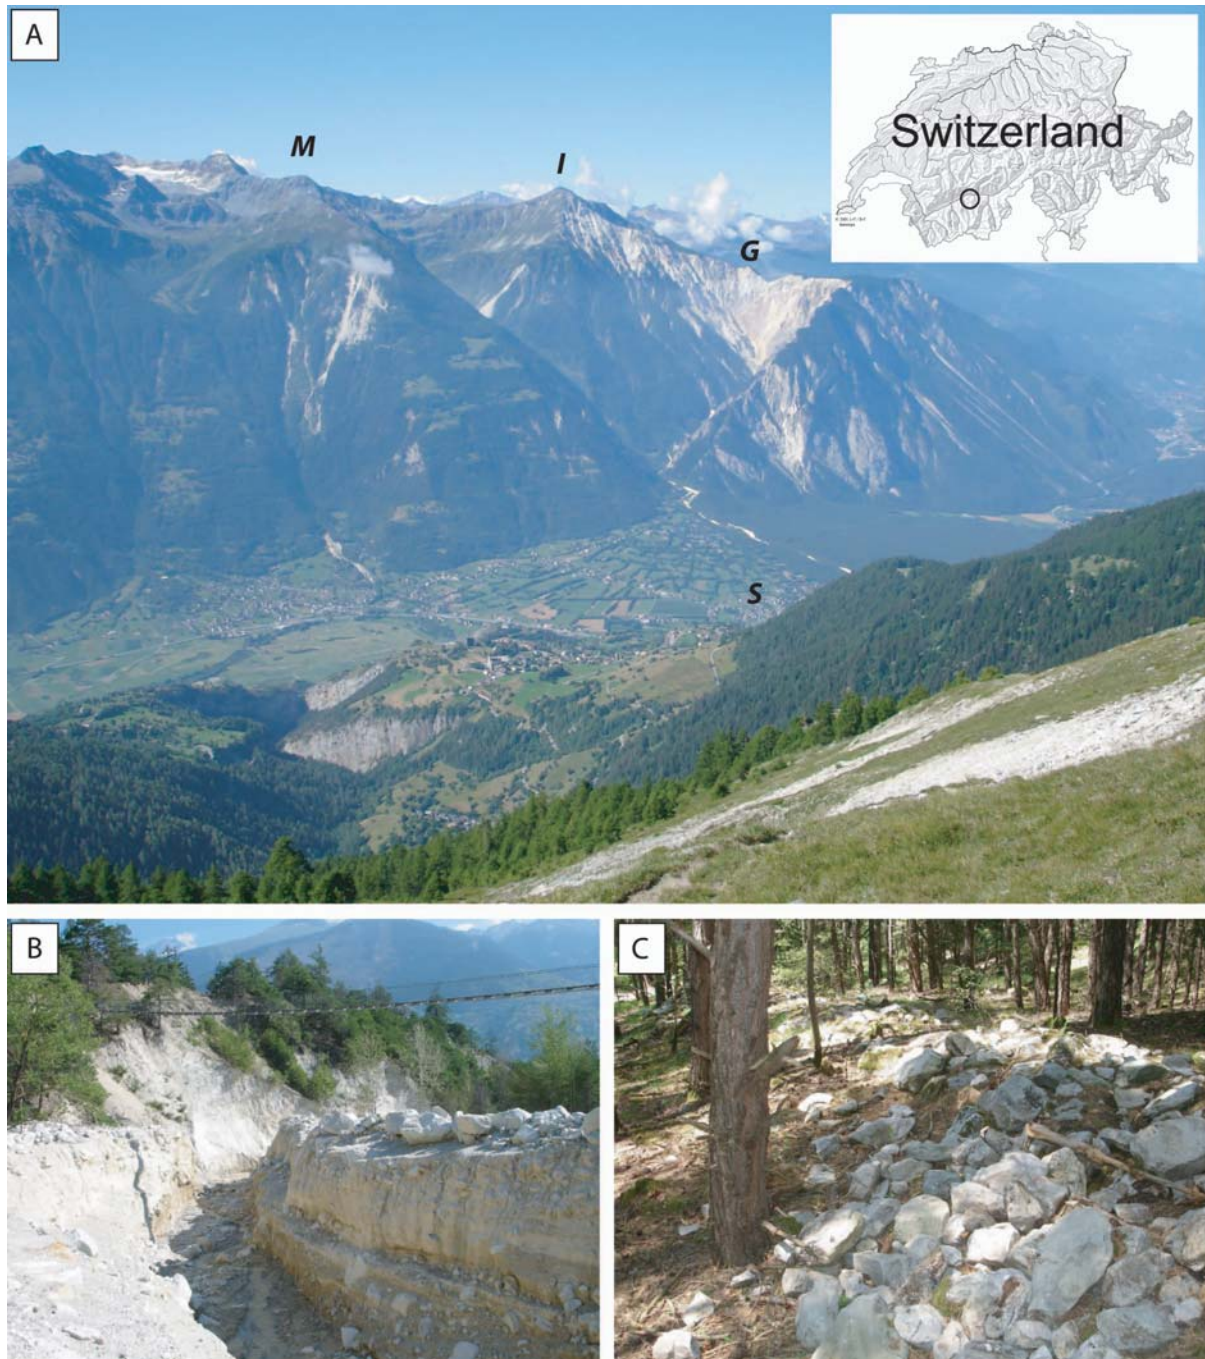
**Fig. (2).** (A) Overview of the Illgraben basin with the catchment located between the Gorwetschgrat (*G*), Illhorn (*I*) and Meretschihorn (*M*) and the debris-flow fan with the village of Susten (*S*); (B) The Illgraben torrent is deeply incised on the cone and the canyon reaches depths of up to 25 m; (C) Deposits of former debris-flow activity are scarce and levees are only identified occasionally on the present-day cone surface.

The area investigated in this study is the Illgraben, a mountain torrent located in the central part of the Rhone valley (Valais, Swiss Alps, 46° 18' N / 7° 38' E; Figs. (1 and 2A)). The catchment area of the Illgraben covers 10.5 km<sup>2</sup>.

The primary channel has a length of ~3 km, two thirds of the channel are located on the cone, where the torrent meanders in a deeply incised canyon (Fig. 2B). Present-day incision depths on the cone range from 3 to ≥ 25 m.

Debris-flow material originates from a huge and asymmetric erosion corrie between the Illhorn and the Gorwetschgrat (Fig. 2A). The south-east to north-east facing rock walls between the Gorwetschgrat and the Illhorn (2,716

Except for the terraces and a very limited number of lobate deposits or levees (Fig. 2C), geomorphic forms related to past debris-flow activity are comparably scarce on the present-day surface of the Illgraben cone. It appears that material was – as a result of the particular mineralogical composition, granulometry and water content of individual surges – deposited in centimetric to decimetric layers over considerable surfaces of the cone rather than in the form of “typical” lobes or levees.
