NASA/TM-2017-43; 7: 6

Emergency Locator Transmitter Survivability and Reliability Study

Chad M. Stimson ^{cpf} *Justin D. Littell*
Langley Research Center, Hampton, Virginia

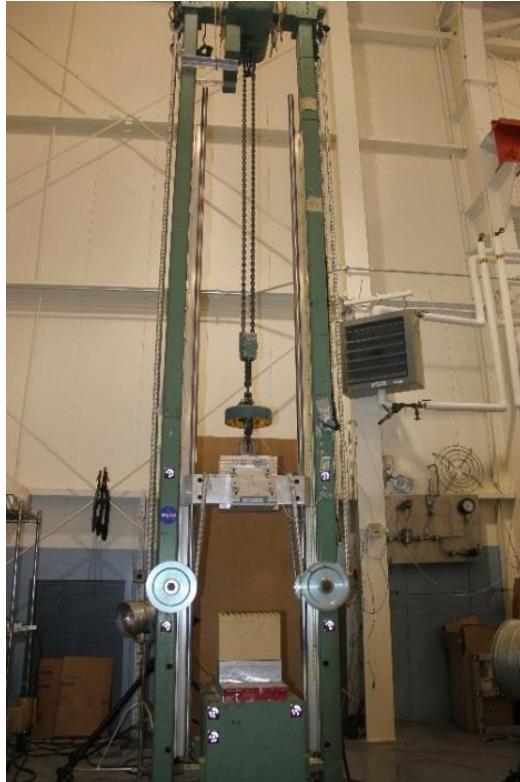
Figure 1. Vertical Drop Tower at LaRC

Crash safety testing was performed on a variety of commercially available ELTs representative of typical Automatic-Fixed (AF) GA systems. A total of 287 tests were conducted using the 14-ft vertical drop tower facility at LaRC, which is shown in Figure 1.

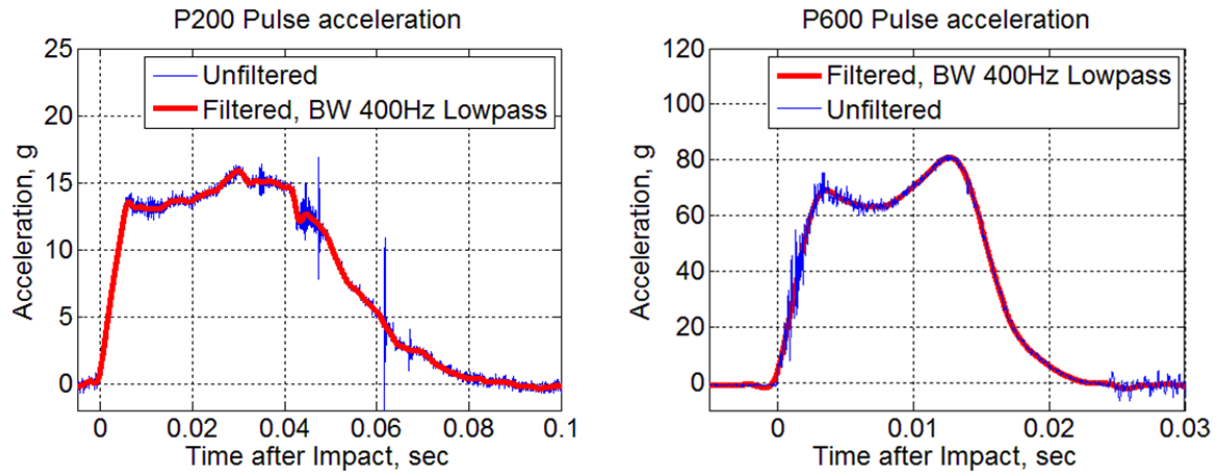
Figure 3. Representative Crash Safety Test Pulseforms

It is noted that the total energy contained within either pulse was lower than the one required by the current MOPS, ensuring that any negative performance observations would not be due to structural over-test. Given the correlation with fullscale airframe crash data and other existing standards governing emergency landing conditions, the P200/P600 pair was deemed to be a reasonable set with which to conduct the series of tests. A representative time-history of both pulses is shown in Figure 3.

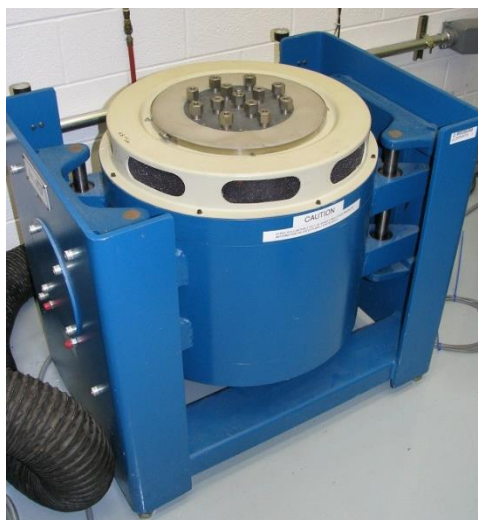
Figure 6. Vibration Test Facility

In light of documented performance issues of ELT crash sensors after exposure to in-service vibration environments [7], vibration testing of a variety of ELTs was conducted on the electro-dynamic shaker at LaRC shown in Figure 6.

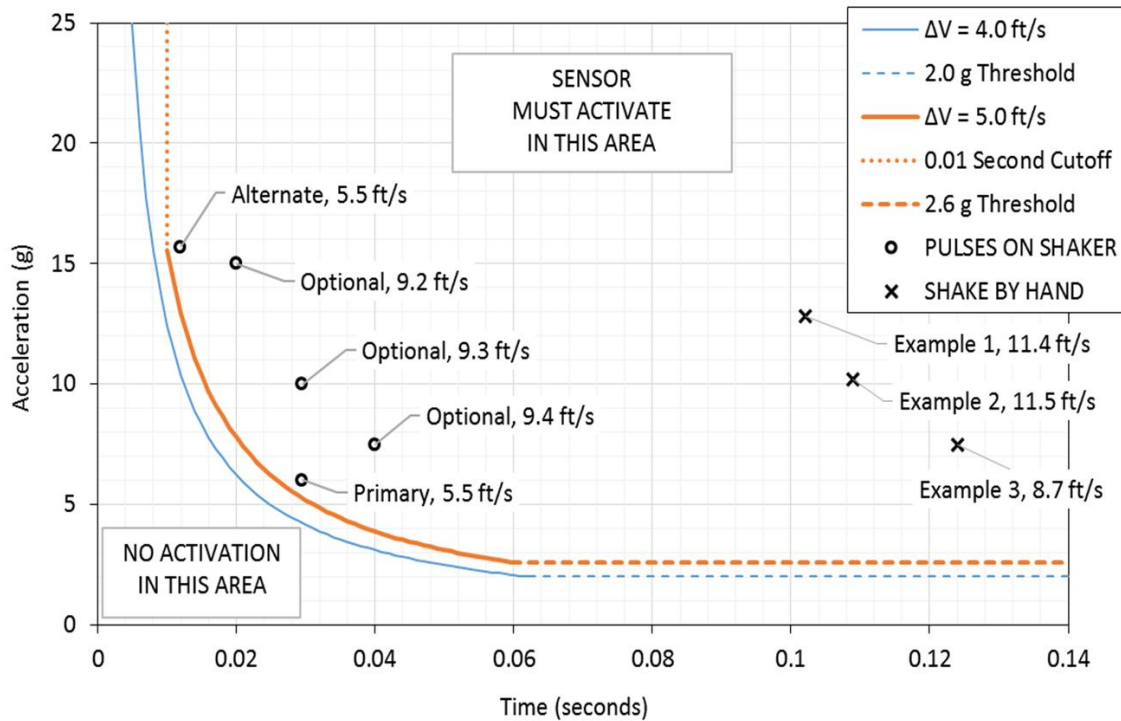
Figure 7. *Vibration Test - Aliveness Pulses Compared to Crash Sensor MOPS*

In the event that the aliveness pulse did not trigger the ELT to activate, an alternate pulse was used. This pulse was similar except for 15.7 peak-g's and 11.9-msec duration. Each of these pulses lie within the "must activate" range as defined in current ELT MOPS for crash sensor performance as shown in Figure 7. If the unit continued to fail to activate automatically, another series of pulses were input by the shaker and are labeled as "optional" in the figure below. In the event that the beacon failed to activate in response to all of the pulseforms input from the shaker, the unit was removed from its mount, shaken by hand until activation occurred, and the acceleration time-history was recorded by an accelerometer mounted directly to the beacon outer casing. Examples of the pulses recorded in this fashion are included in Figure 7.

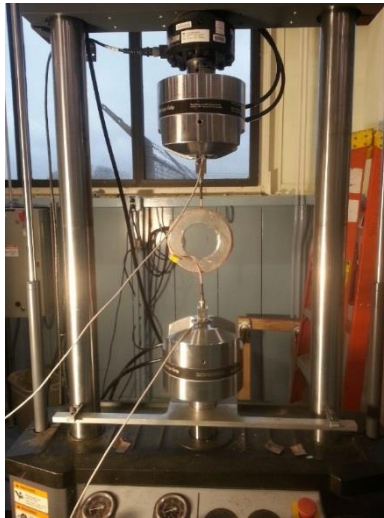
Figure 8. Antenna Cable Tensile Test Setup

Static pull testing of a variety of ELT cable systems (coaxial cable and Bayonet Neill-Concelman (BNC) connectors) was performed using a tensile test facility at a pull rate of 0.1-in/min. The objective was to determine relative strengths of a variety of cable systems commonly used in ELT installations. Cable systems were inspected for structural and electrical continuity during and following each test. The test setup, shown in Figure 8, included a circular ring to take up additional cable length beyond what could be accommodated within the facility stroke limit.

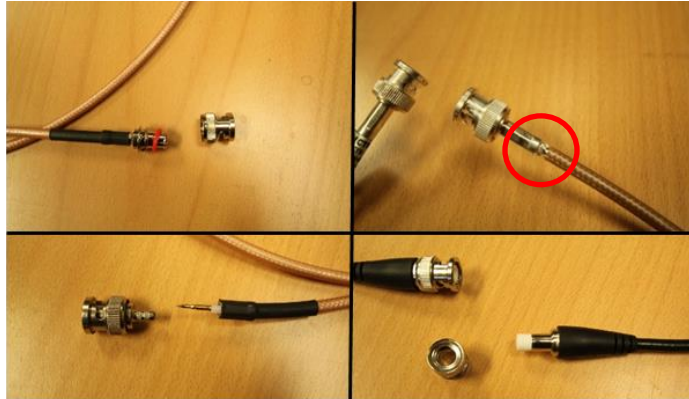
Figure 9. Antenna Cable Connector Failures from Strength Testing

It was observed that vendor supplied cables manufactured in accordance with MIL-DTL-17 exhibited higher static strength characteristics than generic, unmarked cables by a wide margin. For example, the range of static strengths observed with MIL-DTL-17 cable systems was on the order of 80-100 lbf as compared to 20-30 lbf for the generic cables supplied by some ELT vendors. Representative failures are shown in Figure 9.

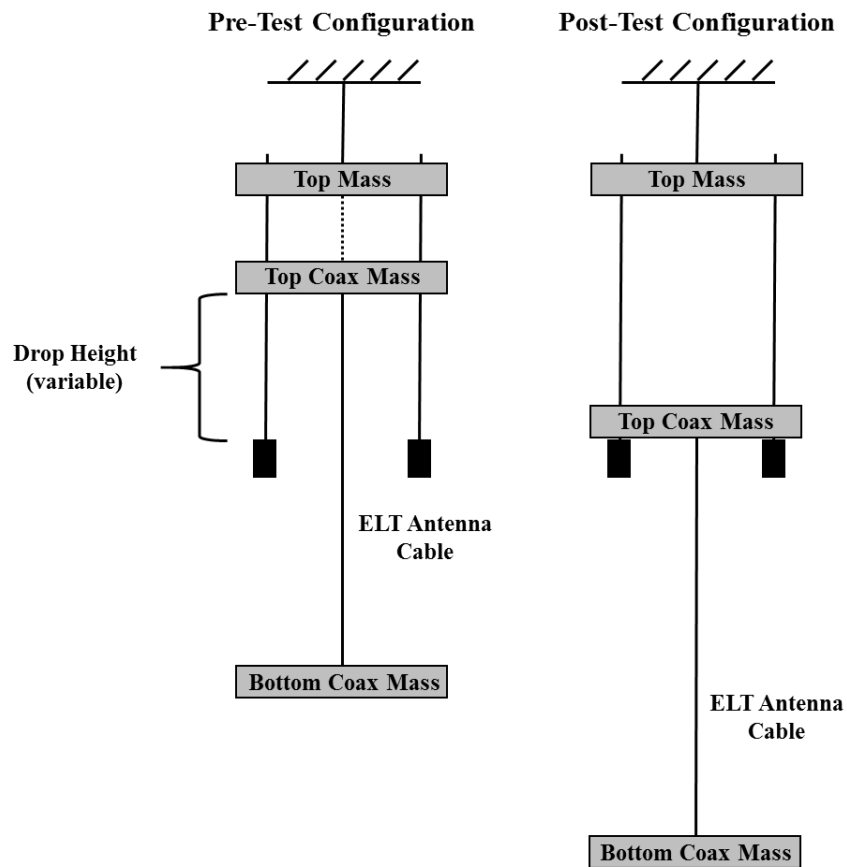
Figure 10. Antenna Cable System Dynamic Strength Test Setup

A schematic of the custom facility used for dynamic strength testing of ELT antenna cable systems is provided in Figure 10. The facility was designed to impart an impulsive tensile load on the ELT antenna cable, which was connected to the “top coax mass” and “bottom coax mass” by means of normal BNC connectors.

The test sequence began by severing the connection to the “top mass”, shown with dotted line in the left view of Figure 10, thereby initiating the freefall of the “top coax mass”, ELT antenna cable, and “bottom coax mass”. The freefall was guided by a pair of rods and ended when the “top coax mass” impacted a pair of stops. Two different freefall, or “drop height”, distances were tested, resulting in 5-ft/sec and 10-ft/sec velocities.

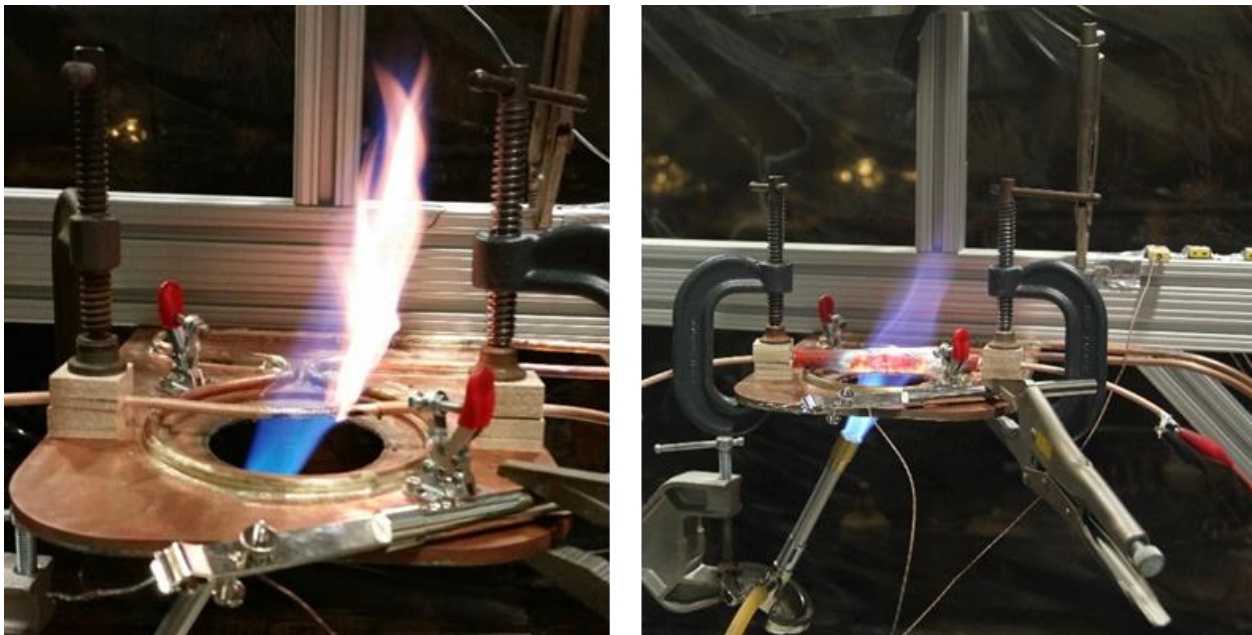
Figure 11. Fire Testing of an Antenna Cable without (left) and with (right) a Firesleeve

A Bunsen burner provided the flame, which enveloped a 1-2-in length of the cable under test. Thermal insulation products tested included an intumescent tape and a variety of firesleeves that are all marketed for the purpose of protecting electrical cables. A picture of a cable and firesleeve undergoing fire testing is shown in Figure 11.

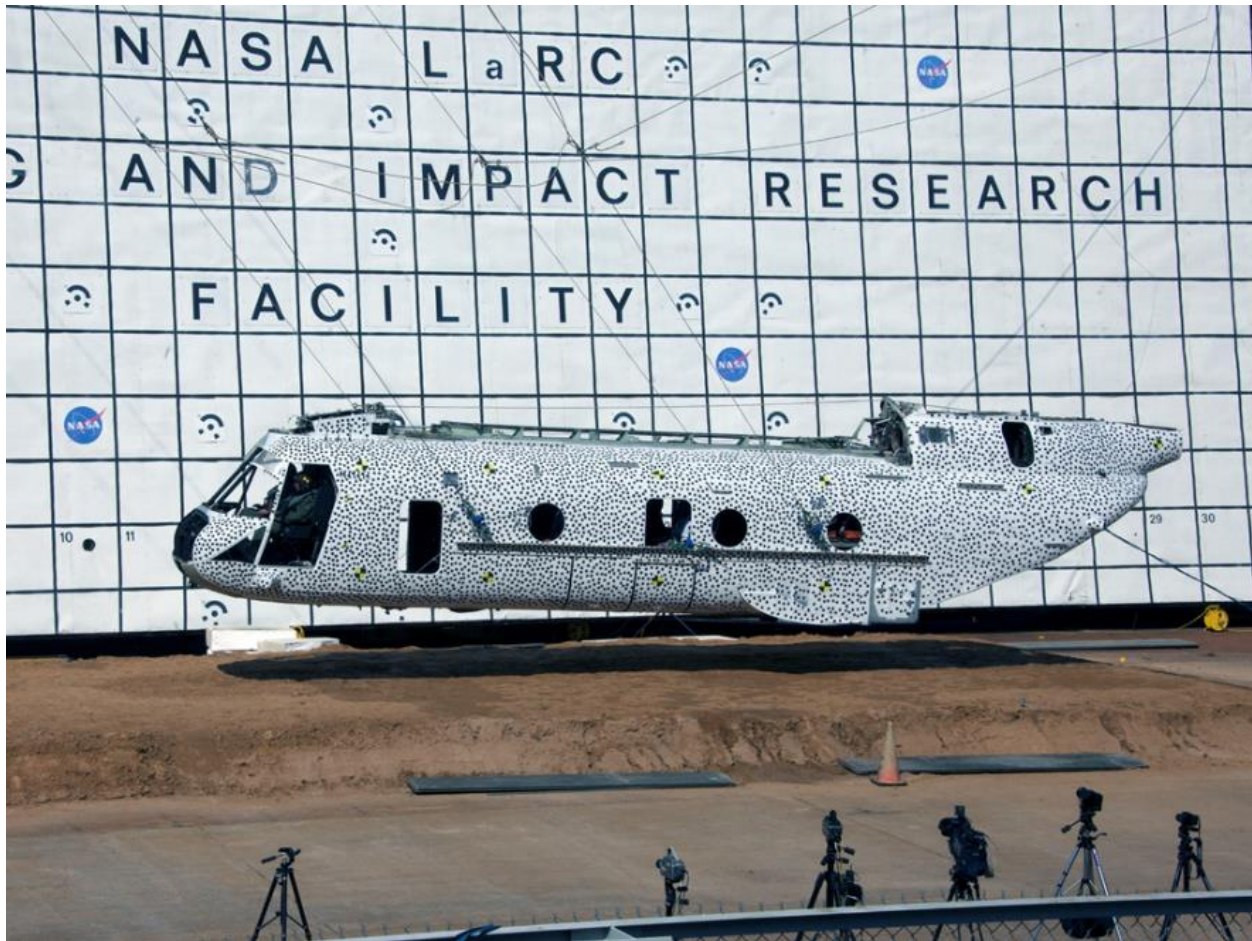
Figure 13. TRACT 2 Test Article

The TRACT 2 test was performed at the LaRC Landing and Impact Research Facility (LandIR) in October of 2014. The test article, a CH-46E fuselage carrying over a dozen experiments onboard, impacted soft soil at 33-ft/sec forward and 25-ft/sec vertical combined velocities. A full description of the test, except for the ELT component, was presented to the American Helicopter Society (AHS) International 71st Annual Forum [22]. A view of the test article exterior is shown in Figure 13.

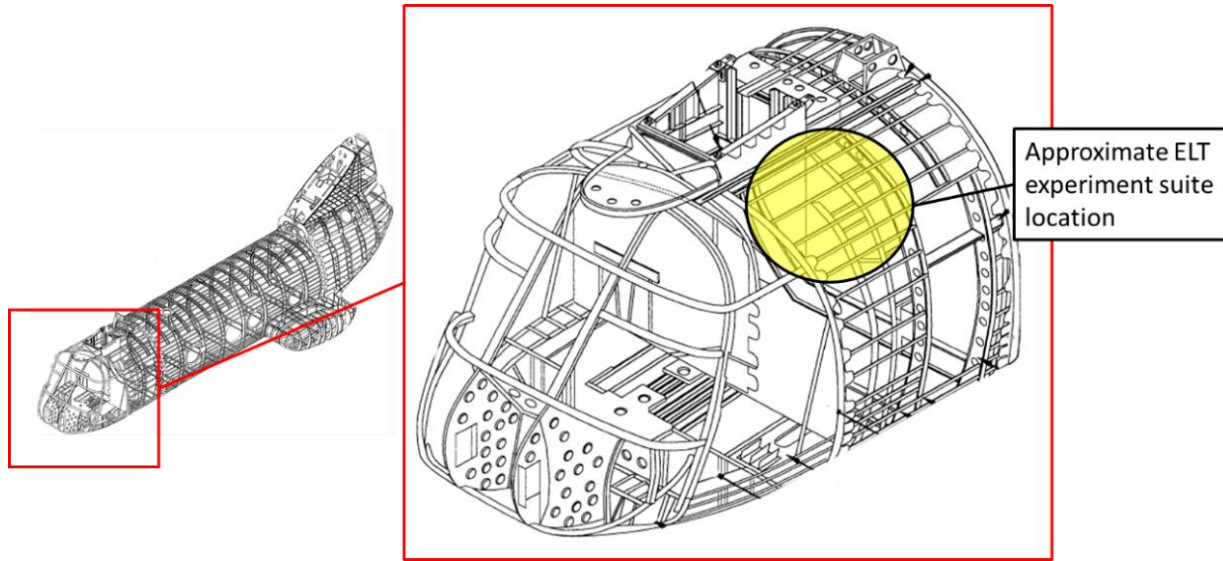
Figure 14. ELT Experiment Suite Onboard TRACT 2

The ELT experiment suite was installed in the forward section of the main cabin, on a shelf on the left side of the front bulkhead. This location was chosen because, of the volumes available, it was large enough to accommodate multiple ELTs and was structurally adequate to satisfy all ELT installation requirements for mounting surface rigidity (no more than 0.1” deflection under 100 lbf load [19]). Figure 14 shows the approximate location of the ELT experiment suite.

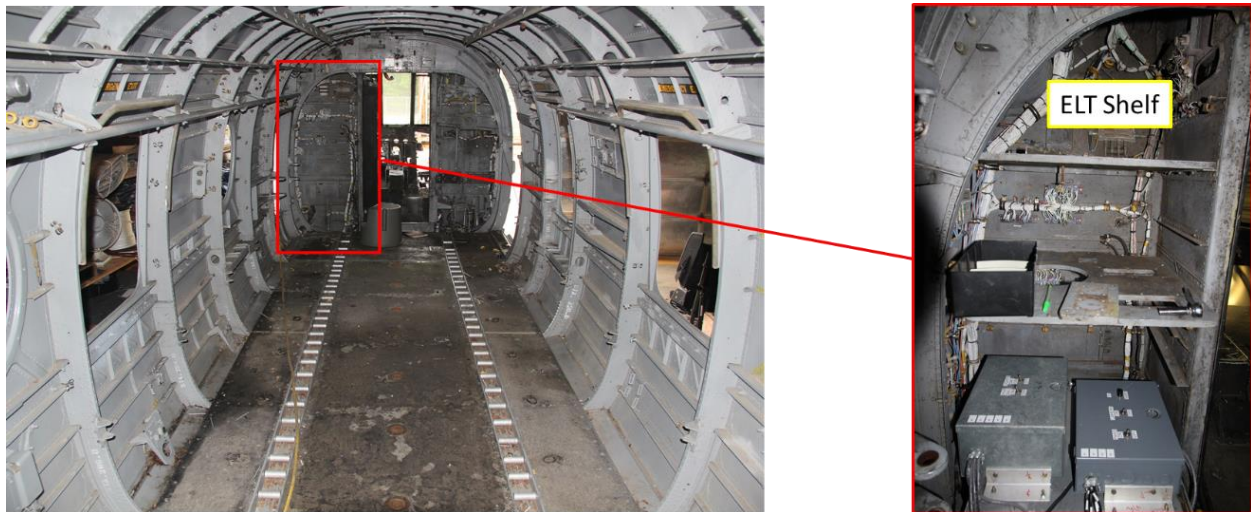
Figure 15. ELT Shelf Onboard TRACT 2

Figure 15, left, shows a picture of the main cabin of the CH-46E. The picture was taken from the midway point of the main cabin, looking forward. Figure 15, right, shows a close-up of the ELT shelf area, which was the uppermost of three shelves. The remaining shelves eventually housed power distribution and communication equipment for the test.

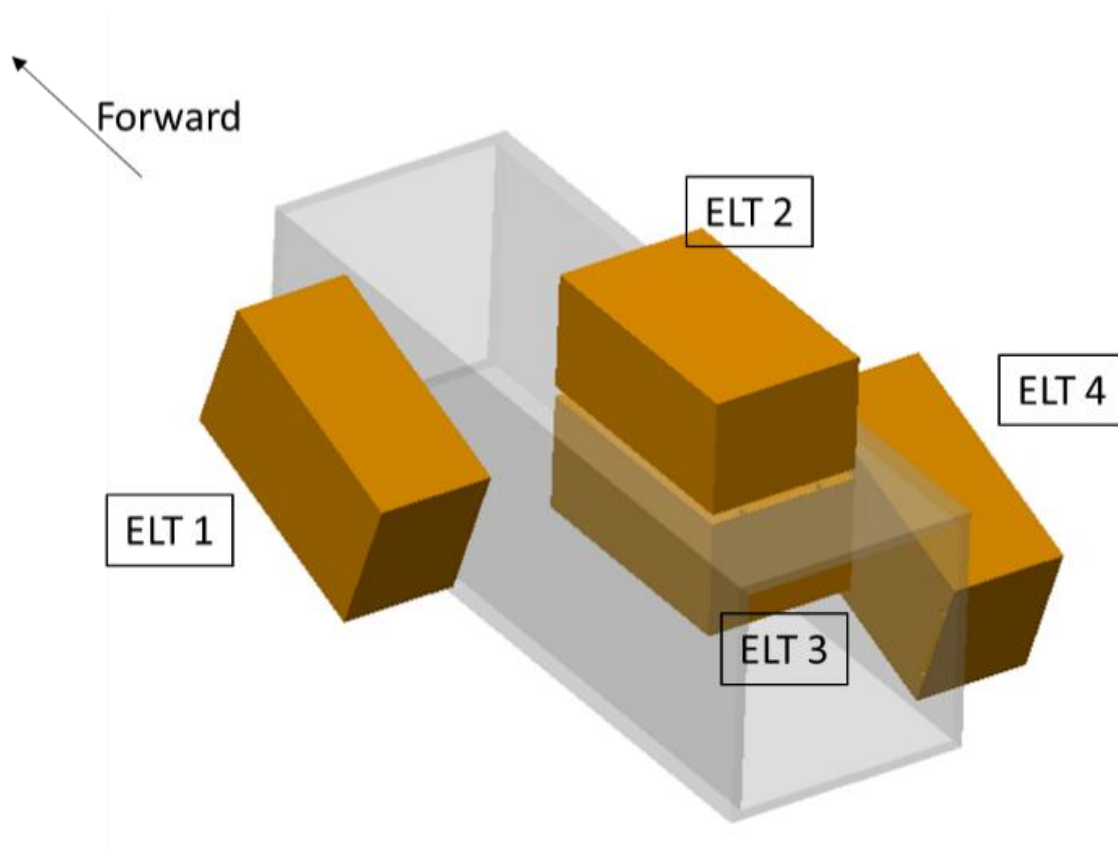
Figure 16. ELT Experiment Suite Configuration for TRACT 2

Figure 16 shows an illustration of the ELT mounting configurations, with the shelf removed for clarity. ELT 1 was in a sidewall-mounted configuration, orientated 16° nose-up to simulate additional pitch beyond the 2.6° orientation of the airframe at impact. ELT 2 was mounted on the top outer surface of the tube, simulating a horizontal floor mounted configuration. ELT 3 was mounted on the top inner surface of the tube, simulating a ceiling mounted configuration, and ELT 4 was sidewall mounted, oriented at 26° nose-up. In all instances, the ELTs were pointing forward, toward the direction of forward flight.

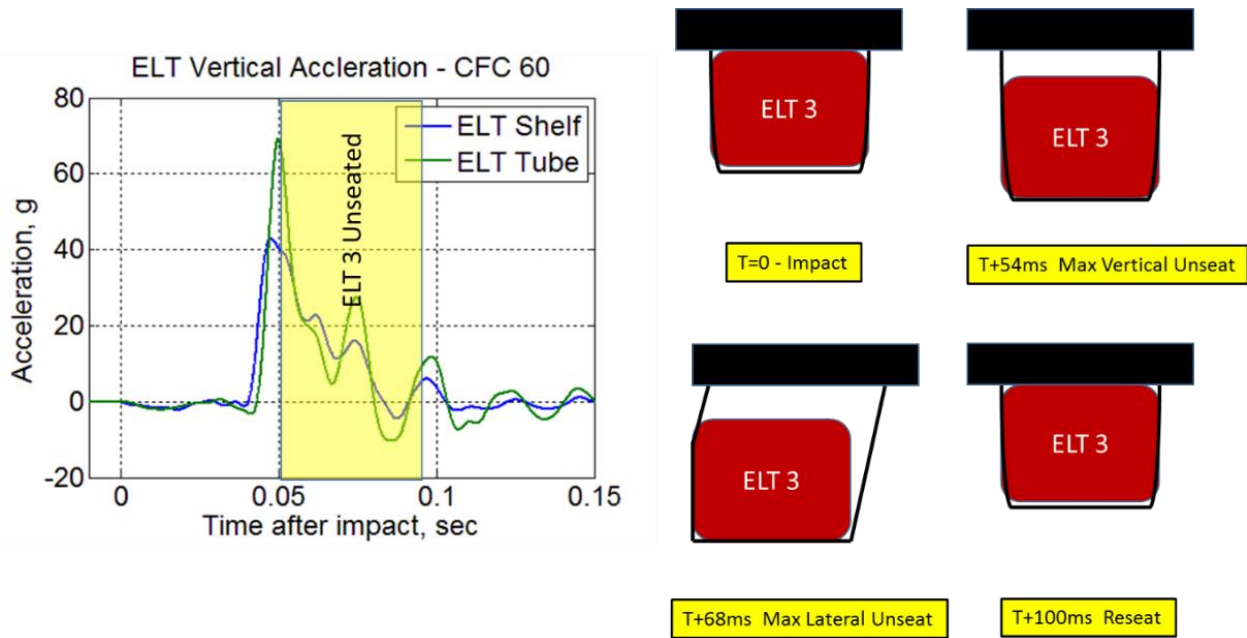
Figure 19. Hook-and-Loop Mounting System Behavior During TRACT 2

There was nominal structural responses from ELTs 1, 2 and 4 during the test, all of which utilized TSO-C126b compliant mounting systems. All units showed no signs of damage when reviewing the video or during post-test inspections. ELT 3, however, exhibited an unseating/reseating behavior as summarized in Figure 19. ELT 3 utilized a hook-and-loop style mounting system, but was brand new.

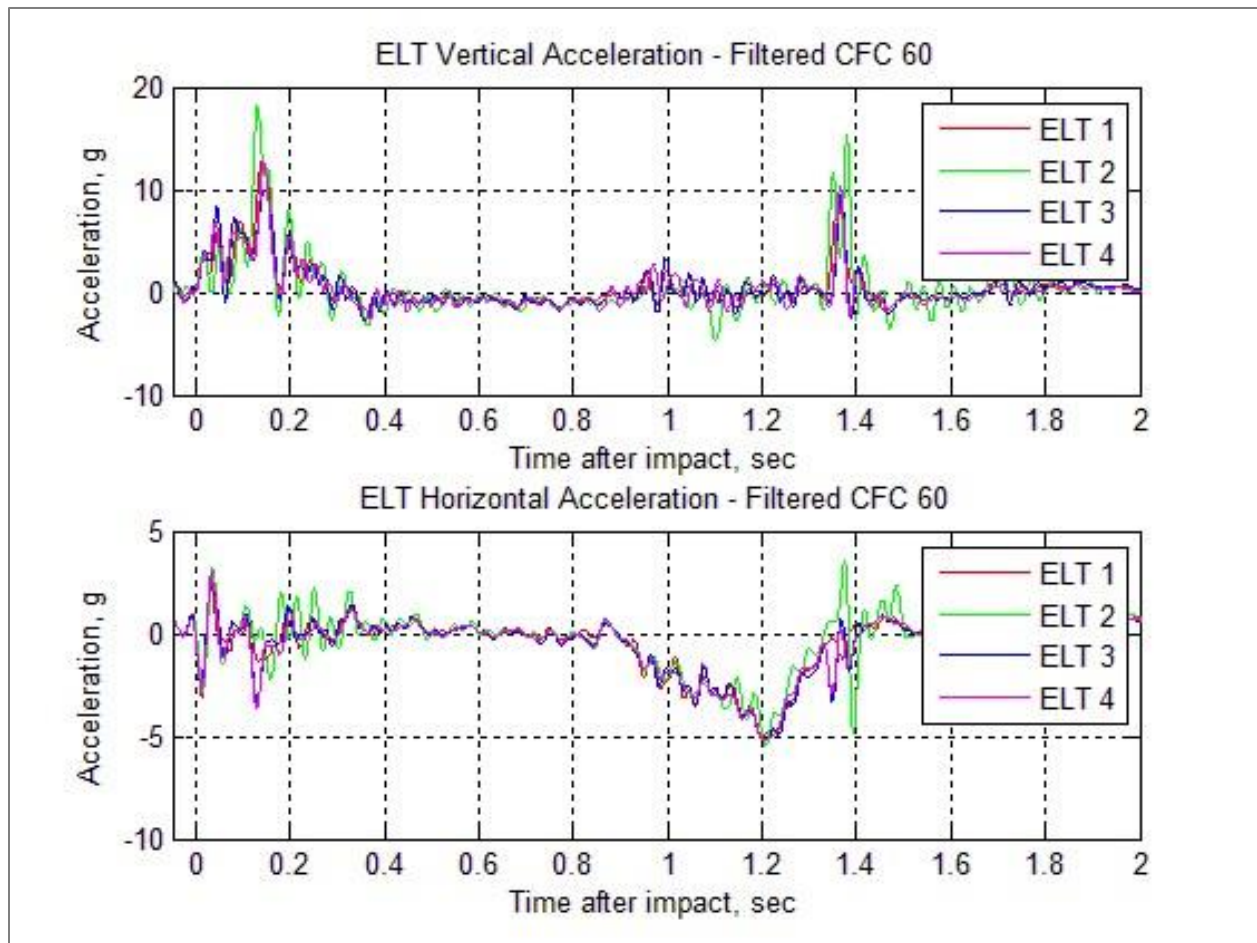
Figure 22. Beacon Accelerations - Airplane Crash Test 1

Figure 22 shows the acceleration environment experienced by each ELT beacon. Ground impact corresponds approximately from time 0- to 0.4-sec as shown in the vertical acceleration plot. Net impact corresponds approximately from time 0.9- to 1.6-sec as shown in the horizontal acceleration plot.
