NASA TECHNICAL  
MEMORANDUM

TESTING OF URANIUM NITRIDE FUEL  
IN T-111 CLADDING AT 1200 K  
CLADDING TEMPERATURE

*by Robert G. Rohal, Thomas N. Tambling,  
and Roger L. Smith*

*Lewis Research Center  
Cleveland, Ohio 44135*

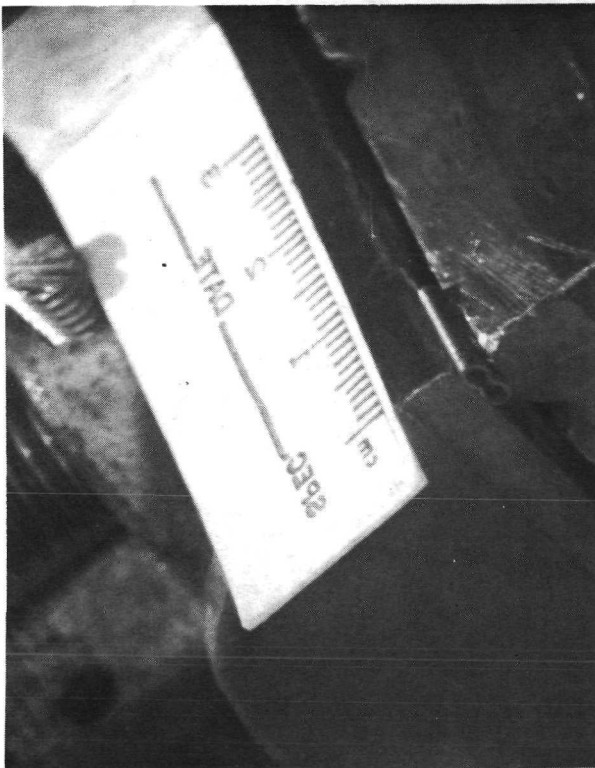
Figure 9. - Progression of compression test of ring from fuel pin 322B.

Two rings were cut from the clad tube of fuel pin 322B in exactly the same way as was done for fuel pin 321D. The first ring was placed in a vise and compressed. This ring could be compressed to about one-half its diameter before any cracking was observed. Further compression produced cracks in the ring. The progress of this ring compression test is shown in figure 9. This compression indicated that the clad of fuel pin 322B was significantly more ductile than the clad of fuel pin 321D. The second ring from 322B was vacuum annealed at 1311 K (2360<sup>o</sup> R) for 1 hour. The ring was compressed in a vise; the results of this compression indicated that the ductility of the ring was fully restored.

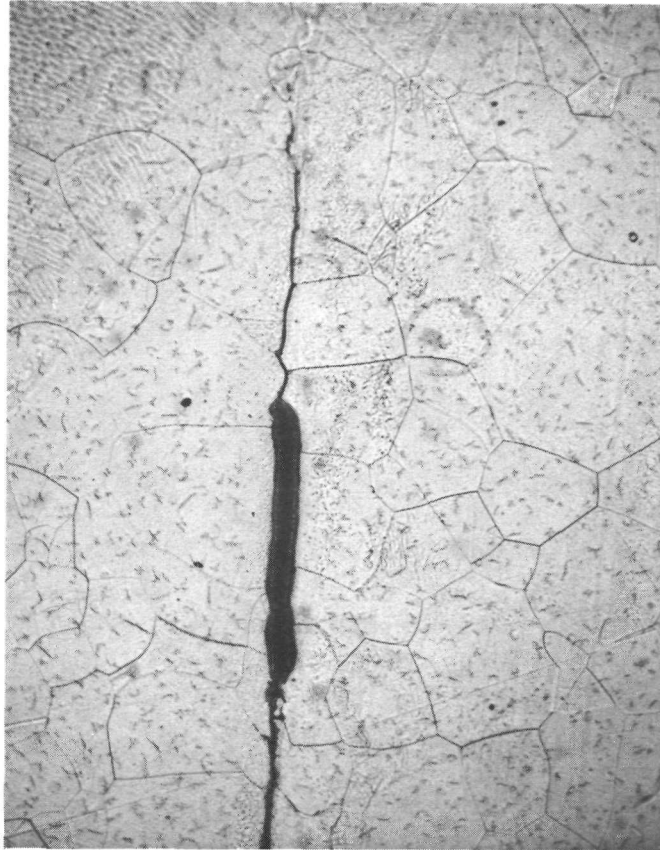
Figure 10. - Photomicrograph of a section of T-111 clad (fuel pin 321B at X250).

In accordance with usual hot laboratory procedure, samples of the T-111 clad were polished and etched. The photomicrographs did not reveal any unusual formations in the clad material. A typical photomicrograph is shown in figure 10.
