TIME EXPOSURE STUDIES ON STRESS CORROSION
 CRACKING OF ALUMINUM 2014-T6,
 ALUMINUM 7075-T651, and TITANIUM 6Al-4V

Annual Report
 for the Period
 June 1, 1971 to June 1, 1972

by
 Jethro Terrell

Grambling College Grambling, La. 71245

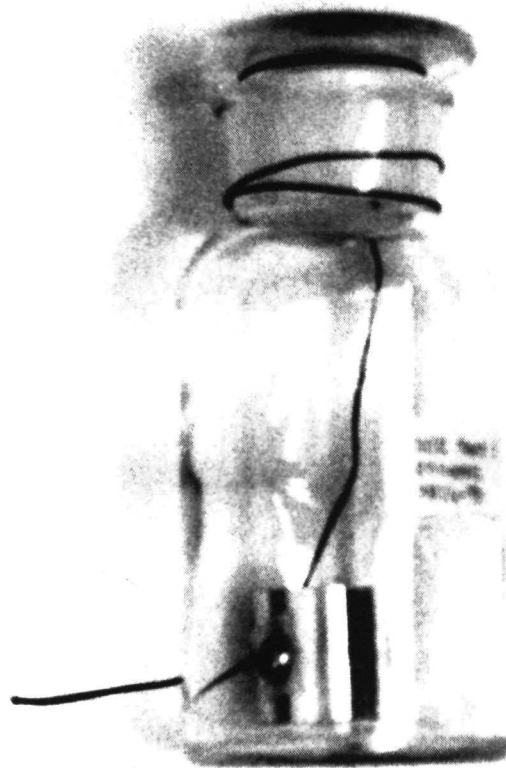
FIG. 1 TYPICAL CHAMBER USED FOR CONSTANT IMMERSION
STRESS CORROSION TESTING

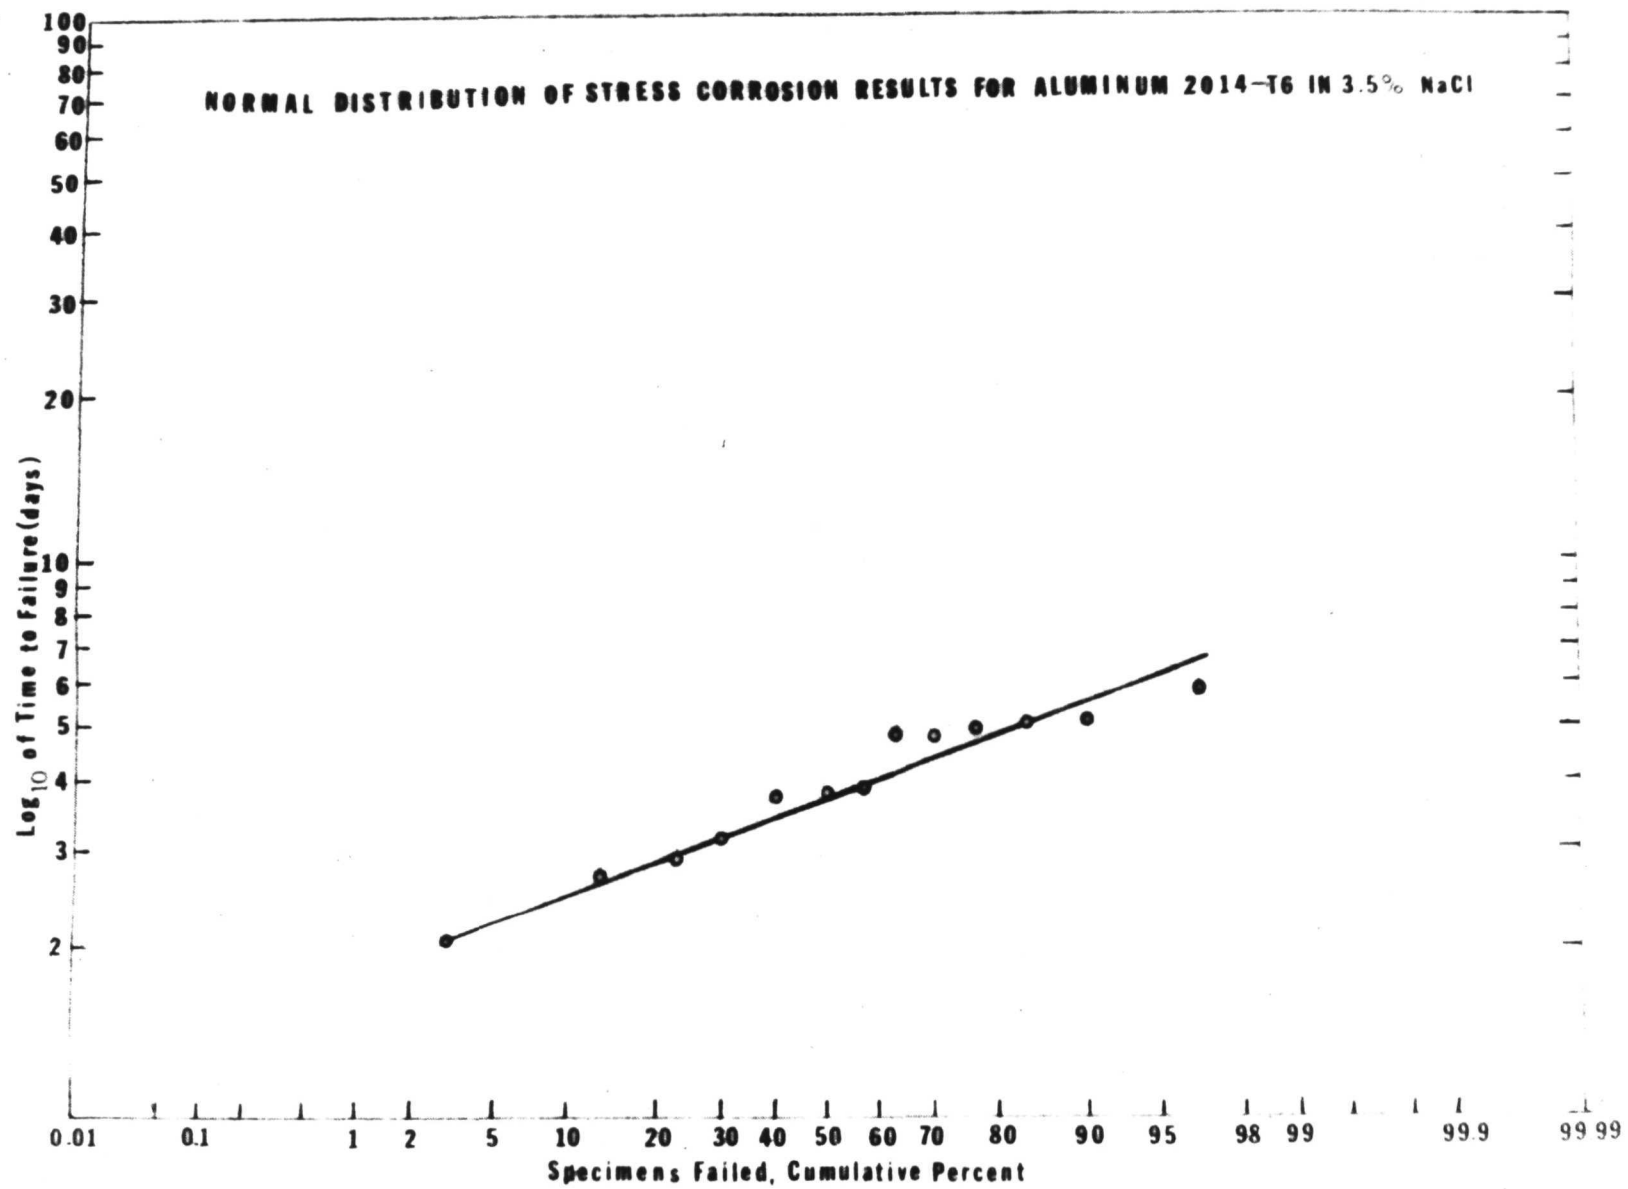
Fig. 3 Probable distribution of failure time for 2014-T6 c-ring stressed short transversely to 75% Y.S.

Time-to-failure (days) versus cumulative percentage were plotted on logarithmic probability paper and the standard deviation and sample mean were determined from the graph. This method resulted in an estimated popu-

lation standard deviation of .04 days and a population average of 3.7 days. This compares to a sample standard deviation of 1.14 days and a sample average of 3.9 days [see table A].

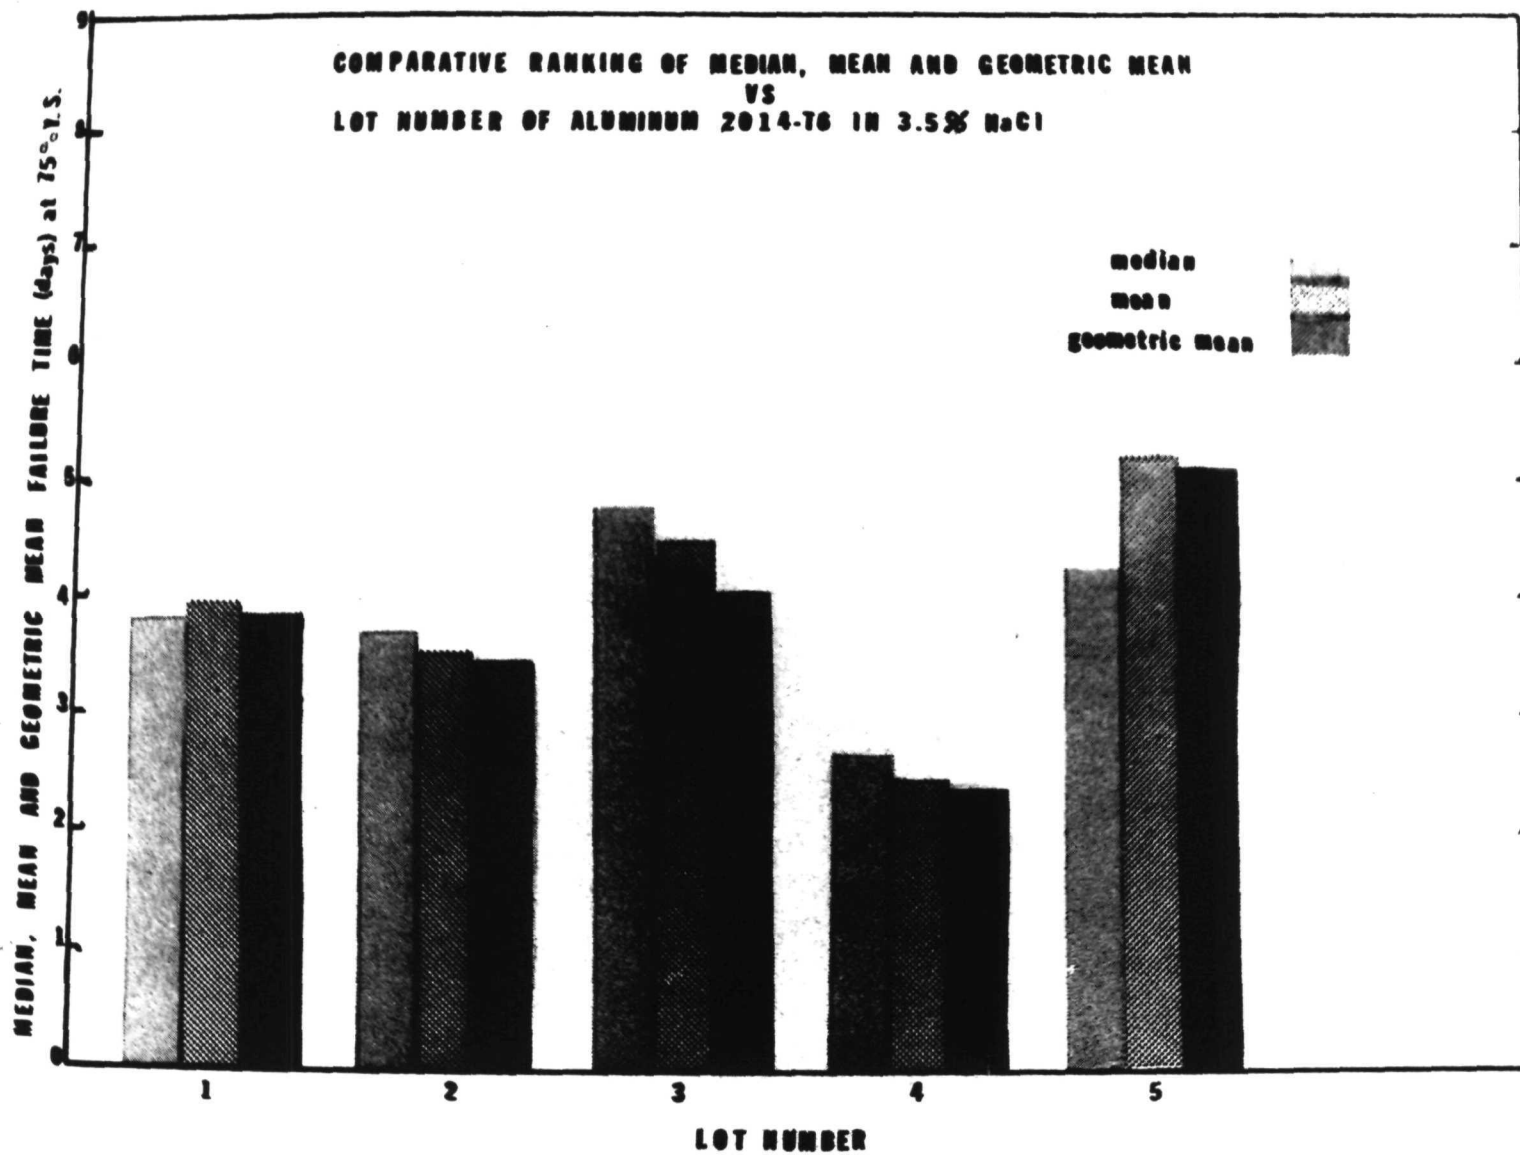
Fig.4 Comparison of median, mean, and geometric mean failure time for 5 lots(3 specimen /lot)

Fig. 4 shows a comparative ranking of median, mean and geometric mean failure times for 2014-T6 in 3.5% NaCl (5 lots). It can be seen that the geometric mean is consistently lower (4 out of 5 lots) than mean or median. It has been reported [2] that the geometric mean is meaningful while the arithmetic mean is not very meaningful, and the median is more reproducible. A comparison of the average geometric mean for this alloy with the estimated population mean resulted in no numerical difference.

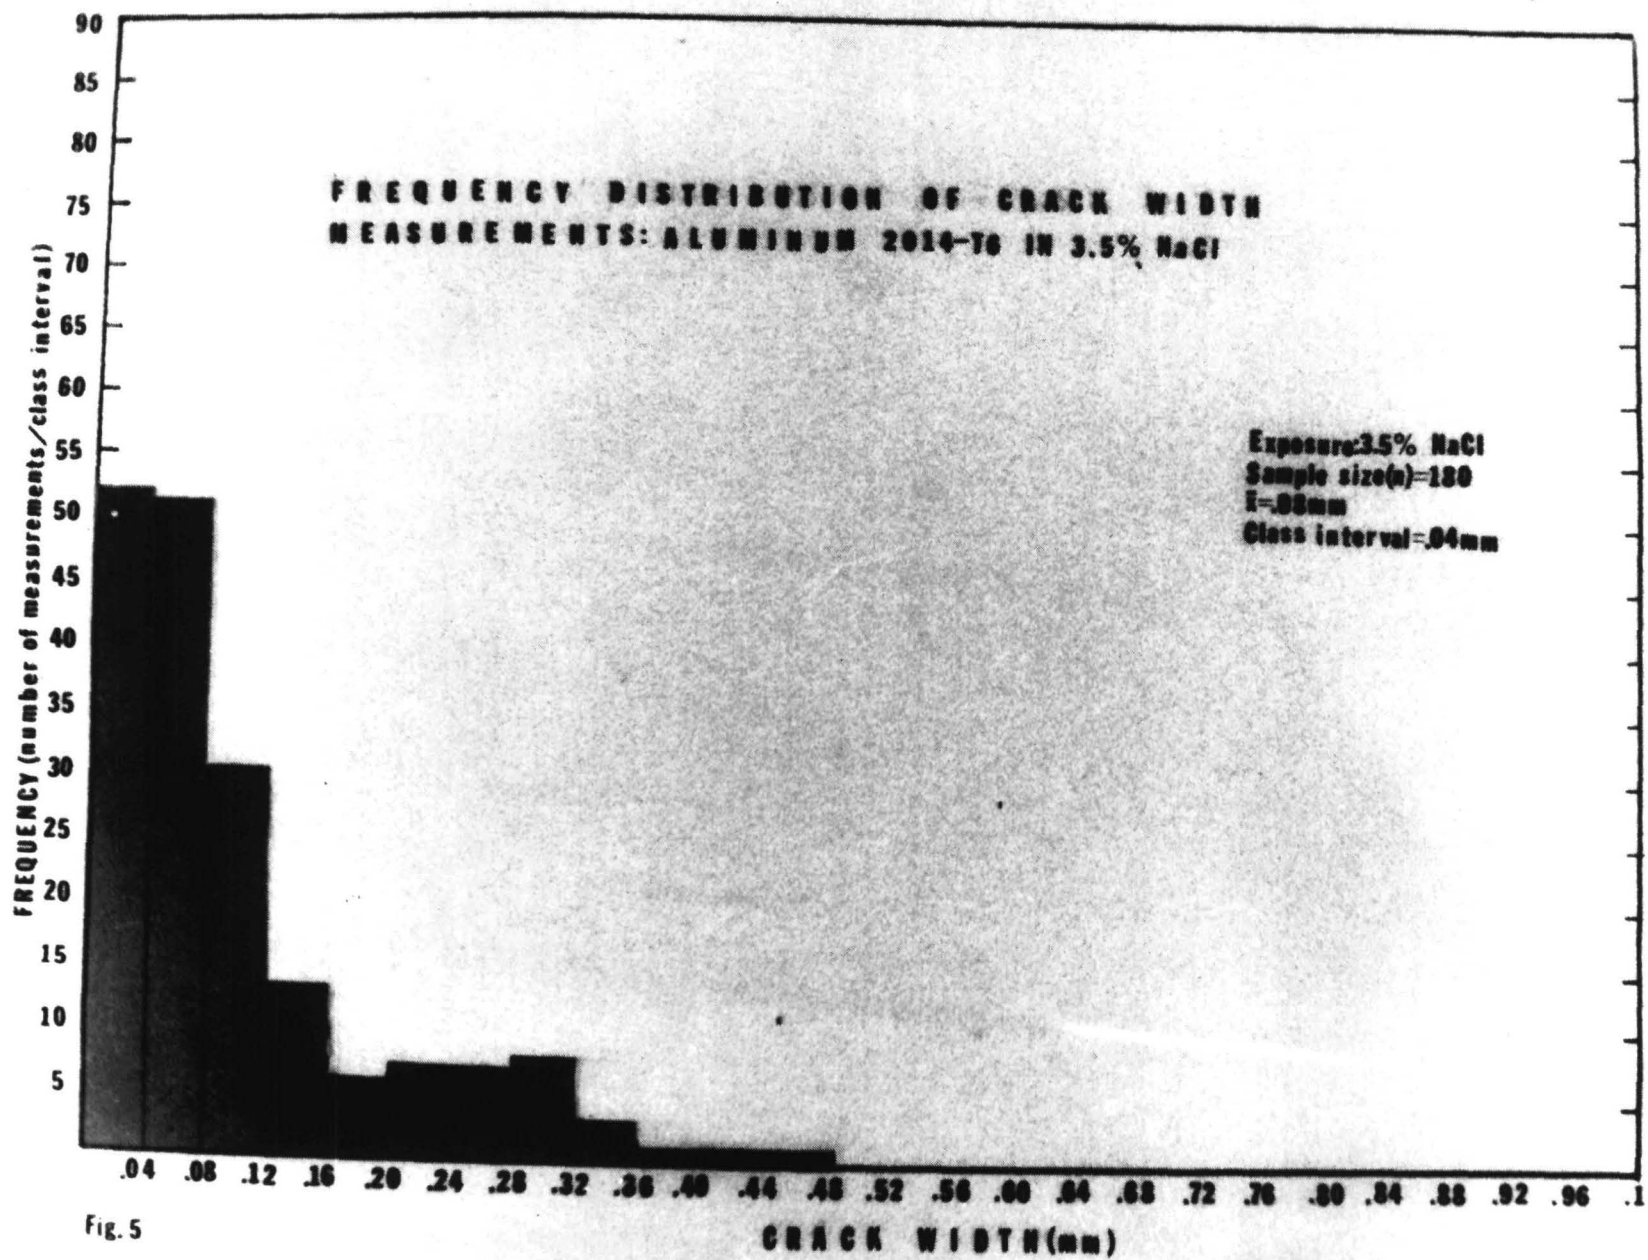
To get some idea of the variation of the surface crack widths, 180 random measurements were made from 5 lots of specimens tested. Measurements were made with the light microscope. Fig. 5 shows how these measurements are distributed. It is seen from the frequency distribution that a large number of SCC range between .02 mm and .08 mm with a sample mean of .08 mm.

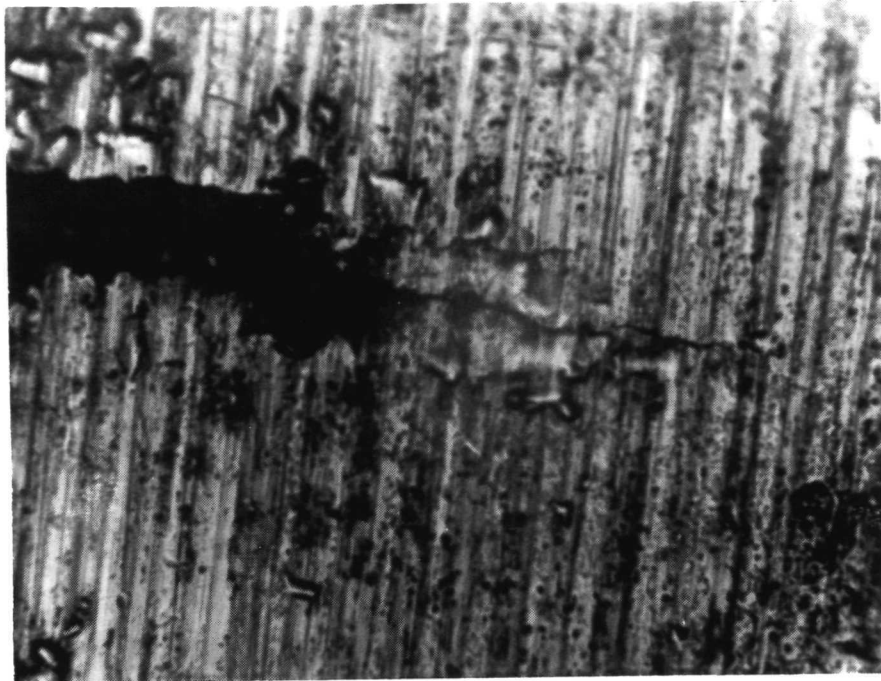
Fig. 6a Light Micrograph of 2014-T6 SCC. Dark round features are corrosion pits and slightly vertical ridges are machining grooves. 150x

With c-ring stressed specimens of 2014-T6 in 3.5% NaCl at pH 6, primary cracks were observed to initiate along tension surface (region of maximum tension stress) and at base of random corrosion pit sites. Also, it is seen that cracking propagates perpendicular to the direction of stress. Microscopic examination reveal many secondary cracks running parallel to the primary (major) crack region. Typical cracks are illustrated by light micrograph in Fig. 6. Additional SCC cracks are shown by electron micrographs in Fig. 7 and 8.

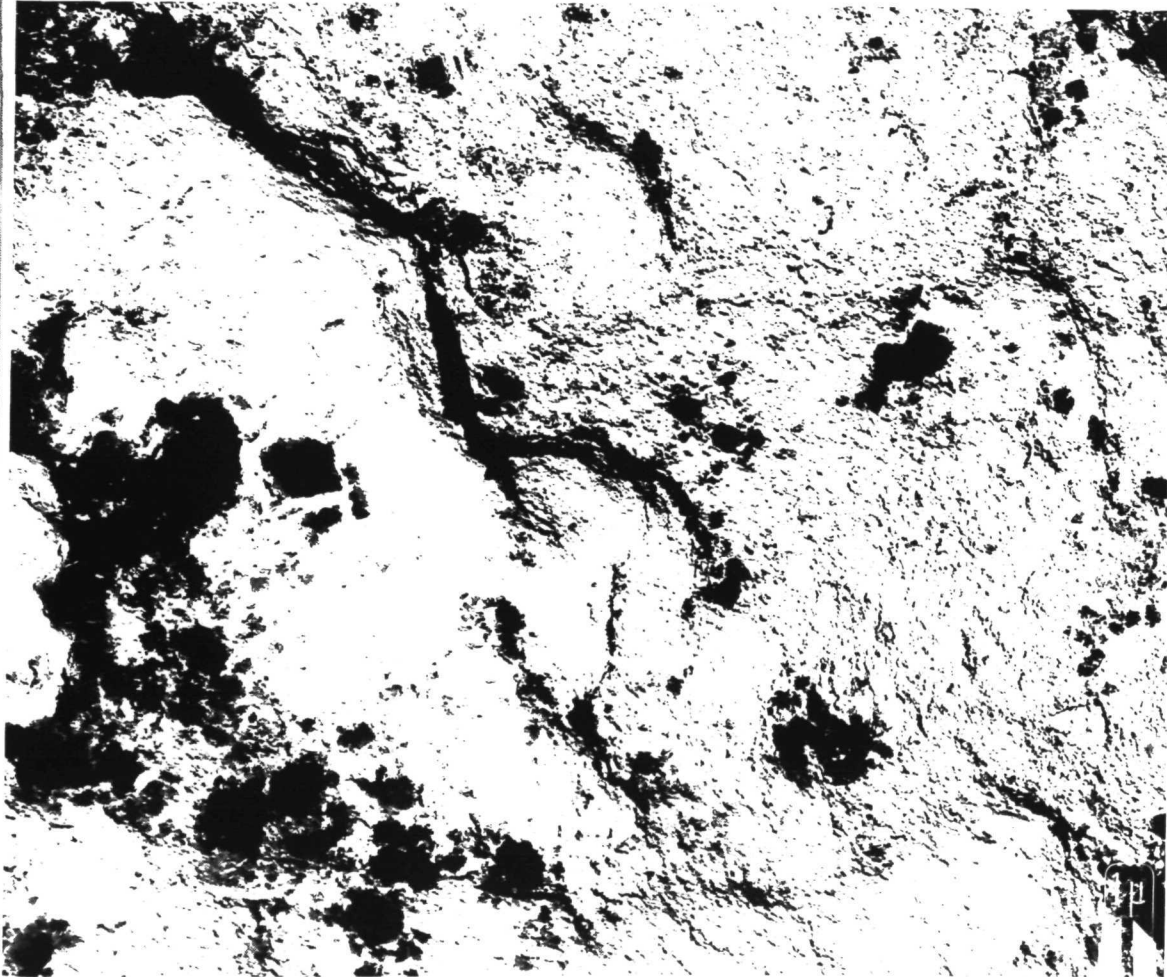
Fig. 7 Electron micrograph of surface replica of 2014-T6 showing stress corrosion cracks. Extensive pitting sites can be seen. 3000x

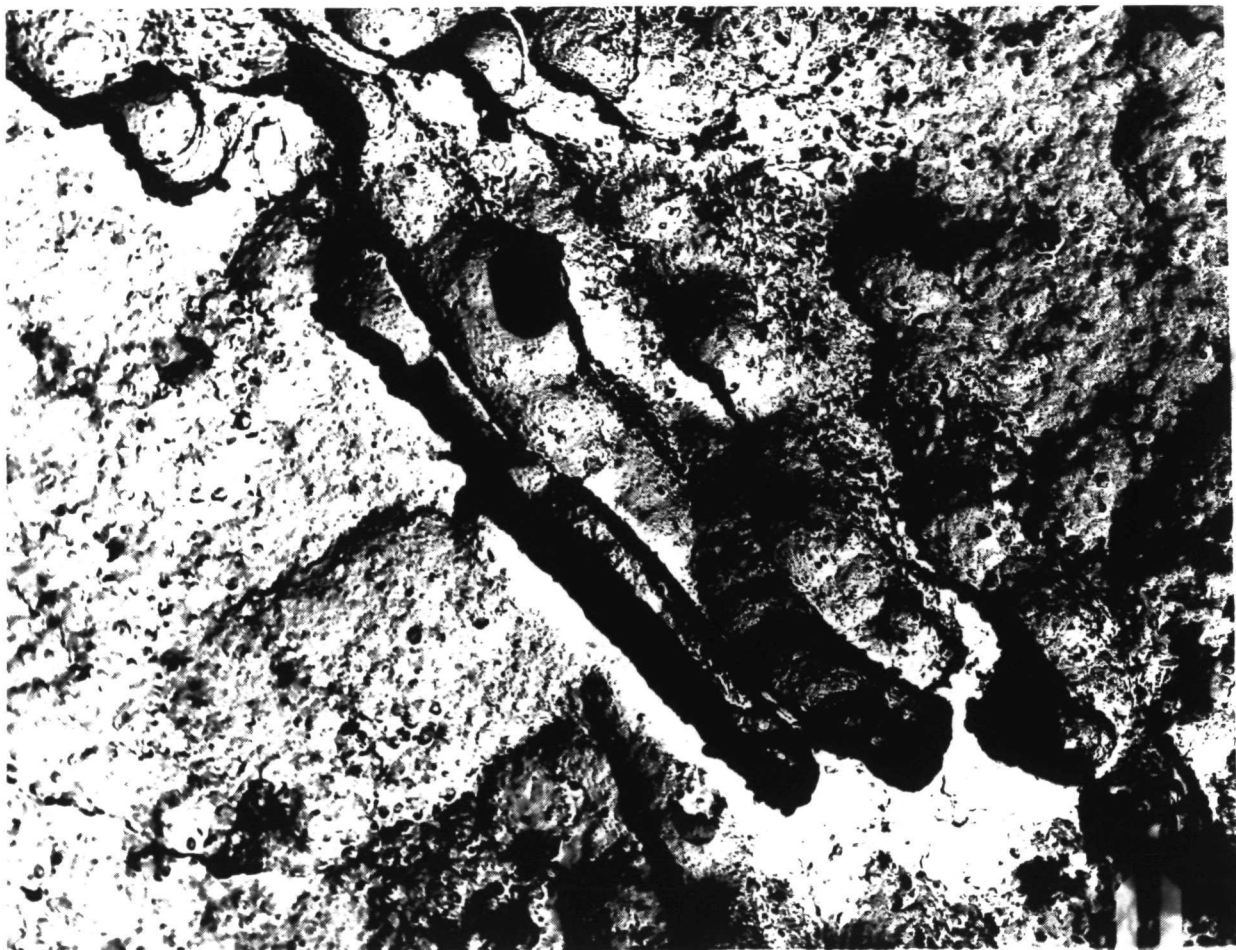
Fig. 8 Electron micrograph of replicated surface of aluminum 2014-T6 showing an intergranular crack (diagonal across center). 3000x

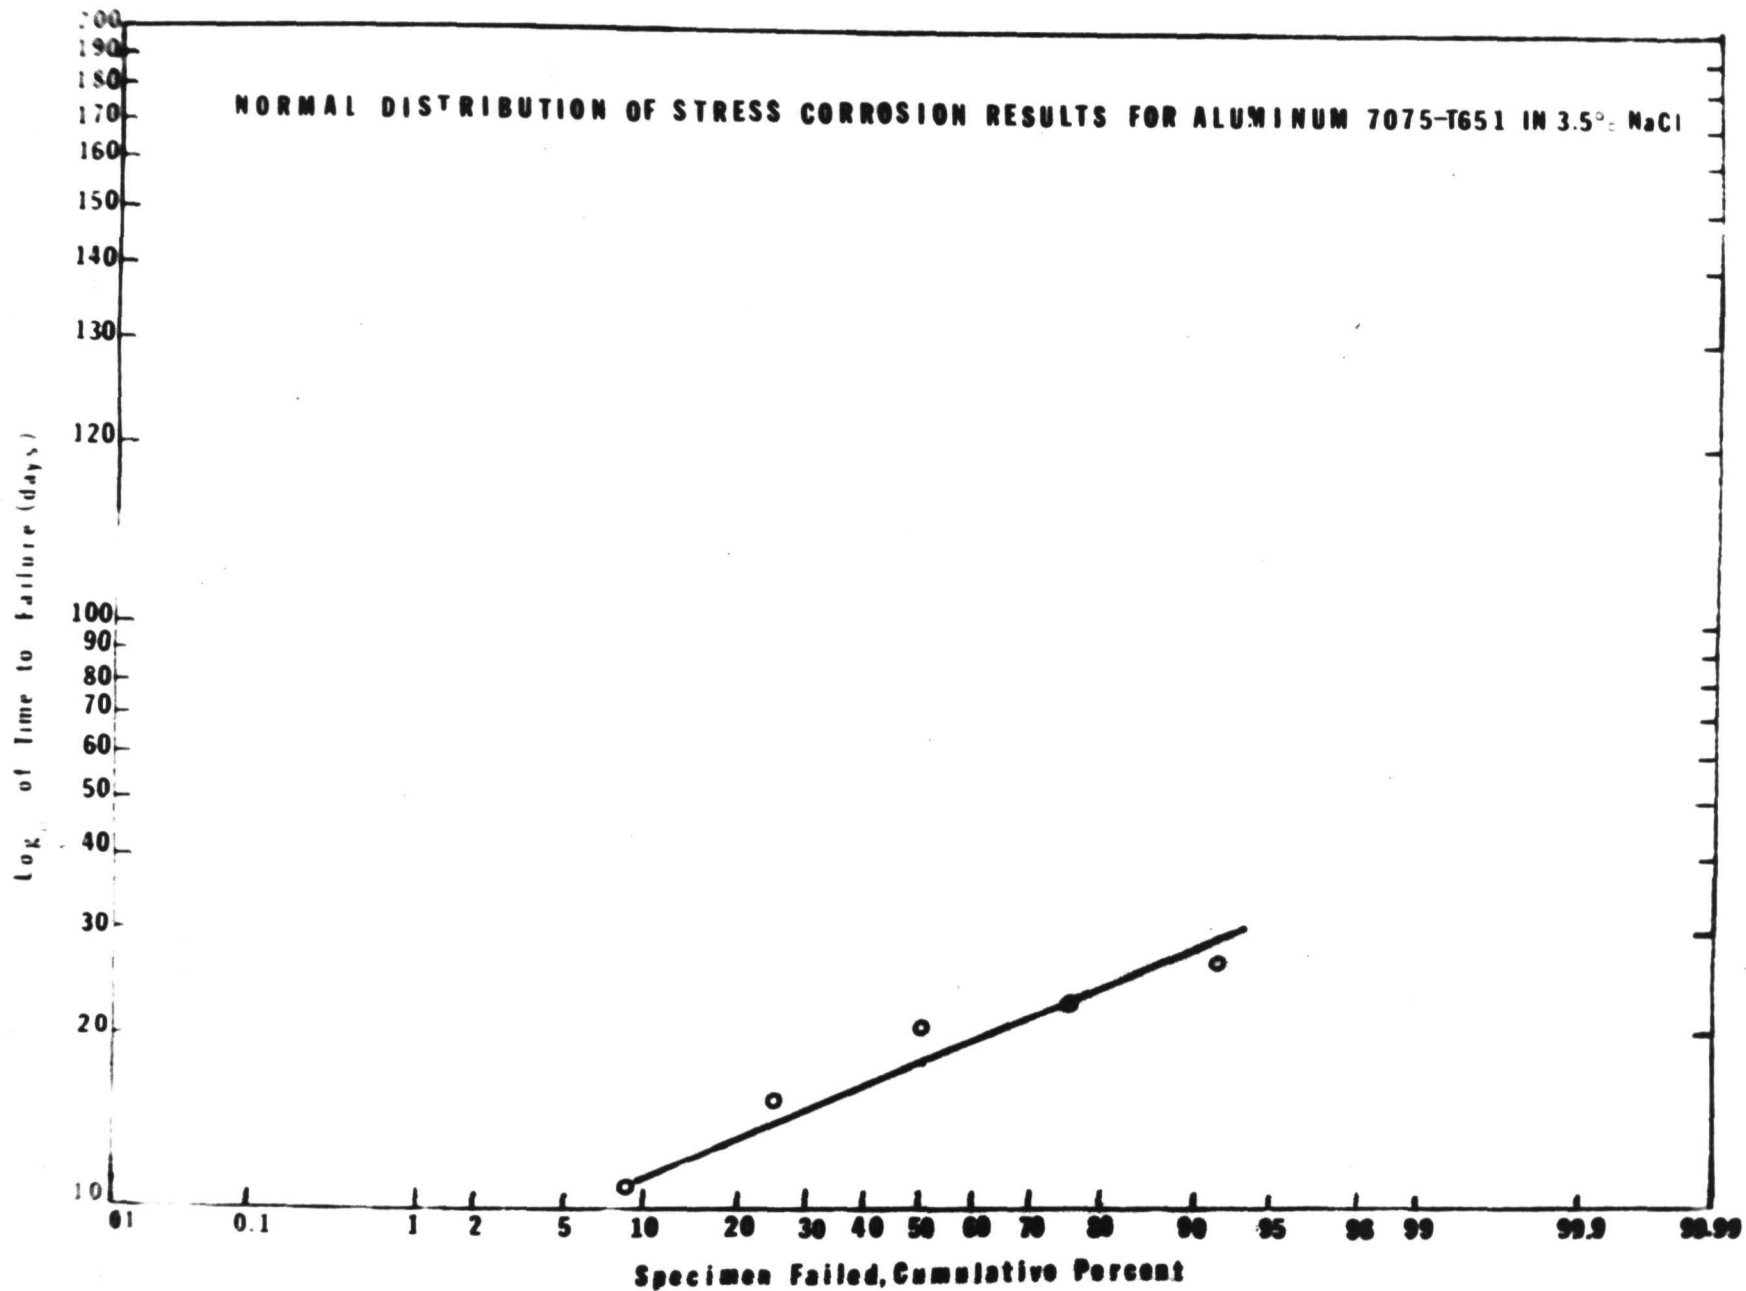
Fig 9 Probable distribution of failure time for 7075-T651 c-ring stressed short transversely to 75% Y.S.

Time-to-failure data for 7075-T651 was treated statistically on the basis of a normal distribution plot where the time-to-failure (or endurance) was plotted against the cumulative percentage on logarithmic probability paper [Fig. 9]. From this method the estimated population standard deviation (as determined from graph) was 7.0 days, whereas the population average was 18 days. On comparing the same kind of data for the sample, the standard deviation was 8.7 days and the sample average was 17.9 days [table 5]. Application of the student t-test for the population average and sample average indicated that these differences were significant. With 5 degrees of freedom, evaluation of the time-to-failure data resulted in a t-value (.03) falling within the critical value of ± 2.13 which is interpreted for 95% confidence interval as statistical significant.

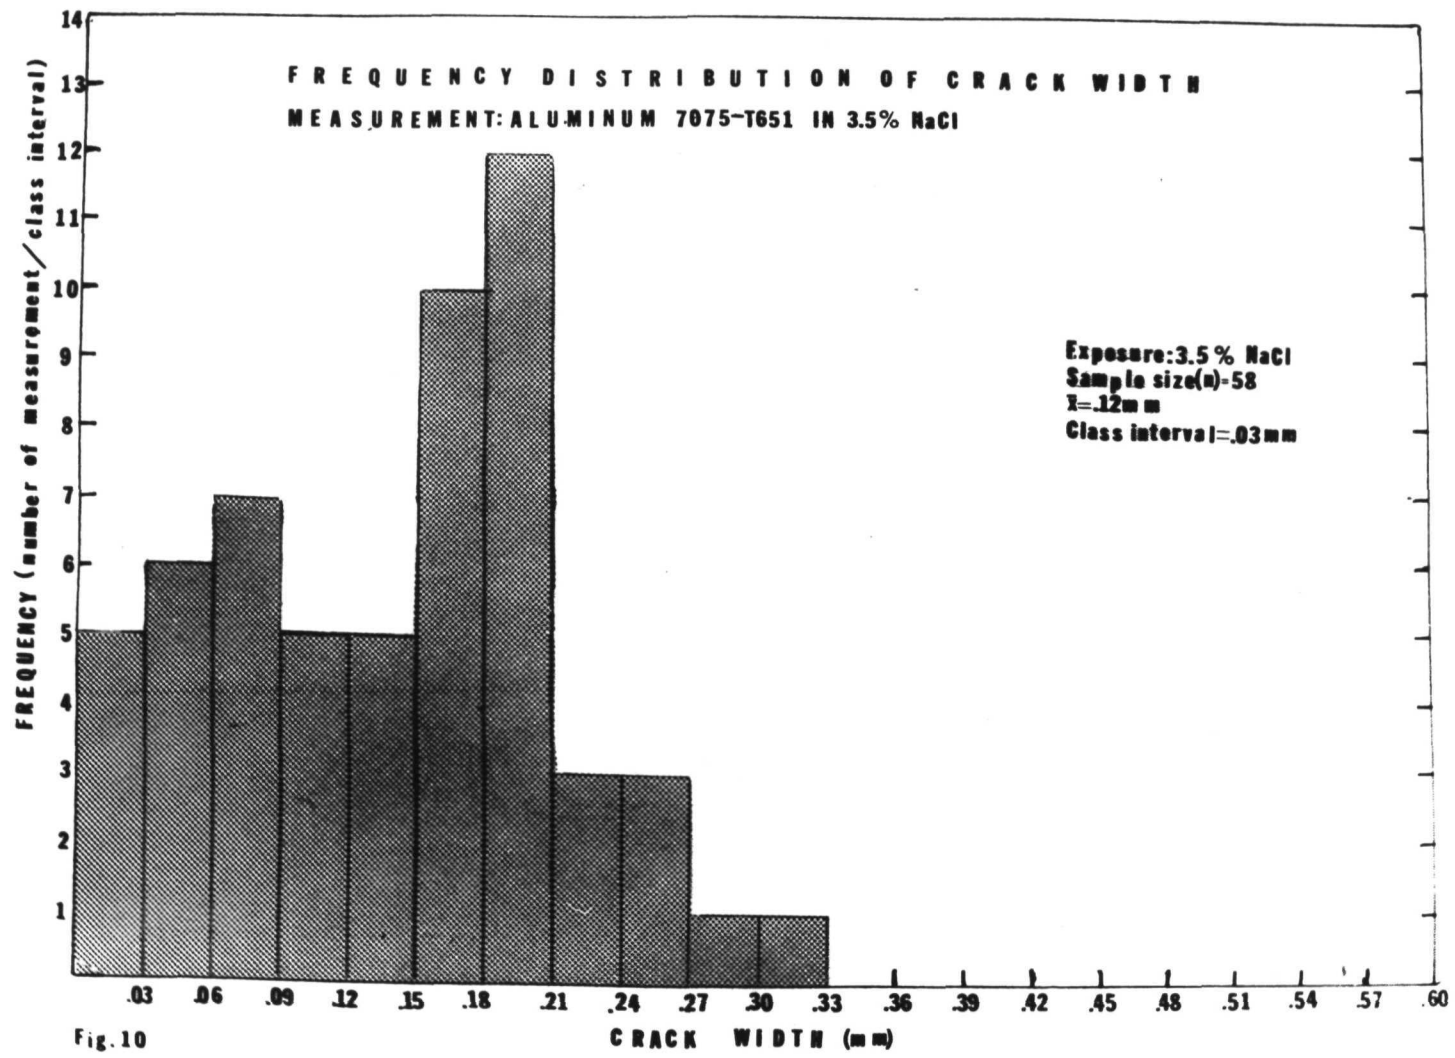
To determine a representative value of the stress corrosion crack width, 80 measurements were made at random points on the surface of 6 specimens which failed in NaCl solution. It was found that the average crack width was .12 mm. Fig. 10 shows a frequency distribution of crack width measurements for this alloy while Fig. 11 and 12 illustrates electron micrographs of the replicated surface along crack regions.

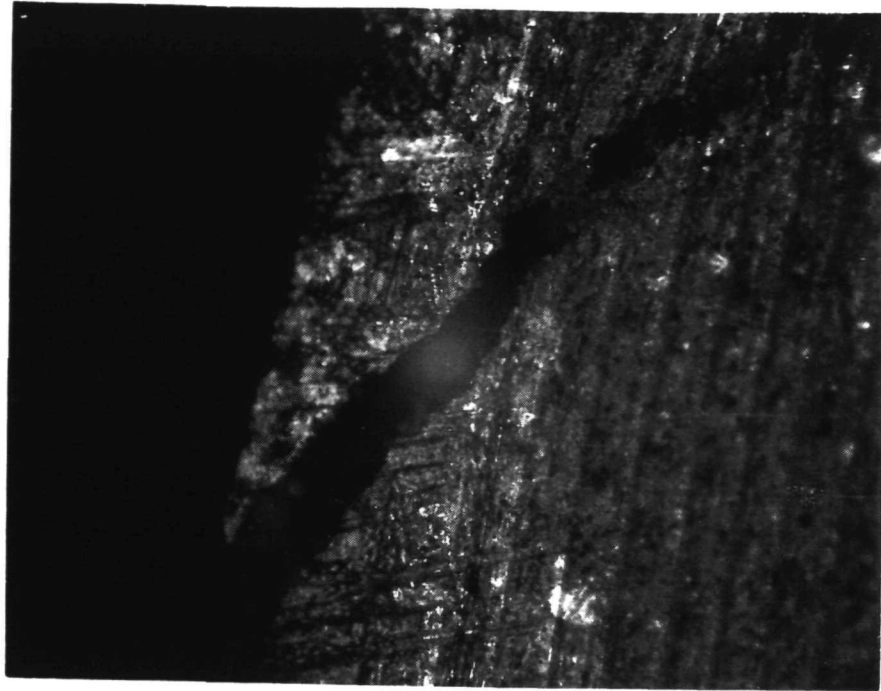
Fig. 11a. Light micrograph of SCC across thickness dimension of c-ring sample failed in 3.5% NaCl. Dark ridges are machining grooves. 600x

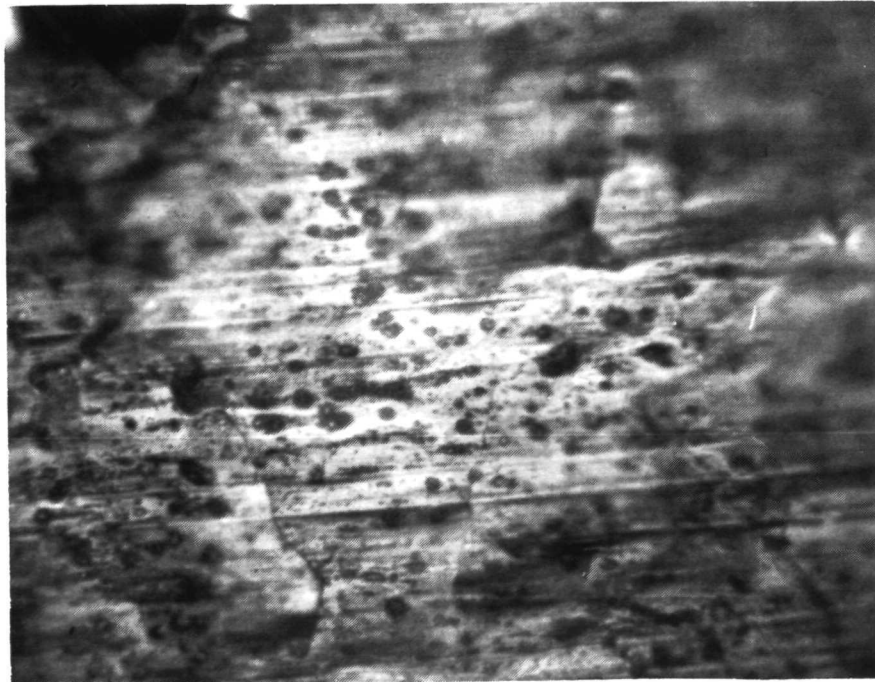
Fig. 11b. Light micrograph of corroded surface of 7075-T651 (3.5% NaCl) showing grain boundary and numerous corrosion pits. Keller's Etch. 600x

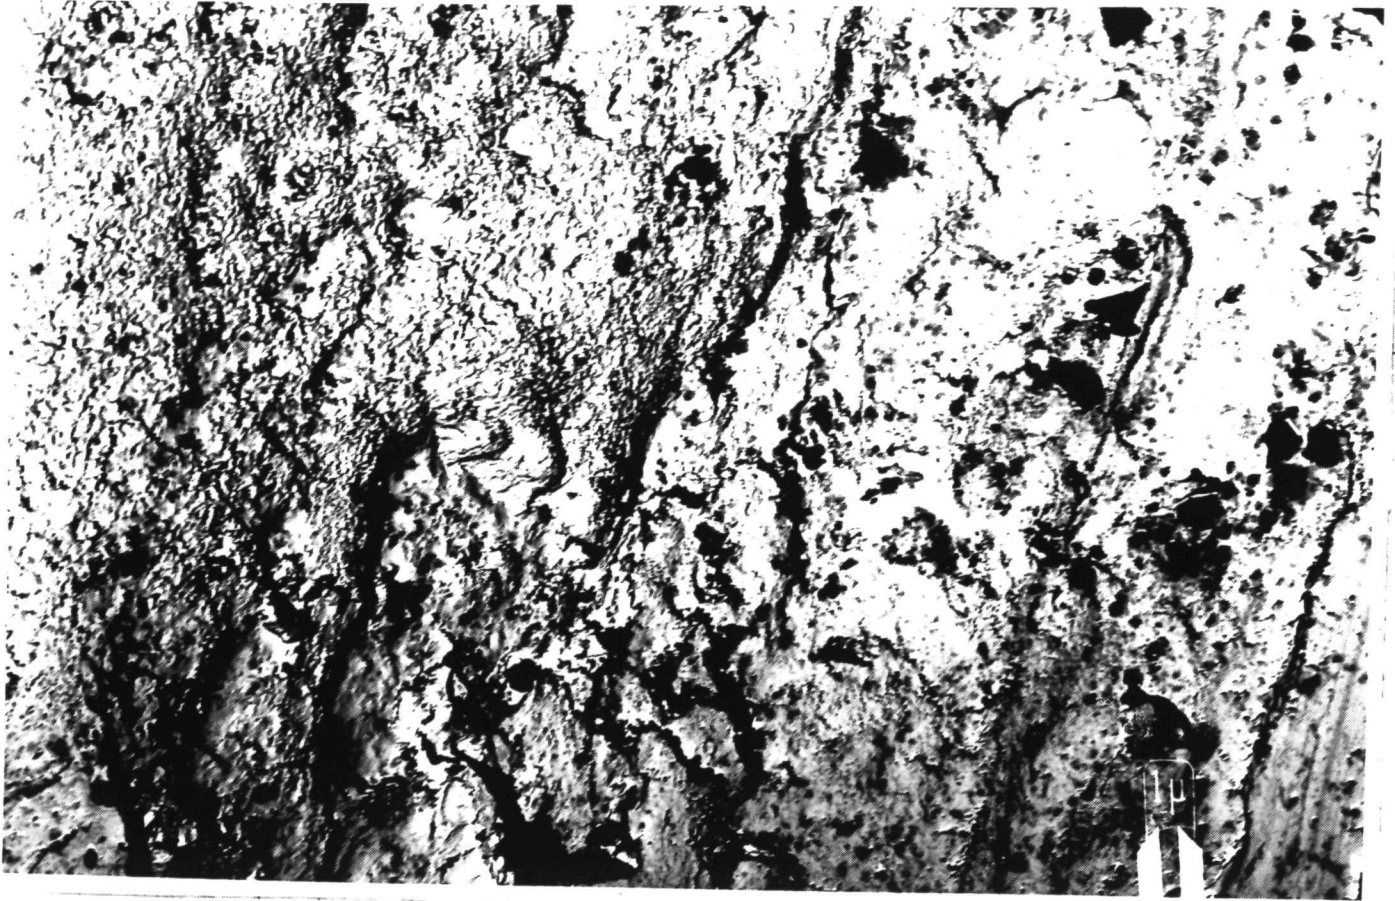
Fig. 12 Electron micrograph of replicated surface of 7075-T651 showing stress corrosion crack running diagonally (continuous dark paths). 3000x

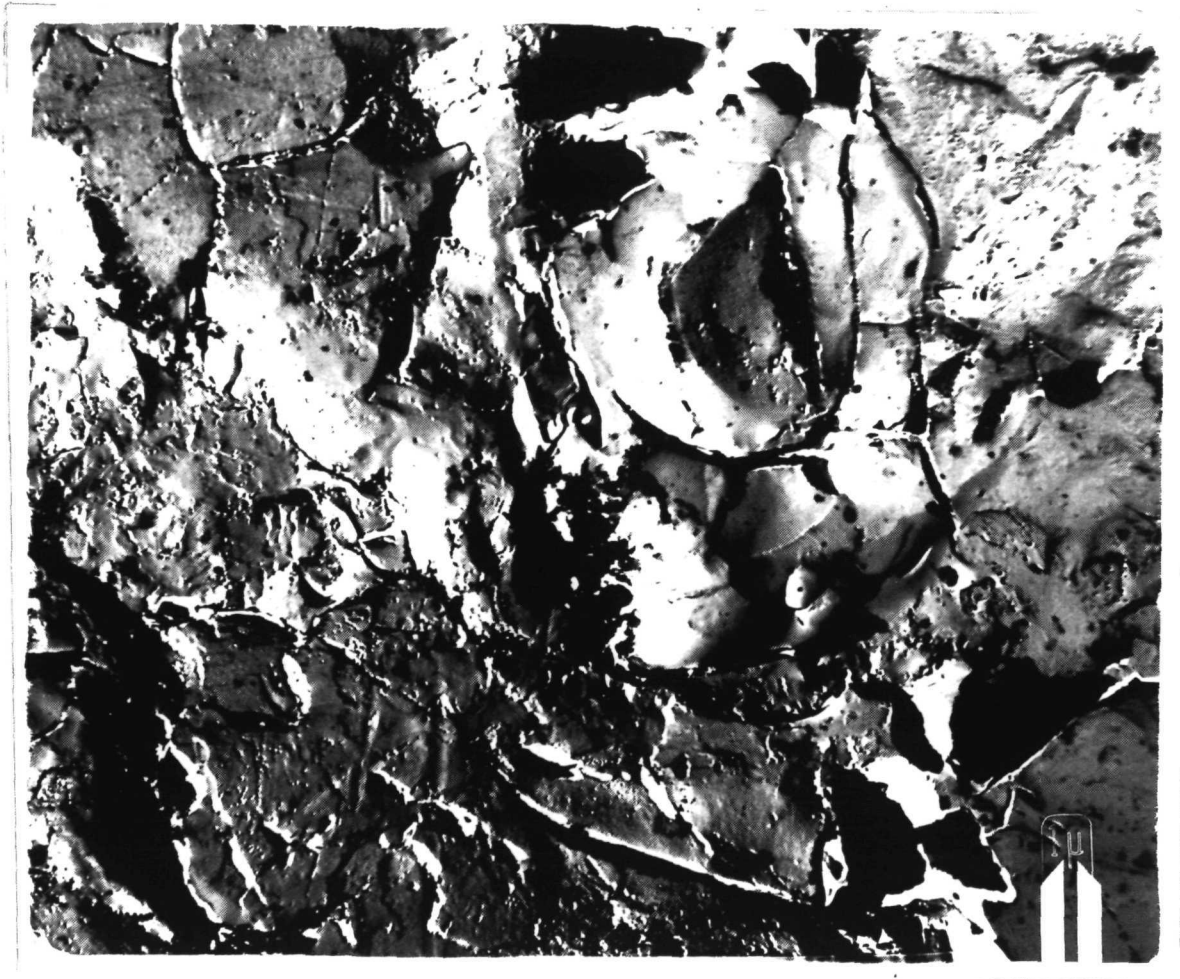
Fig. 13 Electron micrograph of replicated surface of 7075-T651 showing numerous cracks and associated pitting. 1500x
