FABRICATION OF 1/3 SCALE
BORON/EPOXY BOOSTER THRUST STRUCTURE

Phase I Final Report

CR-119958

Advanced Composite Group
GRUMMAN AEROSPACE CORPORATION
Bethpage, New York 11714

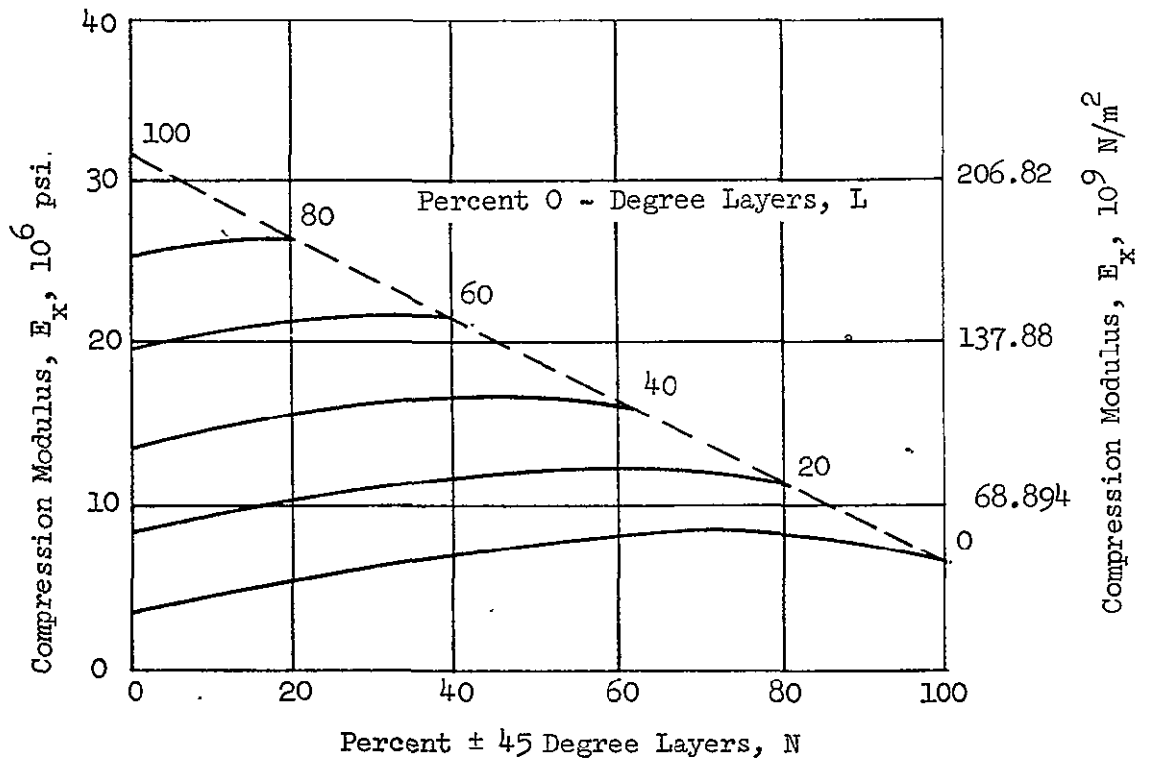
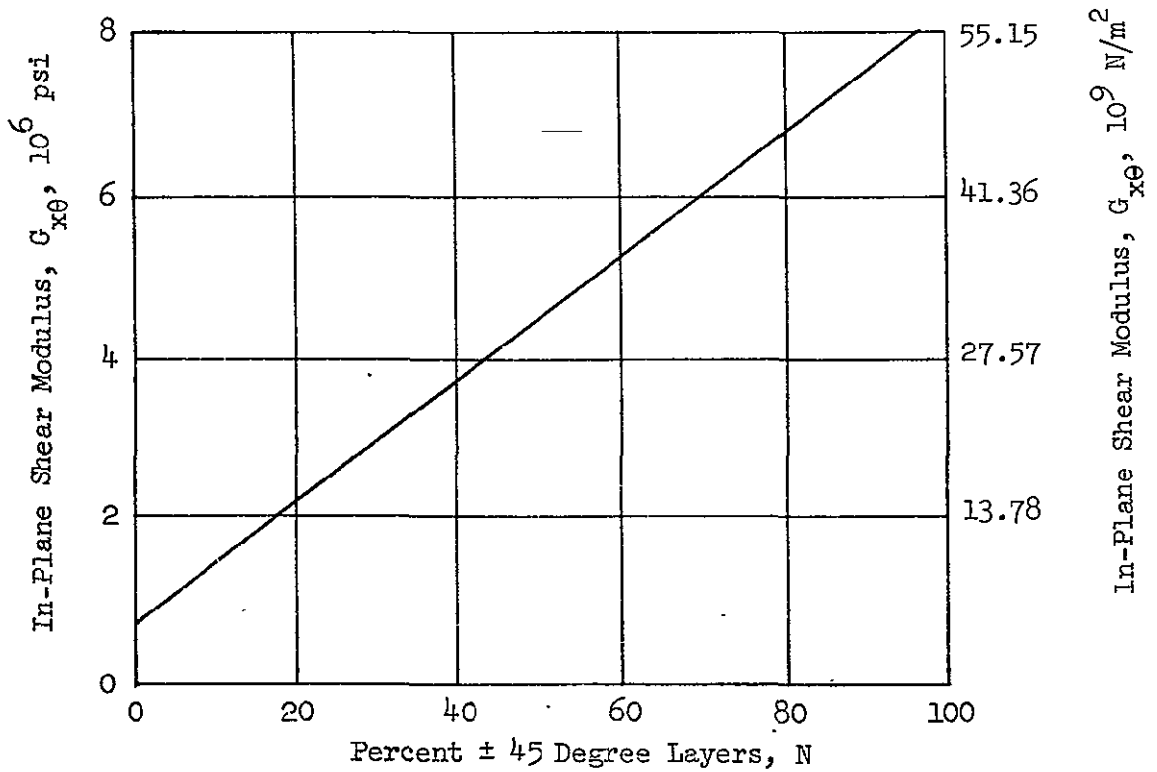
Figure 2-3 Compression and In-Plane Shear Moduli of Elasticity of Boron-Epoxy at Room Temperature

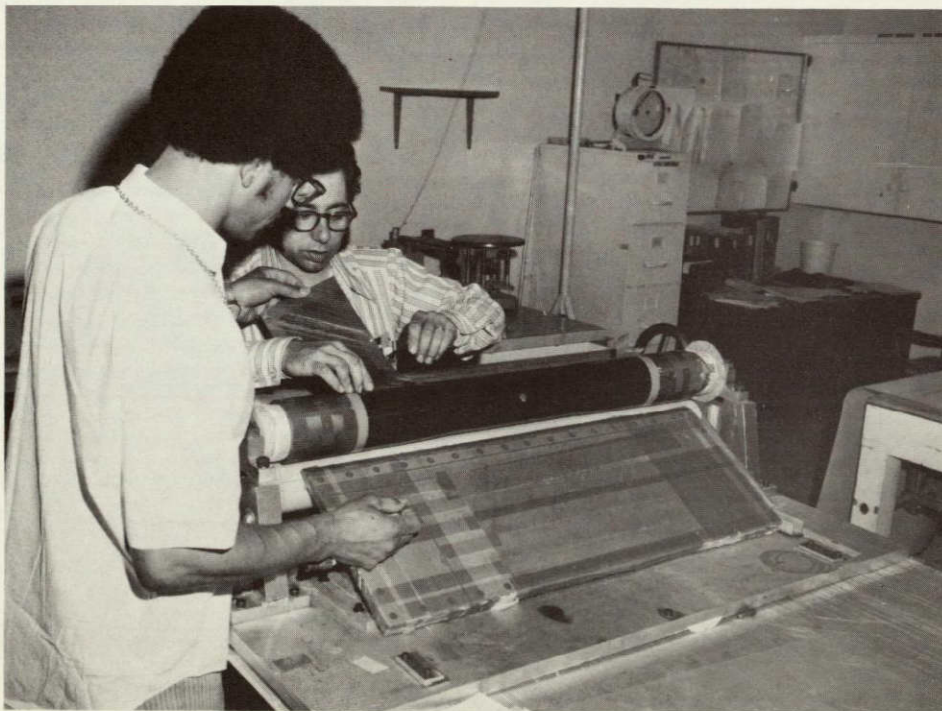
Figure 3-4 Tube Wrapping Machine

- o Apply boron tape to the mylar layup template
- o Position the template on the wrapping machine and attach to the wind-up roller
- o Apply vacuum to the template

- o Wind template 2 turns on the wind-up roller
- o Position layup mandrel and adjust pressure roller
- o Turn wind-up roller until boron tape is fed between the layup mandrel and the pressure roller, transferring the tape to the mandrel

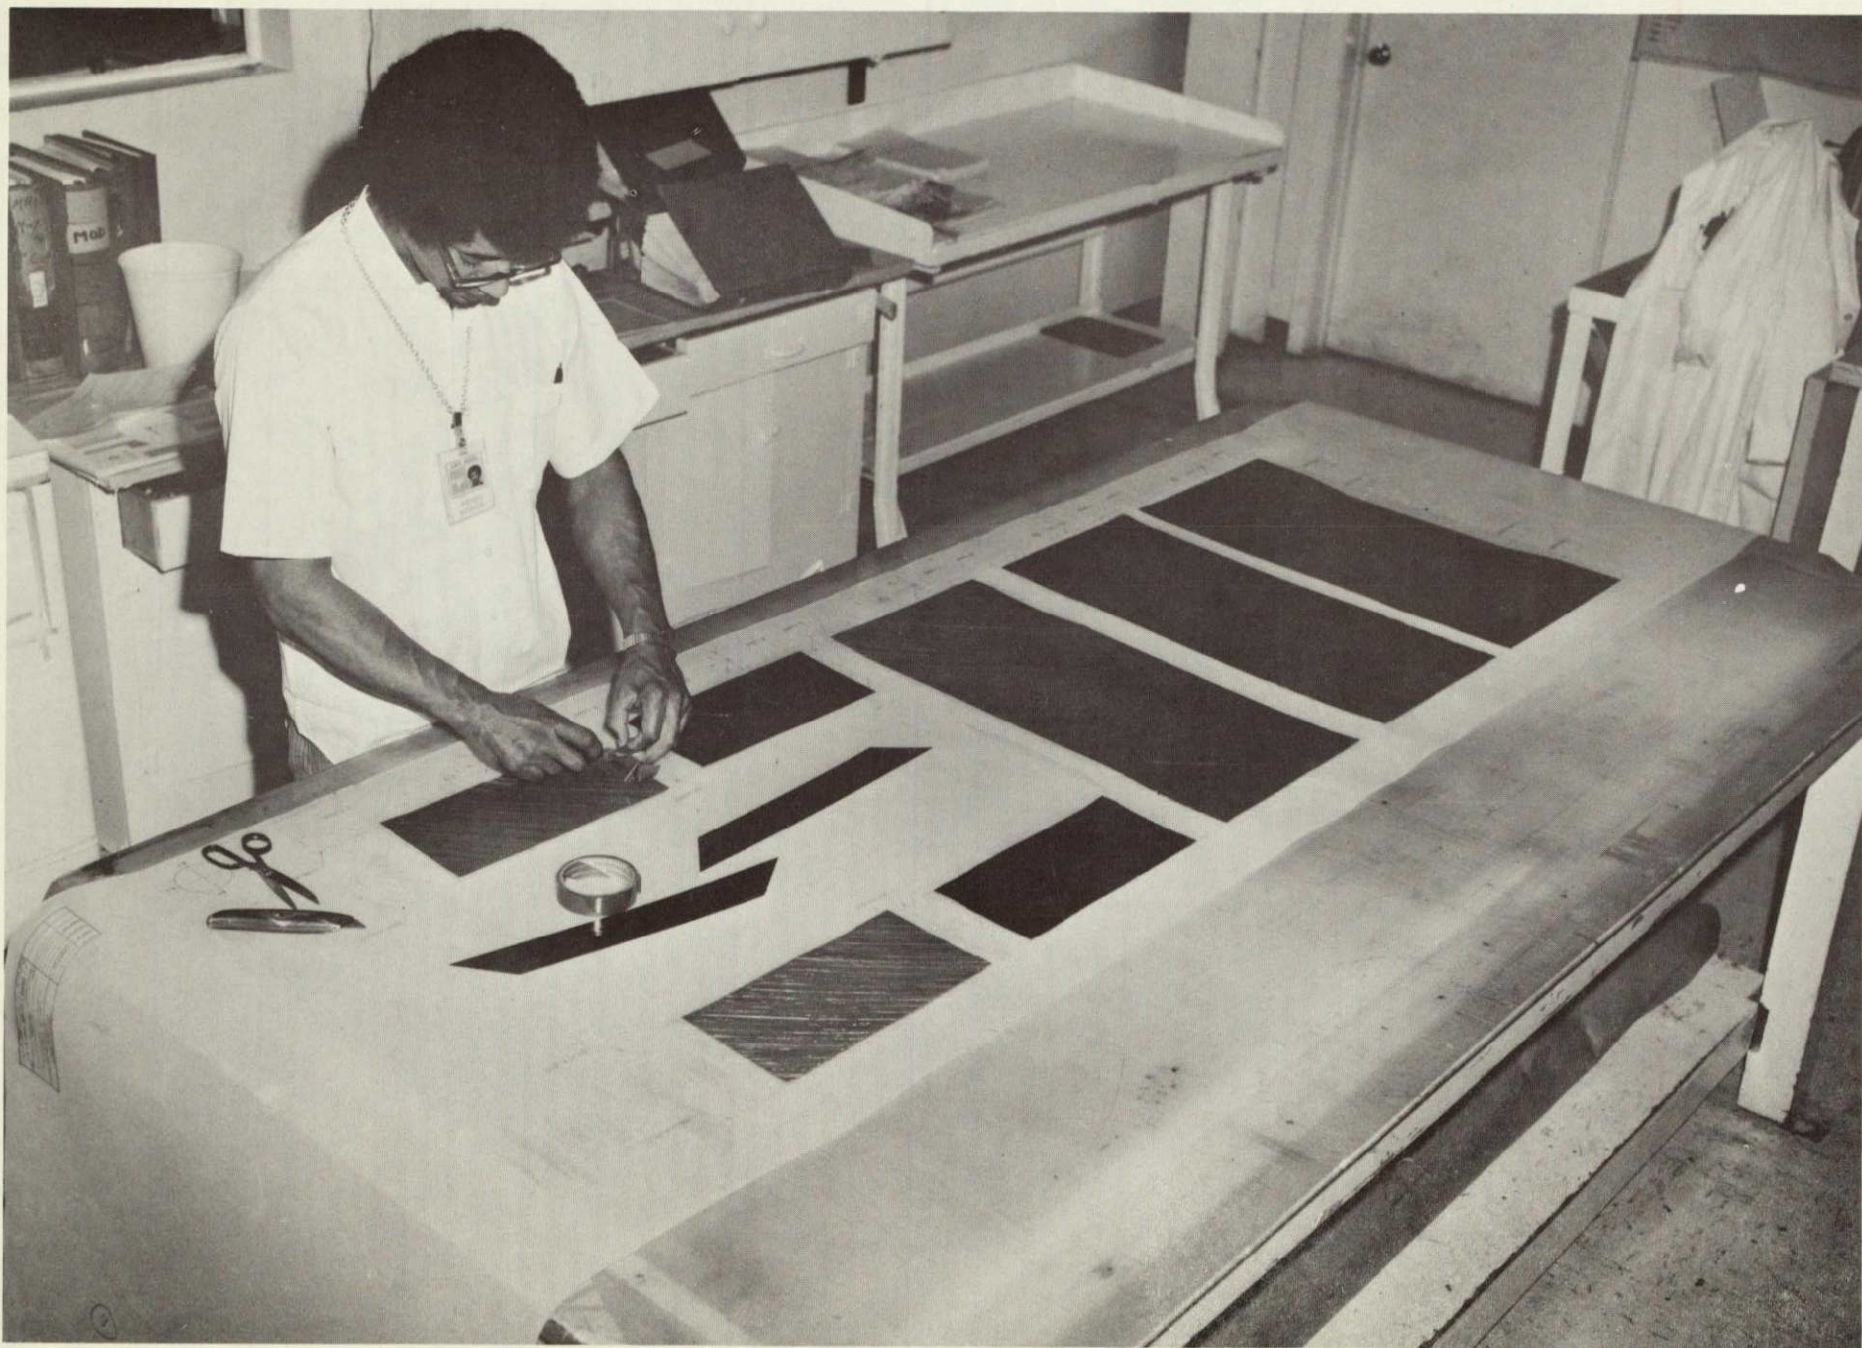
Figure 3-5 Mylar Layup Template

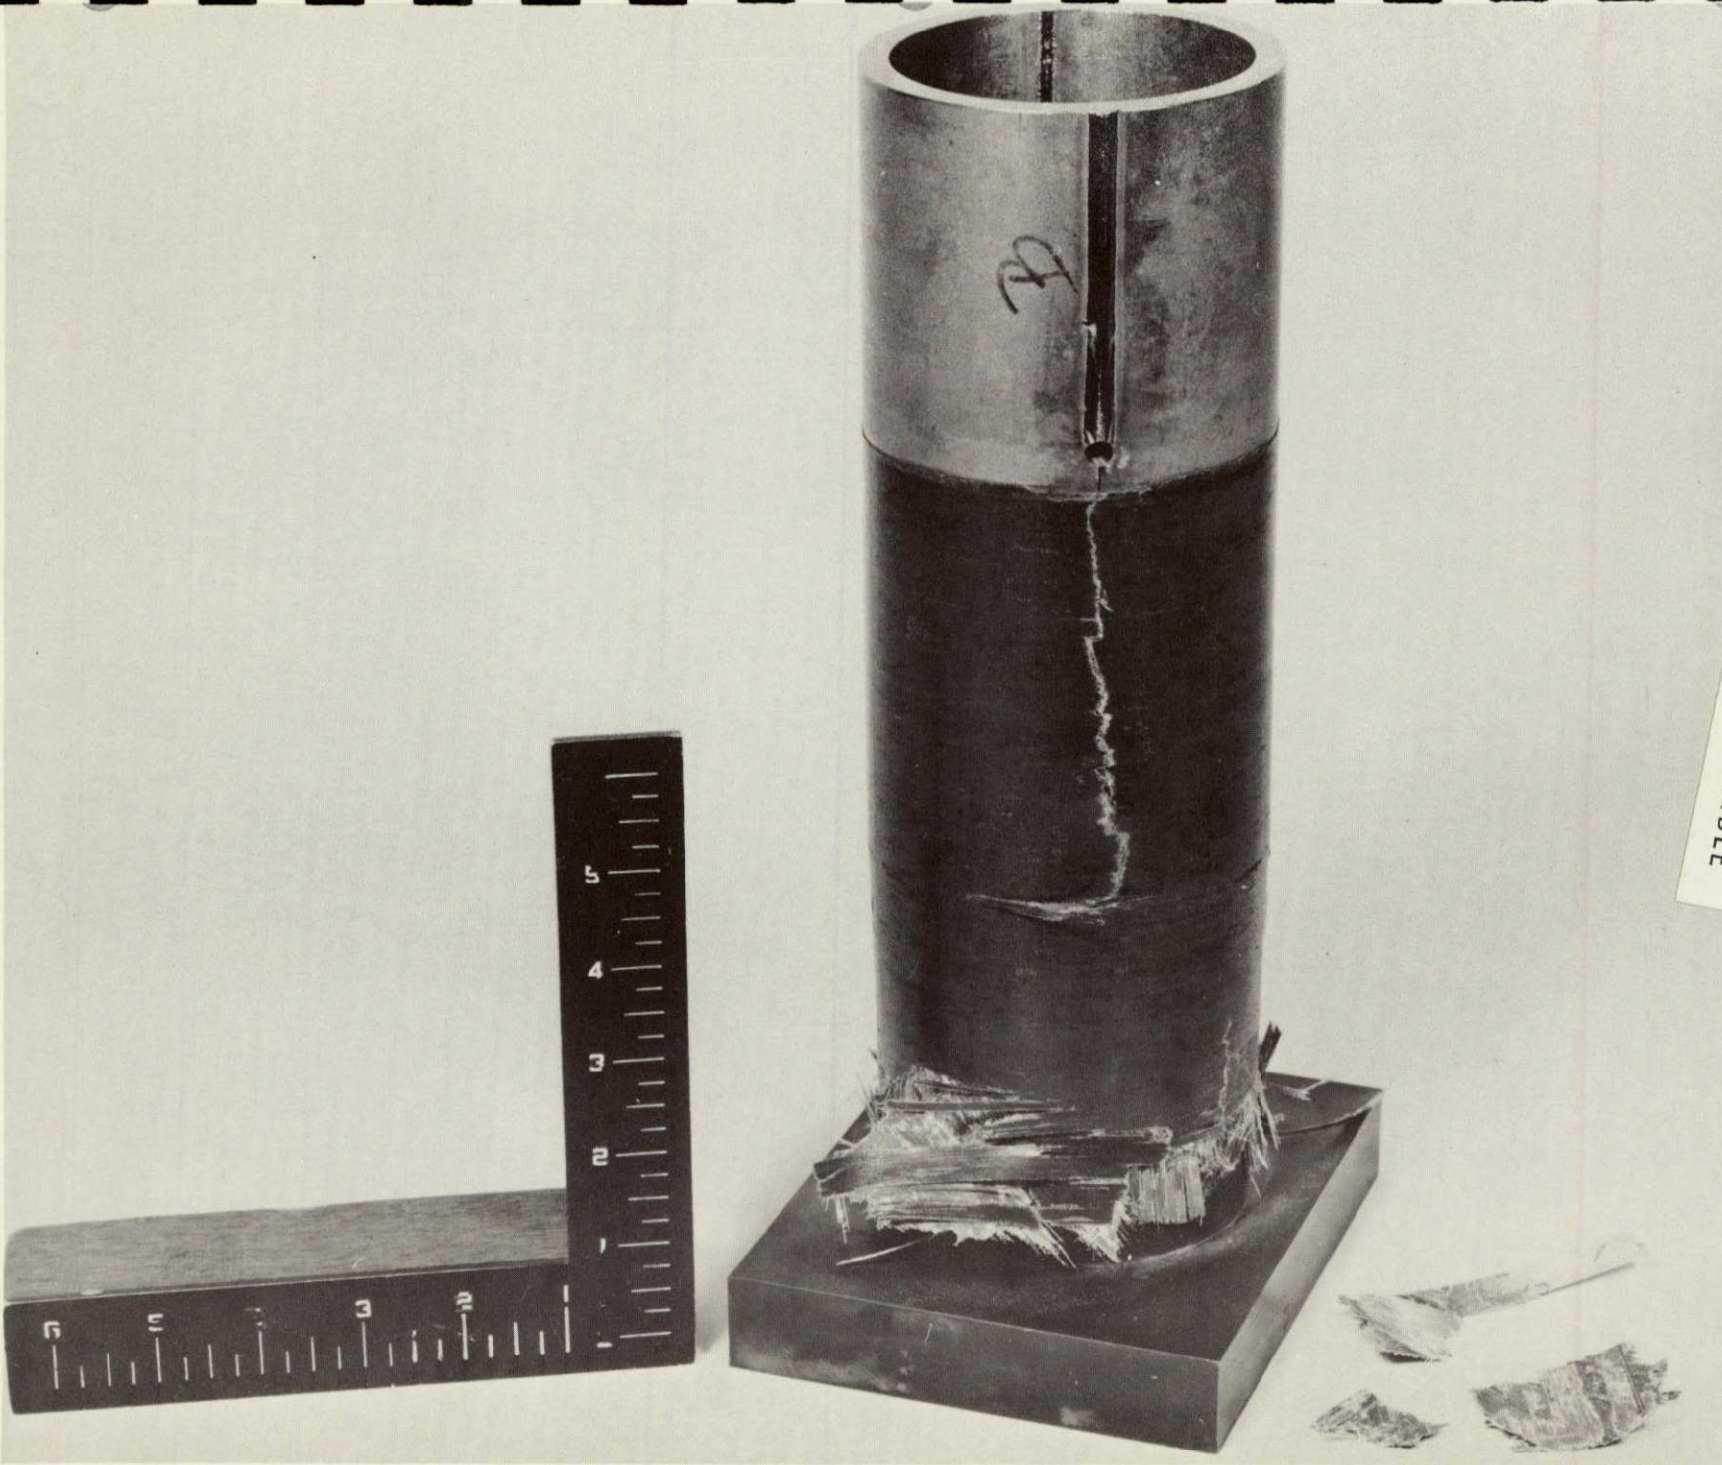
Figure 5-4 Side View of Failed Subelement Number 1

Internal inspection of the specimen indicated that failure of the boron laminate did not extend through the entire thickness. There are two possible explanations for this failure:

- o The steel end fixture provided sufficient restraint to radial growth to induce bending stresses in the tube wall, which would relieve the compressive stress on the inner surface and increase the stress on the outer surface. In an effort to minimize the induced bending stress, the boron end of subelement number 2 was reinforced by a 90° fiberglass overwrap (identical to that used for the first test of this subelement).
- o The presence of some local circumferential delaminations, noted when the part was trimmed, approximately 4-6 plies in depth could reduce the effective thickness of the tube wall and thus the instability stress.

A second failure, extending over the B/Ep to titanium bonded joint at the juncture of the titanium fitting halves, was also noted. This failure originated at the initial splice transition point (load kick point) and progressed approximately 102 mm (4 inches) toward the titanium end. Again, internal inspection of the specimen revealed that the failure did not progress through the entire laminate thickness. The failure appeared to be tensile in nature, which prompted an investigation of induced hoop tension stresses at the load kick point. Results of the analysis showed that hoop stresses could have been developed which were sufficiently large to cause failure of the outer 90 degree ply. The following assumptions were made for this analysis:

A third observed failure, which was the disbonding of the boron from the internal last step of the splice, was noted after the specimen was removed from the test rig. This was probably a secondary failure resulting from the outer ply failures at the boron end.

In conclusion, it was felt that the cause of premature primary failure was not typical, and could be attributed to the presence of delaminations at the boron end of the tube, resulting from the previous test and the quality of the boron laminate.
