NASA CR-72742

INVESTIGATION OF ADVANCED REGENERATIVE  
THRUST CHAMBER DESIGNS

AEROJET LIQUID ROCKET COMPANY

FINAL REPORT

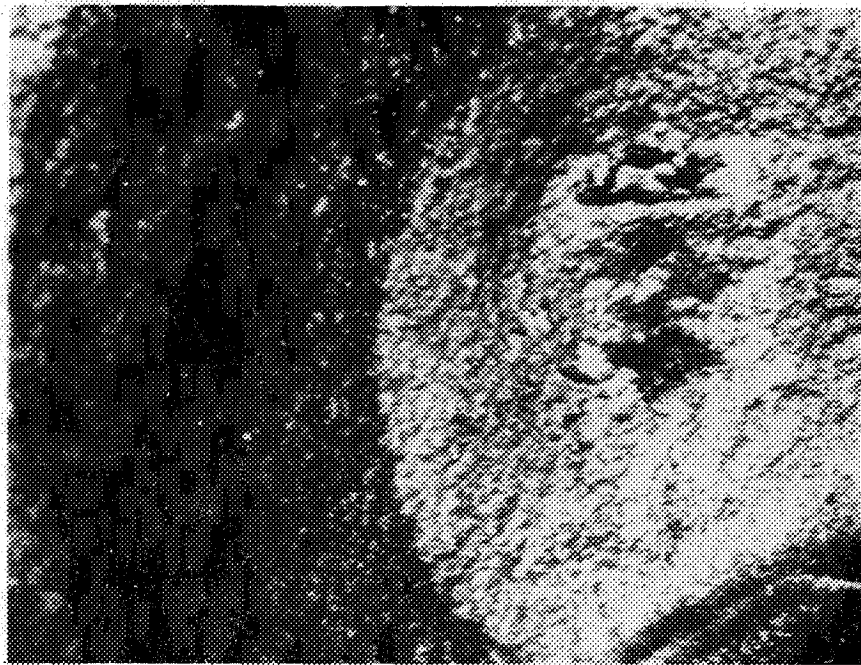
Figure 22. Leak in Chamber Wall - Single Hole

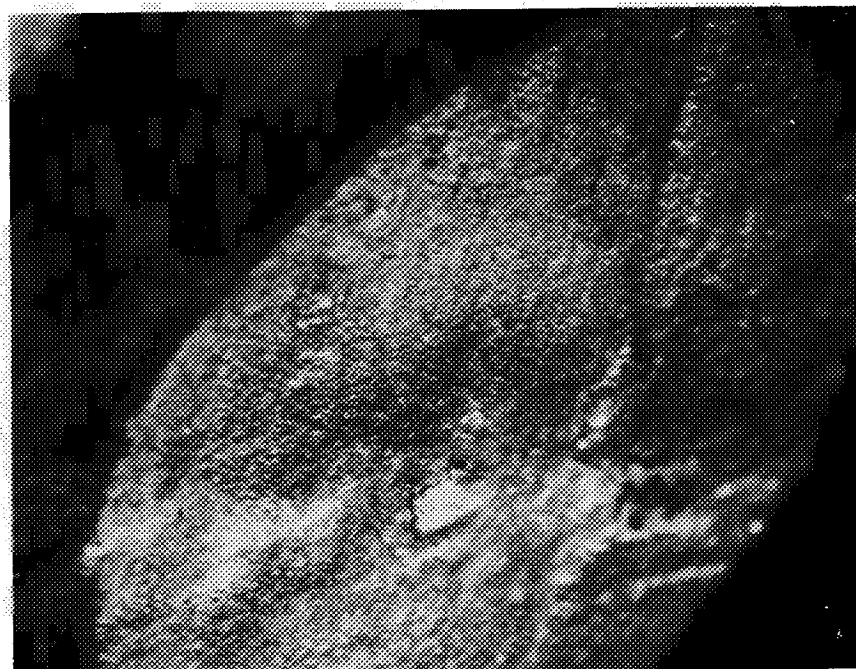
Figure 23. Leak in Chamber Wall - Scattered Porosity

On the basis of fact number (1), it is possible to make the following supposition: a local protrusion resulted in a thin area of the nickel inner shell that failed under the 1100 psig proof load. The appearance of the hole in Figure 23 tends to support this theory.
