NASA APOLLO PROGRAM WORKING PAPER NC. 1325

FRACTURE MECHANICS ANALYSIS OF APOLLO  
BLOCK I TITANIUM ALLOY PRESSURE VESSELS  
(COMMAND AND SERVICE MODULES)

MANNED SPACECRAFT CENTER  
HOUSTON, TEXAS

February 1967

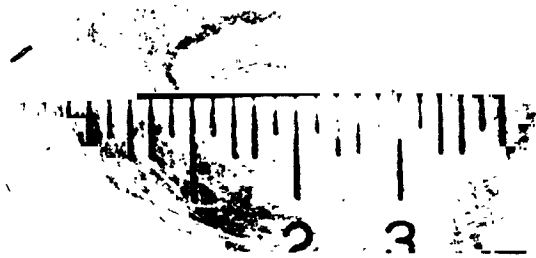
(a) Fractograph of test specimen.

(b) Explanation of characteristics.

Figure 3. - Flaw characteristics for Ti-6Al-4V test specimens exposed to methanol.

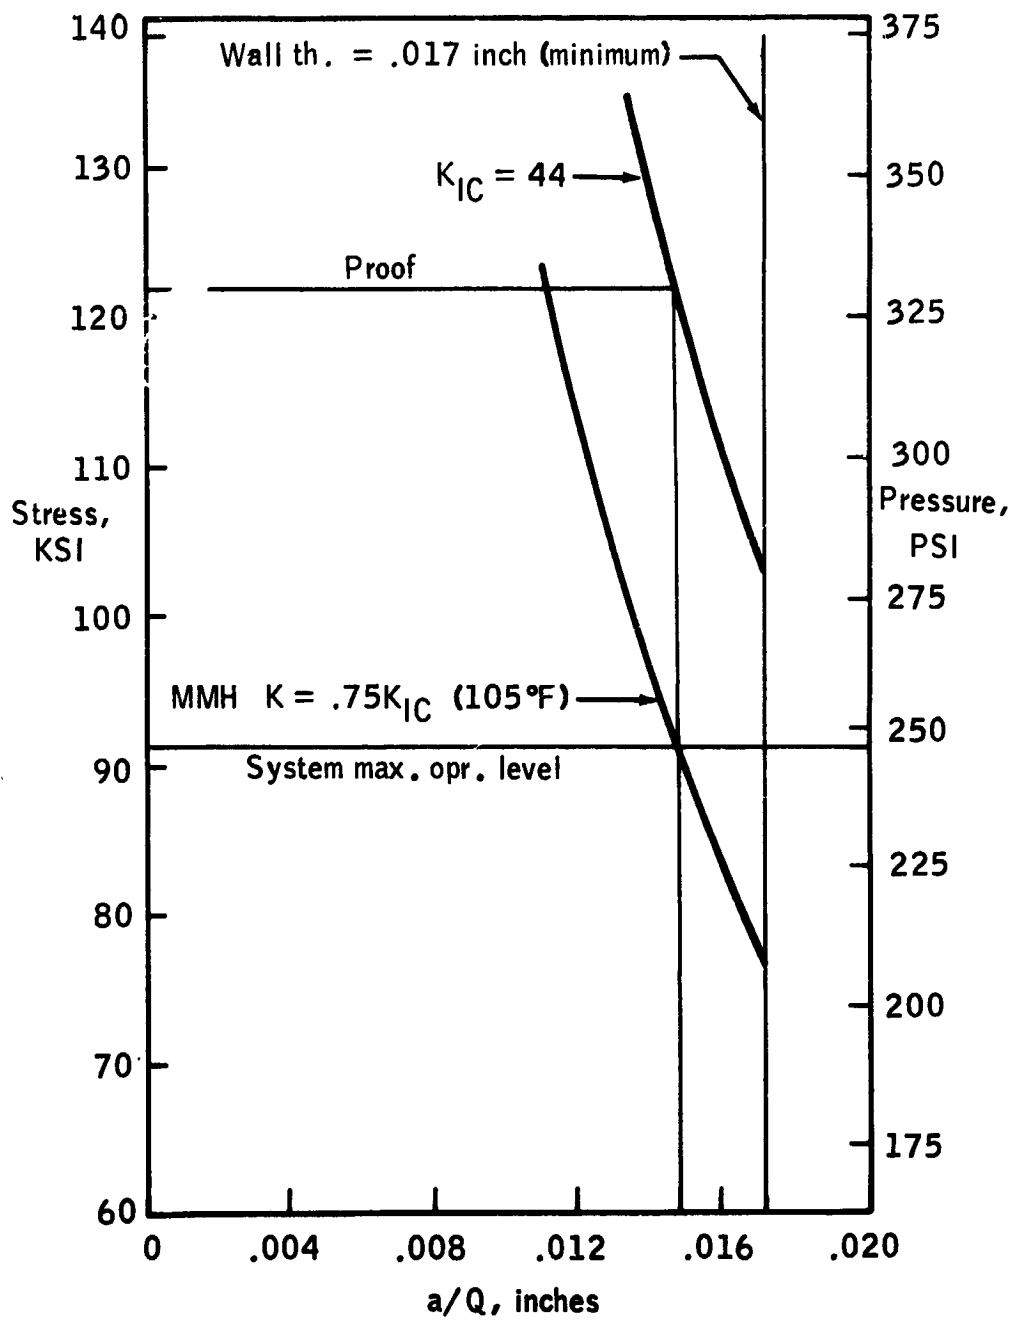
Figure 14. - Analysis of SM RCS fuel vessel proof test and operating conditions.
