A COMPENDIUM OF NASA AEROBEE SOUNDING ROCKET LAUNCHINGS FOR 1964

by Jon R. Busse, Merrill T. Leffler, George E. Kraft, and Paul S. Bushnell, Jr. Goddard Space Flight Center Greenbelt, Md.

NATIONAL AERONAUTICS AND SPACE ADMINISTRATION • WASHINGTON, D. C. • JULY 1967

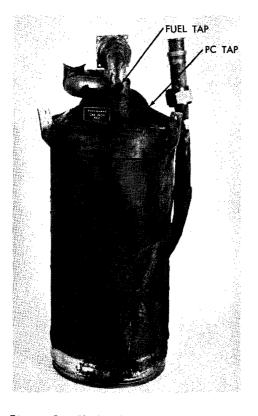
Figure 35—Flight 4.113 GA-GI thrust chamber jacket showing broken pressure chamber and fuel taps.

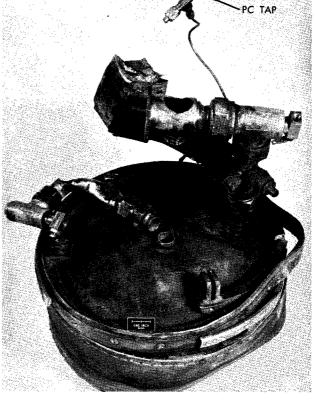
Figure 36—Flight 4.113 GA-GI aft fuel tank bulkhead showing burned aniline deposits.

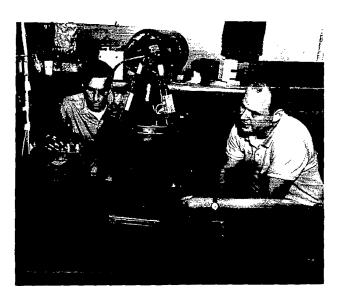
Figure 54—Experiment section without the extension casing, flight 4.108 GE.
