NASA TN D-3512

HYPERVELOCITY IMPACTS INTO STAINLESS-STEEL TUBES ARMORED WITH REINFORCED BERYLLIUM

*by A. R. McMillan
General Motors Corporation*

*James H. Diedrich and Nestor Clough
Lewis Research Center*

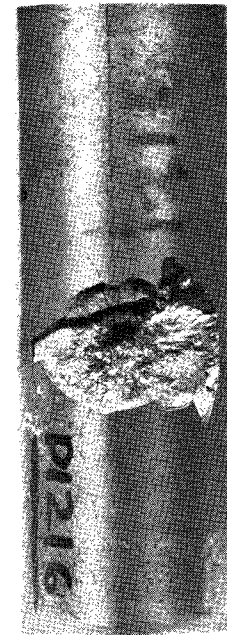
First impact

View of both impacts

Second impact

Figure 9. - Fiber-reinforced beryllium armored tube after two impacts. Test conditions (each impact): 3/32-inch Pyrex sphere; nominal impact velocity, 24 000 feet per second; target temperature, 1300 F.

Double impact. - A fiber-reinforced target was impacted twice to determine if repeated impacts would result in removal of large segments of the armor cracked by the first impact. On the particular target tested, the second impact was made approximately 90° from the first impact in the same plane. Figure 9 shows both impacts and the condition of the armor between the craters. Large segments of the armor were not lost, and the increase in cracking damage was not appreciable. The cracked area around the second crater was slightly larger than that around the first crater, as can be seen from a

comparison with figure 8. Neither of the impacts, however, perforated the liner tube, and only internal dimples were visible on the inside surface of the tube.

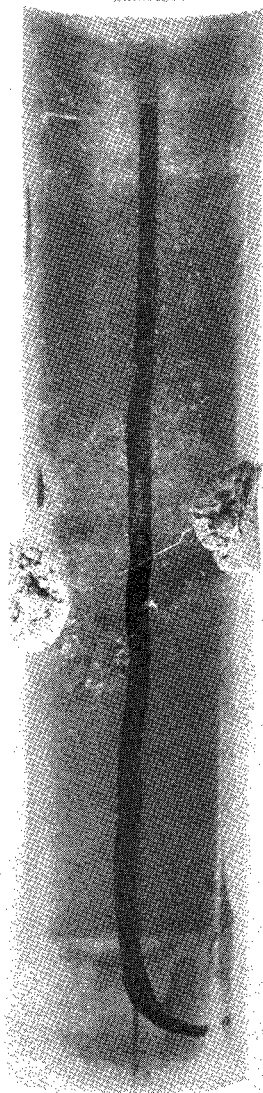
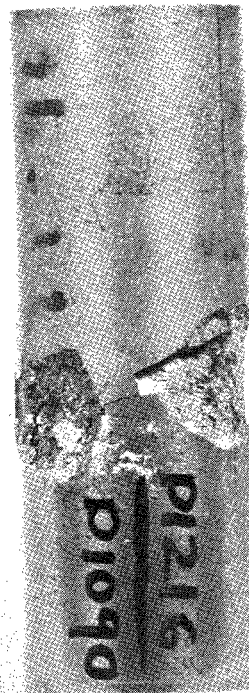
Unreinforced

Fiber reinforced

Figure 10. - Unreinforced and fiber-reinforced beryllium tubes after two impacts. Test conditions: 3/32-inch-diameter Pyrex sphere; nominal impact velocity, 24 000 feet per second; target temperature, 1300° F.

Figure 10 shows a comparison of an unreinforced-beryllium-armored tube (ref. 4) after two impacts and target 4 of this investigation. As shown in table I (p. 6), the unreinforced target was impacted at approximately the same velocity but at a greater impact angle. Also, the wall thickness of the liner tube for the unreinforced target was 0.010 inch thick, while all targets tested in this investigation had 0.028-inch-thick liners; however, the gross damage aspects of the two targets can be compared.

Neither the fiber-reinforced nor the unreinforced targets lost armor from the combined effect of the two impacts. The liner tubes were not perforated on either of the targets, and only dimples appeared on the inner surface of the liner under the

points of impact. A crack connecting the two craters was observed on both of the targets.
