NASA TN D-2499

**THE SUSCEPTIBILITY OF SIX STAINLESS
STEELS TO STRESS CORROSION AT
AMBIENT AND ELEVATED TEMPERATURES**

by David N. Braski

Langley Research Center

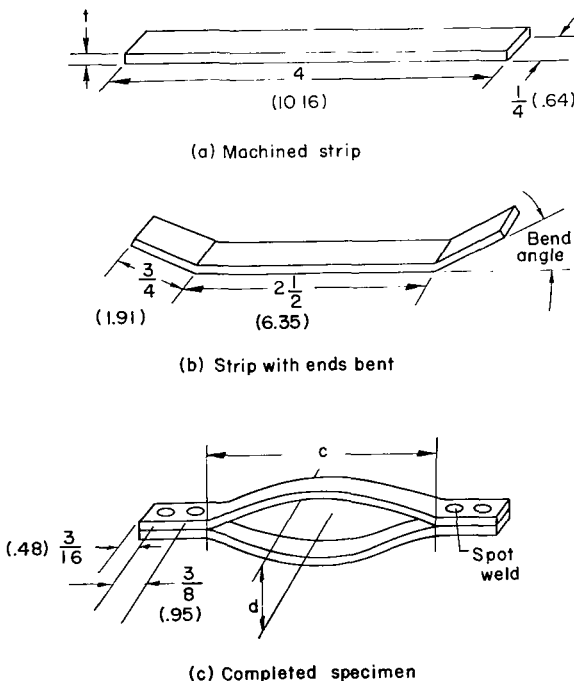
Figure 1.- Construction of self-stressed specimen. Dimensions are given in inches and parenthetically in centimeters.

Self-stressed specimens, similar to those used in reference 2, were constructed from sheet material as shown in figure 1. The specimens were fabricated in both longitudinal and transverse grain directions to provide a maximum fiber stress of 100 ksi (690 MN/m^2) as follows:

- (1) Cut and machine 4 by 1/4 inch (10.16 by 0.64 cm) strips (fig. 1(a)).
- (2) Heat treat if applicable. (See table II.)
- (3) Bend ends of each strip to proper bend angle (approximately 25° for 0.025 inch (0.064 cm) and 12° for 0.050 inch (0.127 cm) material). (See fig. 1(b).)
- (4) Clean the strips chemically. (See appendix.)

(5) Place two cleaned strips together, clamp the ends and spot-weld (fig. 1(c)). All specimens were handled carefully with clean white gloves throughout this operation to prevent any contamination.
