Environ Earth Sci (2013) 69:1451–1469
DOI 10.1007/s12665-013-2246-x

Stability assessment of marble statuary of the Schlossbrücke (Berlin, Germany) based on rock strength measurements and ultrasonic wave velocities

Keywords Marble weathering · Mechanical properties · Ultrasonic wave velocities · Stability assessment · Cultural heritage

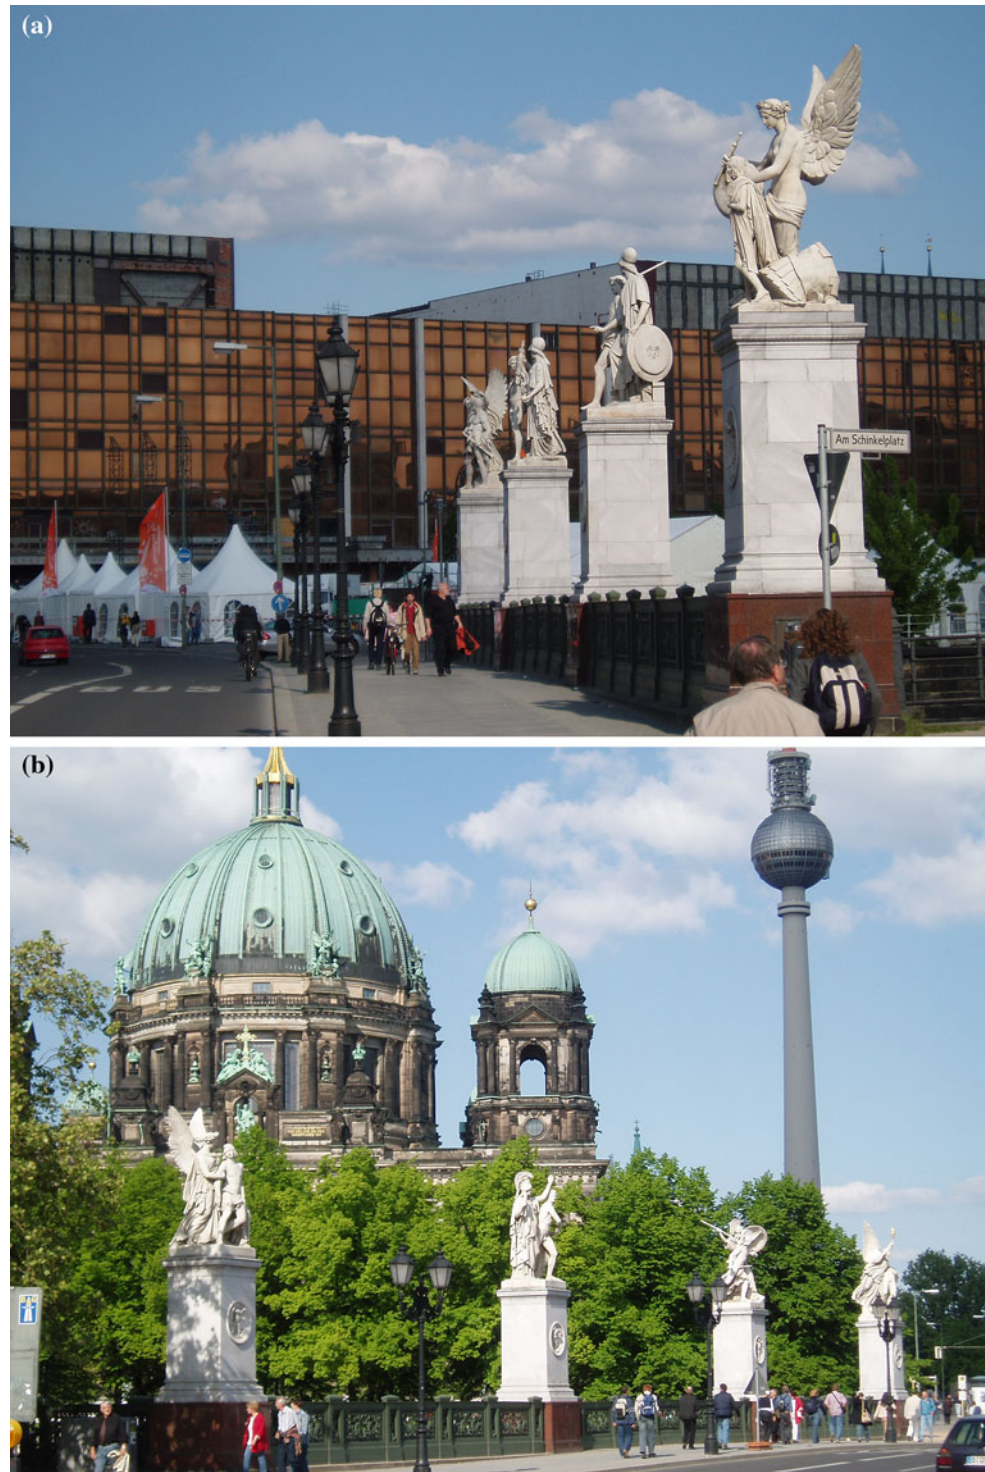
Fig. 1 Schlossbrücke, Unter den Linden/Berlin (all statues are given on two photographs a and b)

Significant artworks have been constructed from marble in antiquity and present historical times. The “Schlossbrücke” in Berlin with its monumental sculptural groups made of Carrara marble is situated in the center of Berlin on the rim of the Museum Island, an UNESCO world cultural heritage site (Fig. 1). The sculptures now show considerable signs of damage. These examples and many others documented elsewhere have shown that the utilization of marble as a building stone can be problematic. Marble is known for its ability of undergoing a complete destruction of the fabric over time. On the other hand, thin marble plates are increasingly used as facade stones instead of solid blocks. These plates tend to bend inelastically leading to destruction within a short period of time (see

The Schlossbrücke was constructed between 1822 and 1824 in the classical style according to a design by Karl Friedrich Schinkel. Artistically, this is the most beautiful bridge in the city of Berlin (Fig. 1). It was completed in the period from 1842 to 1857 and consists of eight groups of figures constructed of Carrara marble by sculptors of the Schadow and Rauch School. These sculptures, such as the Goddesses of Antiquity (Nike and Athena) with young heroes were also a part of the design plans of Schinkel. High pedestals of red granite were constructed on the stone pillars of the bridge and serve as the base for the larger-than-life sculptures. The ensemble of bridge figures made of Carrara marble is reminiscent of the Angels Bridge in Rome and is one of the outstanding examples of the world famous Berlin sculptural school of the nineteenth century. The bridge, with its monumental groups of figures, is a major element of the sculptural program designed by Schinkel and Rauch. Today they line up along a busy inner city street, which is a major traffic artery and forms a part of the buffer zone around the Museum Island. This circumstance, i.e. the location of the bridge in the center of

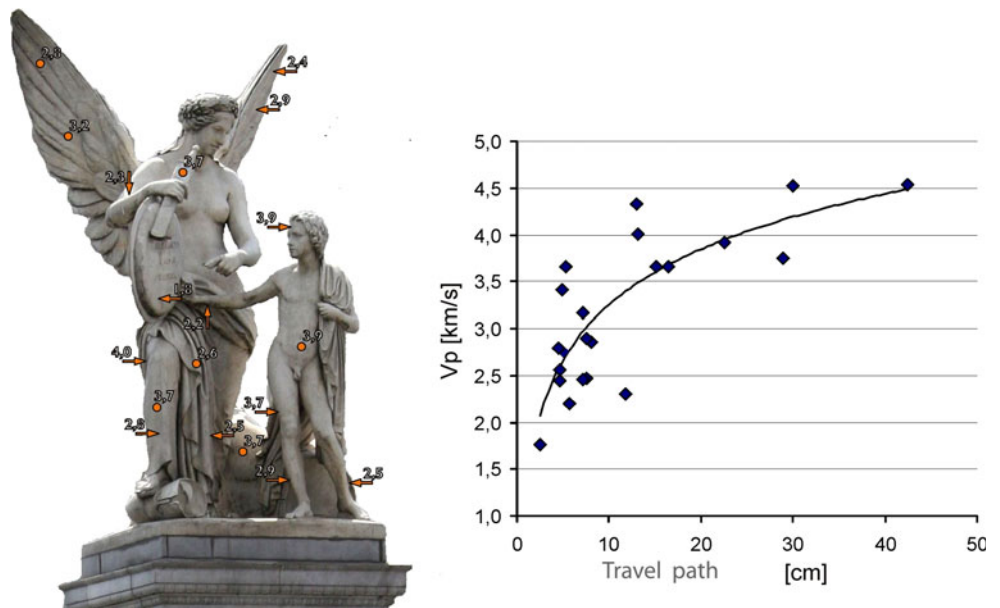
Fig. 2 Ultrasonic analysis on monuments revealed by transmission measurements on the sculpture “Nike educates the boy in history”, Unter den Linden, Berlin, Germany (*dots* refer to a *vertical ray path*, while *arrows* characterize a *diagonal ray path*)

In the last several decades, measurements of the ultrasonic velocities have achieved more and more acceptance as a tool for analyzing the damage of marbles (Figs. 2, 3). The advantage of this method is the more or less non-

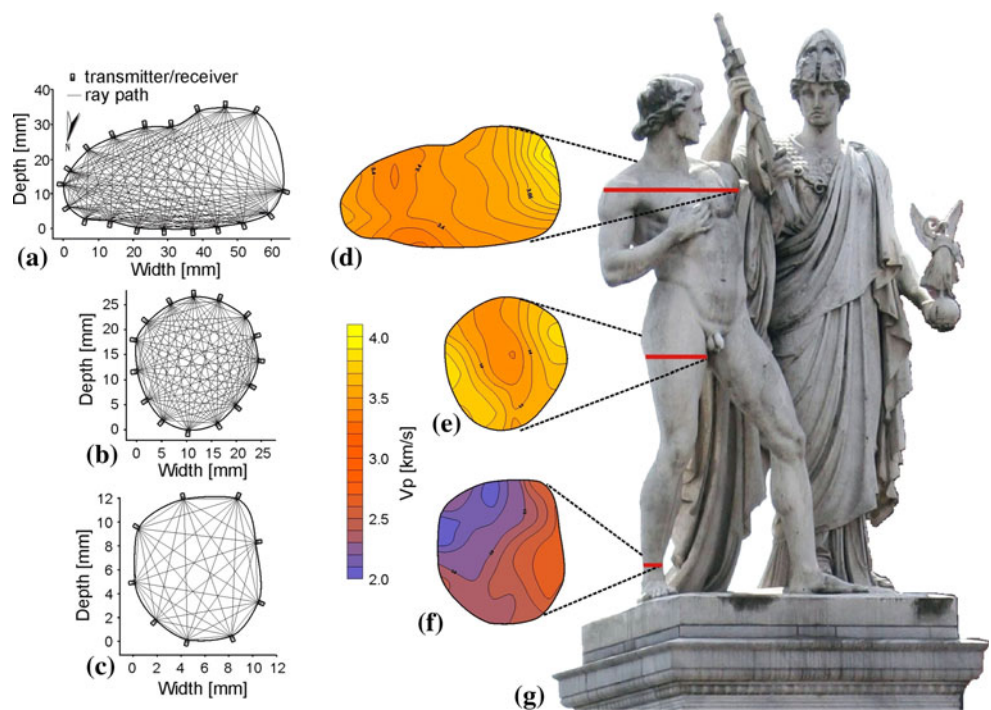
Fig. 3 Tomographic reproduction for evaluating local V_p intensities on *three slices* of the Sculpture group “Athena arms the warrior” (a–g)

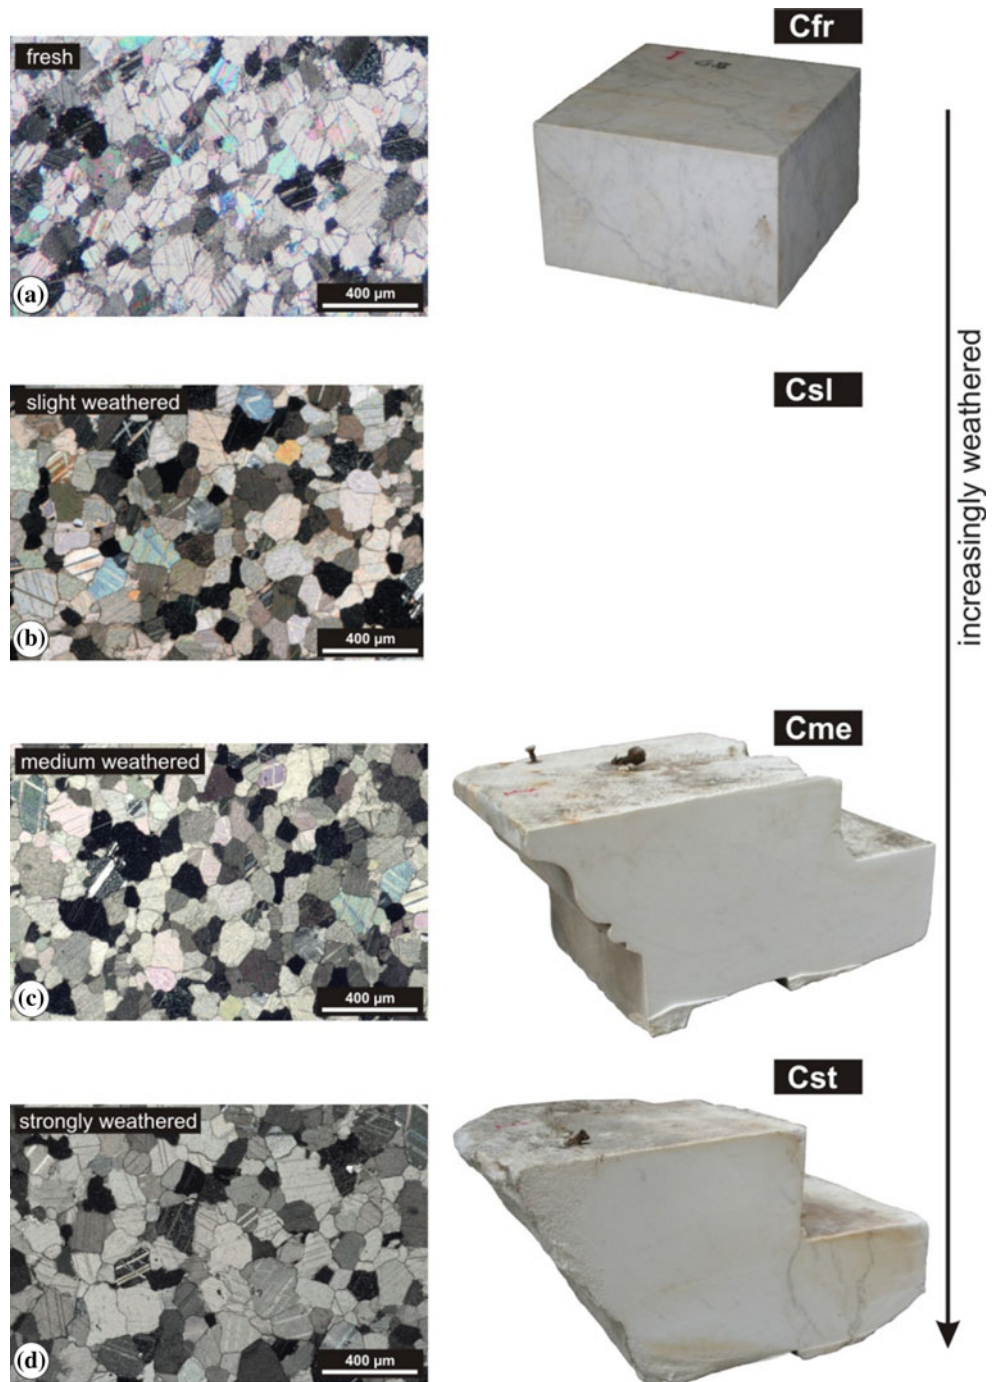
Fig. 4 Investigated samples of Carrara marble: weathered specimens from the Marble Palace in Potsdam and a fresh reference sample from the quarry near Gioia (Italy)

For the investigation of the strength properties and its cross correlation to ultrasonic wave velocities as a function of the state of weathering, representative Carrara marble samples were collected (Fig. 4) representing four different preservation conditions: fresh (Cfr), slightly weathered (Csl), medium weathered (Cme), and strongly weathered (Csr). All weathered samples come from the Marble Palace in Potsdam (Germany). The samples were originally part of an Attica cornice of the palace’s south wing. The marble samples were produced during the time of construction and were replaced during the restoration work at the end of the twentieth century. The fresh sample was taken from a quarry near Gioia in the Carrara region of Italy.

Macroscopically, the samples are characterized by a more or less comparable appearance. They show a weak and irregular dark veined metamorphic layering. A strongly oriented foliation is not observable. However, the veins show a slight preferred orientation. Between the dark veins the marbles appear milky white, which is a typical attribute of weathered Carrara marble (Fig. 4). In contrast, the fresh

The investigated marbles exhibit a medium grain size of about 180 µm. The samples show a more or less polygonal and equigranular grain fabric (Fig. 4). The grain boundaries are slightly curved to weakly interlocking. Often straight boundaries occur. Polysynthetic twinning of the calcite grains is rare. Cleavage planes occur frequently and are observable in the fresh sample. This may be due to mechanical deformation during the thin section preparation.

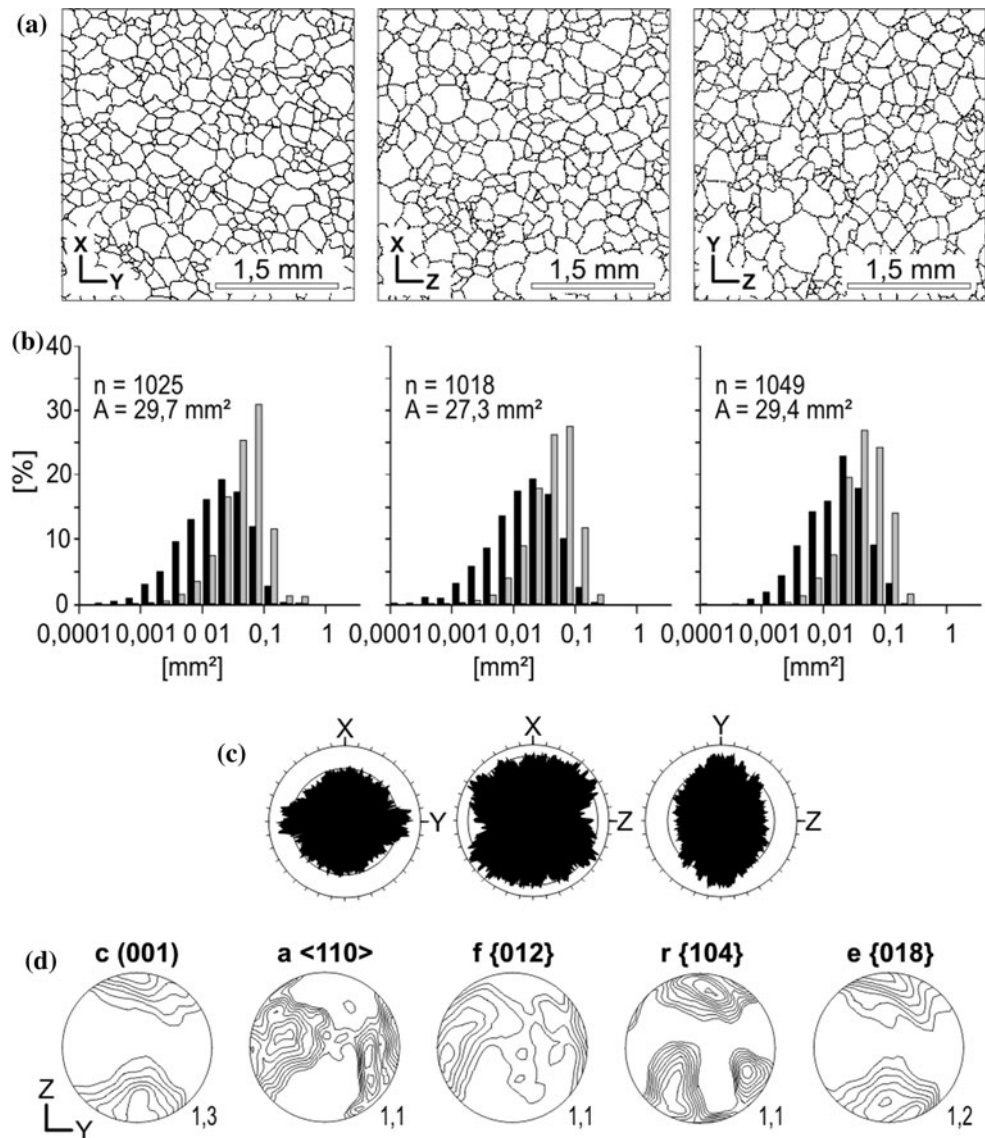
Fig. 5 Microfabric analysis of the slightly weathered Carrara marble sample. **a** Grain fabric, **b** grain size distribution, **c** grain boundary orientation and **d** lattice preferred orientation of calcite crystals (texture)

Detailed fabric investigations were done on the slightly weathered sample (Fig. 5). Image analysis was performed on three orthogonal digitized thin sections (Duyster 1991). Macroscopically, the specimen shows a bright white color and contains irregular gray veins. The veins are folded and display a streak-like distortion and usually range from 0.5 to 2 cm in width. A preferred orientation of the veins is not clearly detectable. The sample shows a weak decay in the form of granular disintegration.

Microstructurally, the Carrara sample shows a nearly equigranular polygonal grain fabric (Fig. 5a) with straight grain boundaries and 120° triple-point junctions (Fig. 5a). The grain size is given as an average area parameter (Fig. 5a–d). The percentage of a specific area class was computed as a function of total area and total number of grains (Fig. 5a). The grain size is about $200 \mu\text{m}$ and the

grain size distribution shows a narrow maximum (Fig. 5a). In the XY plane of the investigated sample a weak preferred grain boundary orientation (subparallel Y direction) can be observed (Fig. 5a).

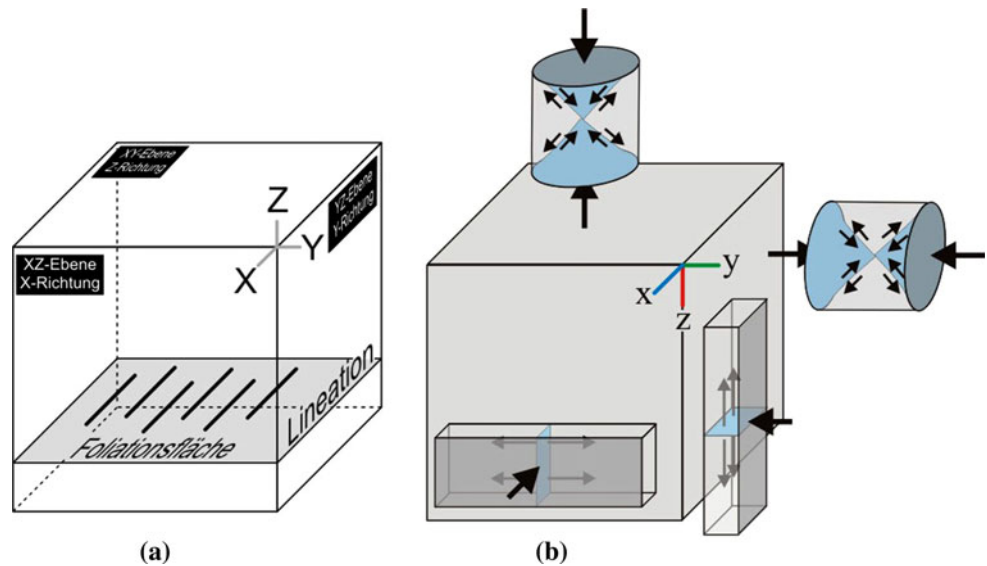
Fig. 6 Used reference system: **a** the three orthogonal directions with regard to the foliation and lineation and **b** directional sampling for flexural and compressive strength analysis with indication of the induced stresses by mechanical loading (arrows)

In order to take the directional dependency of the rock parameters into account, the investigations were performed on specimens from mutually perpendicular directions (Fig. 6). For this a reference coordinate system with respect to the macroscopically visible elements of foliation and lineation was chosen (X, Y, Z). The XY plane delineates the metamorphic foliation.

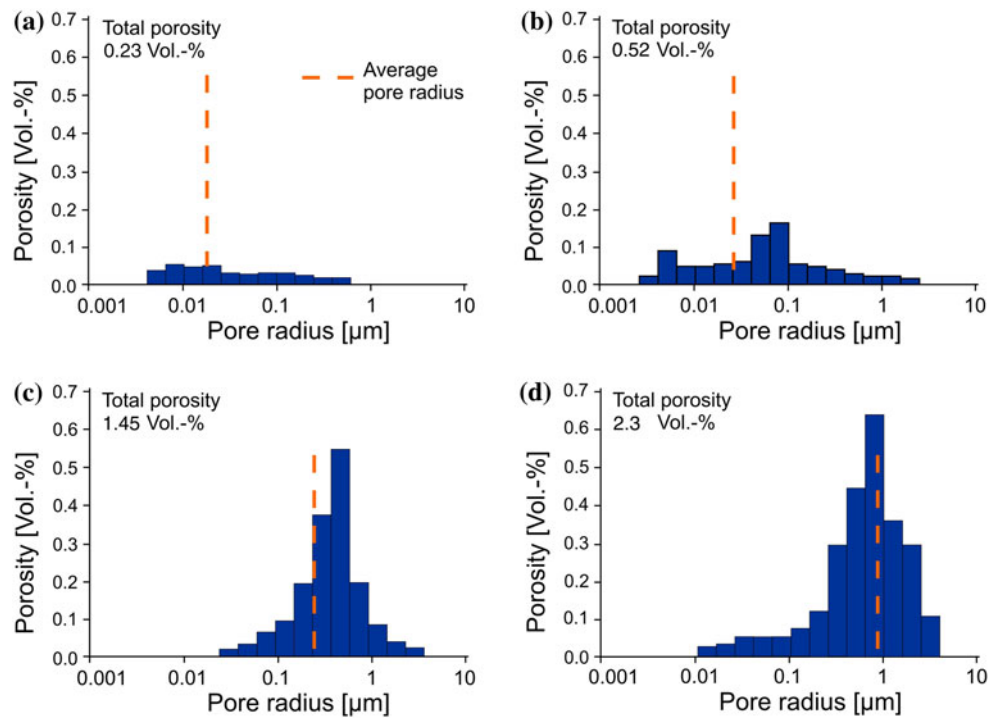
Fig. 7 Pore radius distributions of the investigated samples
a Cfr, **b** Csl, **c** Cme, **d** Cst

The fresh marble sample (Cfr) exhibits a porosity about 0.2 % (Fig. 7; Table 2). This is a typical value for crystalline rocks, which in non-deteriorated preservation states show more or less no porosity (Ruedrich 2003). The slight porosity can still be produced by preparation traces at the sample surfaces. For the strongly deteriorated sample the porosity is strongly increased up to 2.3 %. The slightly weathered sample exhibits a porosity about 0.5 % and the medium deteriorated specimen a porosity of ca. 1.5 %. The progressive increase of the porosity can be traced back to a progressive widening of microcracks during weathering and the connection and access to isolated microcracks.

With increasing porosity a pronounced change of the pore distribution also occurs (Table 2; Fig. 7). Generally, a more or less Gaussian distribution of the pore radius was found with one maximum and a certain amount of smaller or larger pores (unequal unimodal distribution). With

progressive state of deterioration the maximum of the pore radii distribution shows a shifting to larger radii. The maximum is about 0.01 μm for the fresh, about 0.10 μm for the slightly weathered, between 0.10 and 1.00 μm for the medium and about 1.00 μm for the strongly deteriorated sample. Besides the shift of the maximum, a change in the distribution of smaller and larger pores is also observable. The fresh sample shows beside the maximum a relatively high amount of larger pores (Fig. 7a), whereas the pattern of the strongly deteriorated sample exhibits a higher number of pores, which are smaller than the maximum (Fig. 7d). In contrast, for the slight and medium weathered samples the amount of smaller and larger pores beside the maximum is nearly equal (Fig. 7c,d).

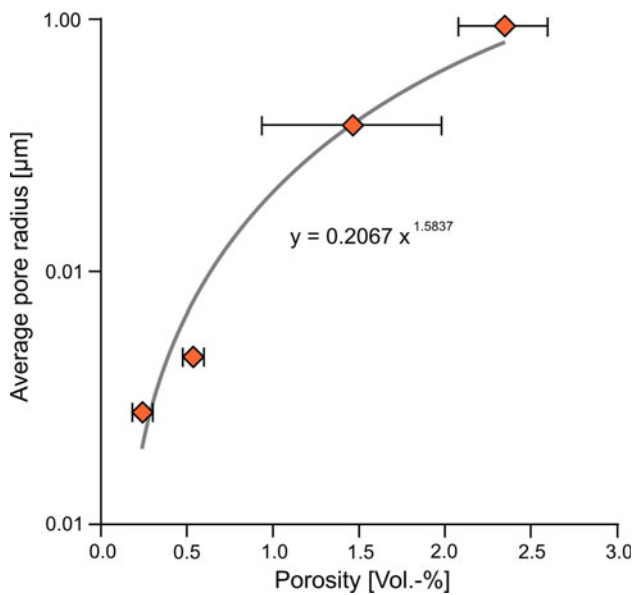
Fig. 8 Average pore radius versus porosity in the investigated samples

In Fig. 8 the average pore radius is plotted versus porosity of the respective sample. The diagram shows that the porosity increases more strongly than the pore radii. This can be explained by a change in the active weathering processes. During progressive deterioration, chemical solution processes start. Due to microcrack opening the water uptake and also drying processes increases. The chemical solution leads to a strong increase in the porosity but affect the pore radii only slightly. Furthermore, the dissolution processes might connect already existing but isolated microcracks, which have a similar pore radius.

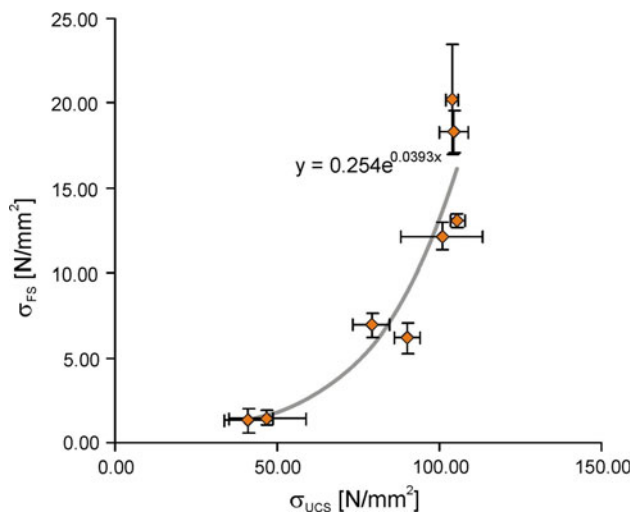
**Fig. 9** Uniaxial compressive strength versus flexural strength of the investigated samples

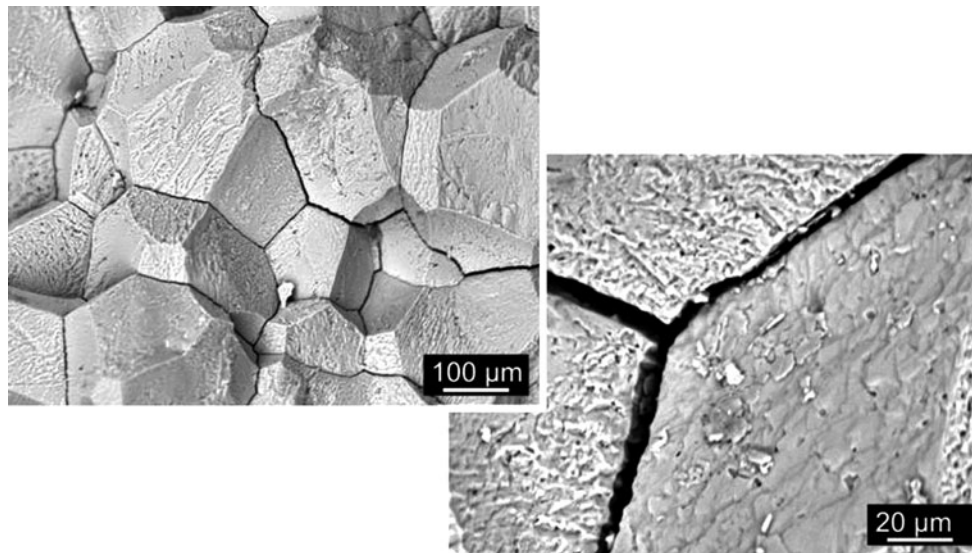
Fig. 10 SEM images depicting well-developed grain boundary fracturing or a loosening of grain boundary cohesion

the fine-grained Carrara marble with its polygonal grain shapes and essentially straight grain boundaries show that the tensile cracks prefer to follow the grain boundaries and seldom trace an intracrystalline path (Siegesmund and Dürrast 2011, see Fig. 10).

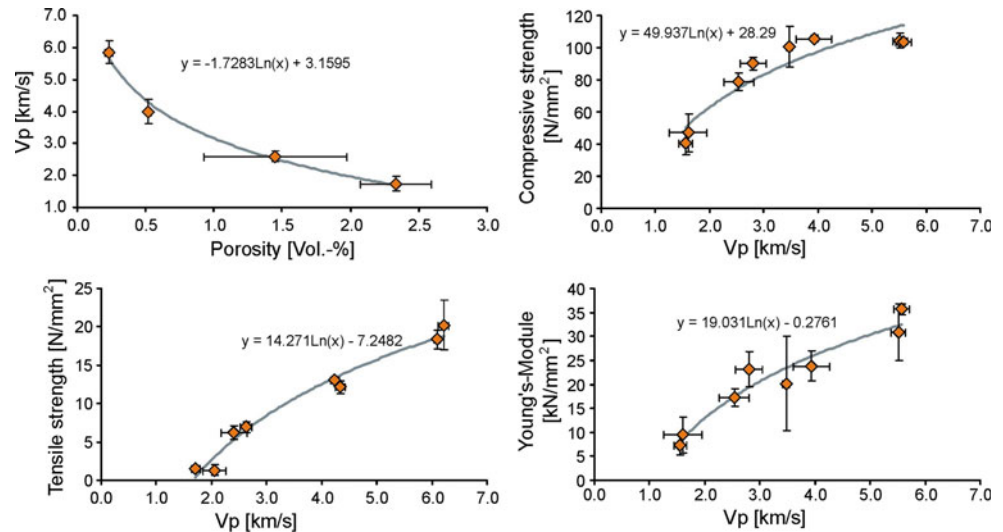
Fig. 11 Correlation of strength data with the elastic properties

The analysis of the mechanical properties is one of the tests often used on natural stones. Many tests, however, are destructive and are not applicable for solving the numerous problems in the field of monument preservation. The compressive strength is apparently in a constant relationship of 1:10 to 1:15 to the tensile strength (Hirschwald 1912). Flexural strength, on the other hand, attains a value of 2 to 2.5 times the value of the tensile strength. Based on statistical analyses, including around 2,100 commercial stones, Mosch and Siegesmund (2007) found that the compressive strength for marbles shows a variation ranging from 32.7 to 210.0 MPa, flexural strength from 2.7 to 28.0 MPa, and the tensile strength ranging from 2.4 to 24.4 MPa. On the basis of data presented in the literature, the determined strength results show a large scattering (Table 3). Furthermore, even the anisotropy is contained in the so-called scattering, which in marbles is very significant. From the statistical data it is also evident that the relationship discussed by Hirschwald (1912) is not met for marbles. For this rock group a significant different relationship is clearly evident (see Fig. 11).

strong reduction in the rock strength, which slows down with every increase in the porosity. The formation of the crack volume in the rock also appears to be discernible in fresh or weakly weathered marble plates. The reduction in the flexural strength from ca. 20 MPa down to 1.3 MPa (Table 3) goes hand in hand with the destruction of the total fabric (Fig. 10). Values obtained for the static E-modulus calculated from the compressive strength display a majority trend, whereby those rocks with the highest strength also show the highest values for the E-modulus.

flexural and compressive strength data given in Fig. 11 are the basis for the internal stress calculation.

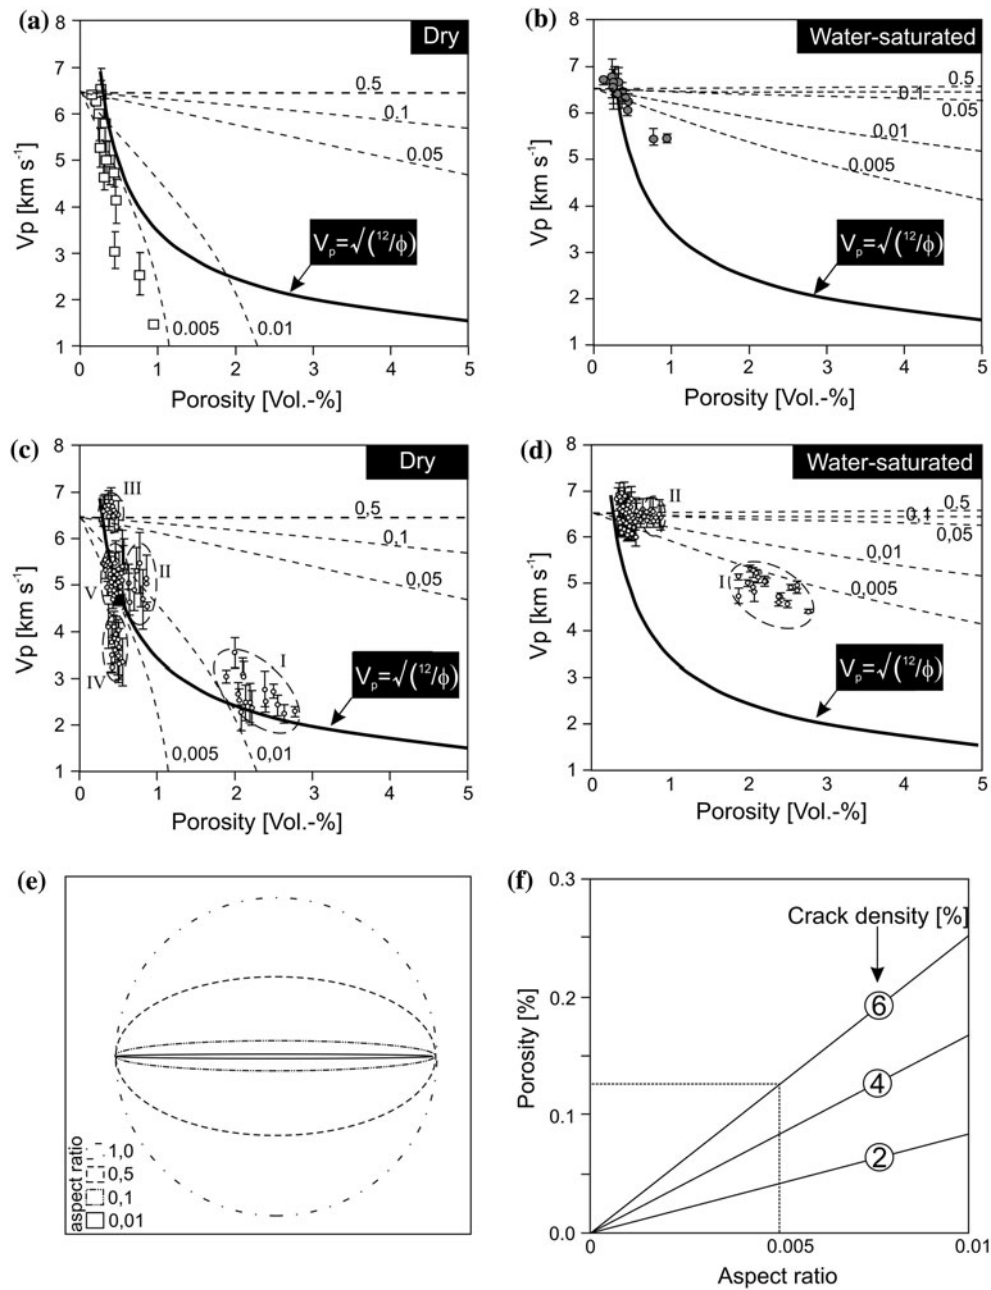
Fig. 12 Average compressional wave velocities for different marble samples as a function of porosity and sample condition: **a** dry samples and **b** water-saturated samples. The anisotropy of the respective marble is illustrated as *error bars*. The velocity/porosity curve of Köhler (1991; *bold line*) and the theoretical predictions according to the models of O’Connell and Budiansky (1974); (*hatched lines*) are added for comparison. For the latter model calculations, the aspect ratio of the cracks assumed in the computations are given. Moreover, in **c** and **d** the mean velocities of the compressive wave for various marble samples in dependence of the porosity and sample state are

shown (*I Carrara and II Grosskunuzendorf, both strongly weathered; III Kauffung; IV Prieborn; V Lasa, Sterzing, Carrara, medium weathering condition*). **e** Schematic representation of the aspect ratio for the sample geometry used in the modeling and based on O’Connell and Budiansky. By an aspect ratio of 0.01 the pores are extremely flat. **f** Theoretical calculation of the porosity increase due to thermal crack formation for different crack densities. A crack density of 6 % (see *dotted line*) is realistic for thermally damaged marbles, which essentially gives an increase in the porosity of 0.125 % (modified after Weiss et al. 2001, 2002b)

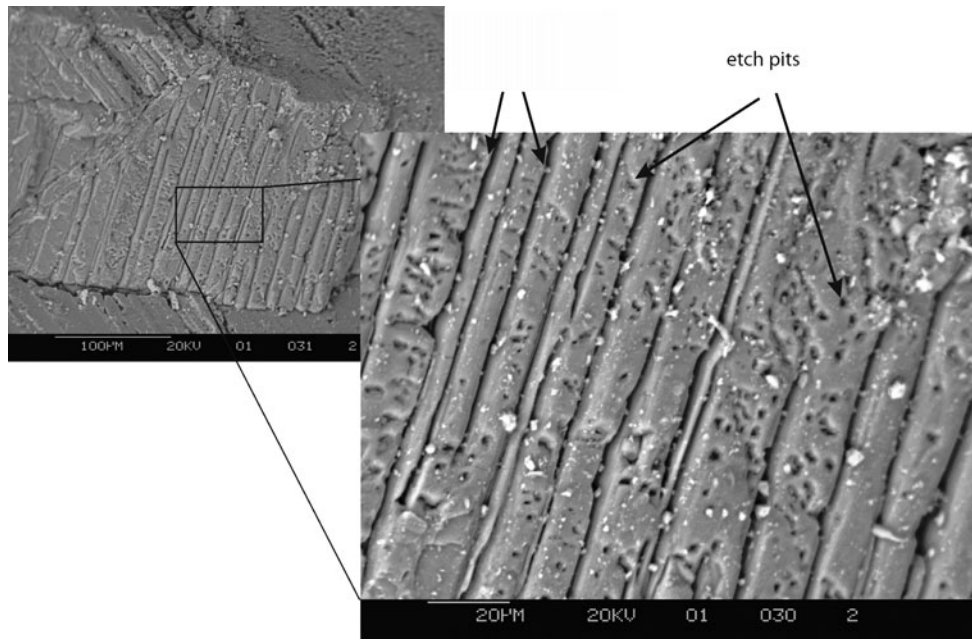
Fig. 13 Etch pits and corrosion phenomena in a marble sample under the SEM

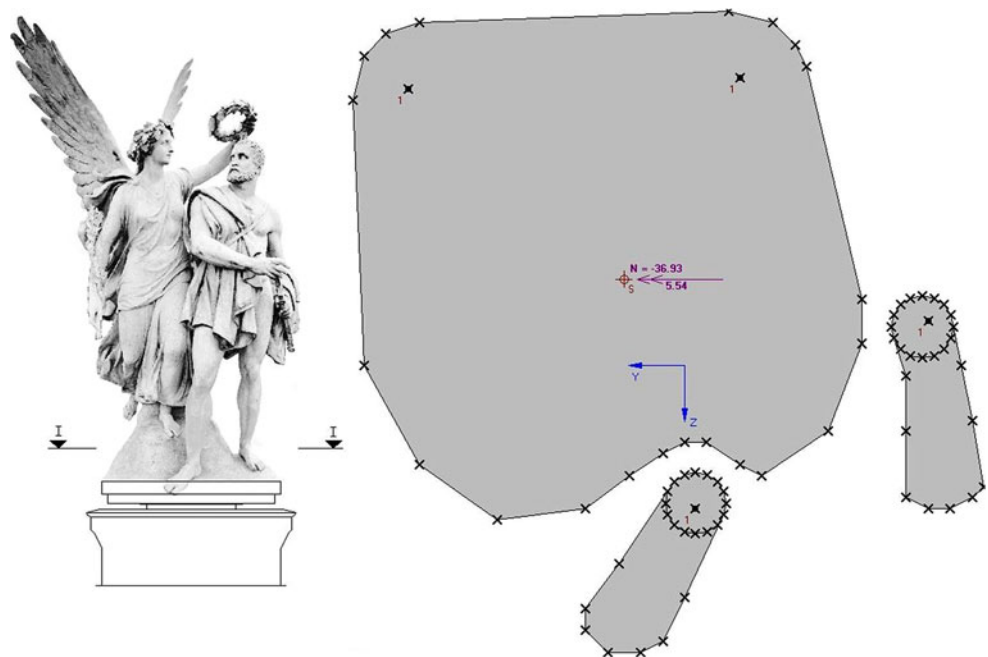
Fig. 14 Intersection I–I near the footing of the statue showing the center of area S

Based on a measurement of the main size proportions and photos of the statues, drawings of the outlines of the figures were generated (Figs. 14, 15). The overall dead load of the statue was estimated by scaling the average volume of a man with 70 kg weight which is 0.075 m³ by the size proportions. Using the density of the marble and the estimated volumes of the attachments of the figure the weight was calculated. The calculations indicate that the

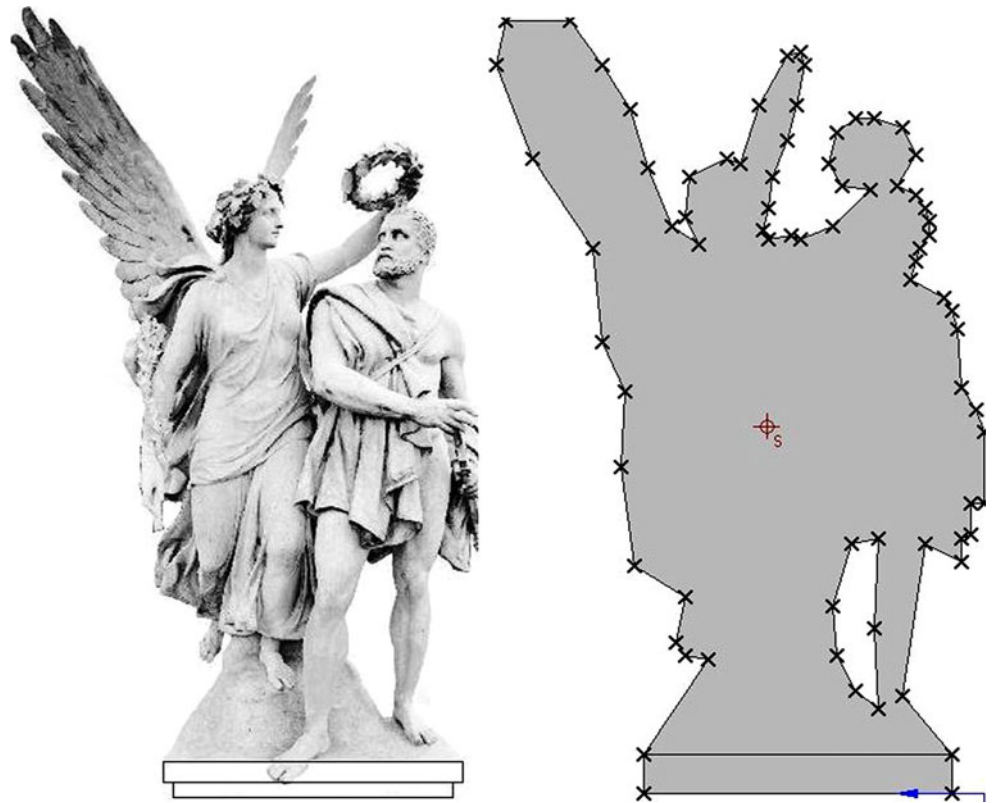
Fig. 15 Elevation of the figure group in the center of area S

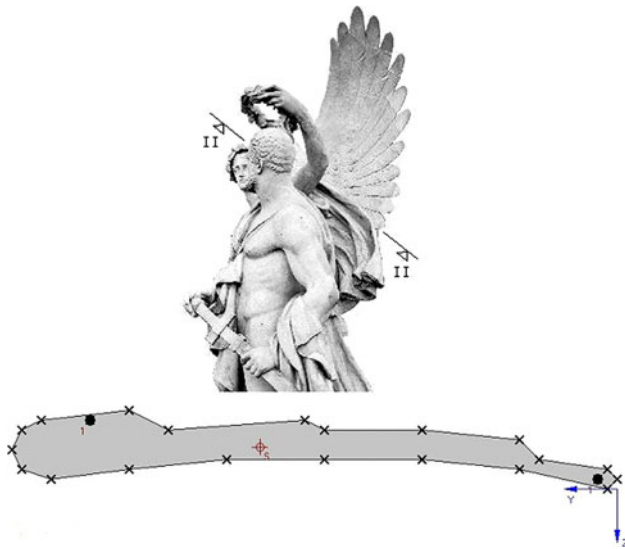
Fig. 16 Intersection of the wing of the statue

In consequence, the internal stress calculations together with the P-wave velocities and the strength data reveal that the most critical parts like the wings of the sculpture and the crown holding hand must be replaced. These parts are designed and manufactured by sculptors for safety reasons.
