# Shear strengthening of wall panels through jacketing with cement mortar reinforced by GFRP grids

This paper gives the results of a series of shear tests carried out on historic wall panels reinforced with an innovative technique by means of jacketing with GFRP (*Glass Fiber Reinforced Plastics*) mesh inserted into an inorganic matrix. Tests were carried out in situ on panels cut from three different historic buildings in Italy: two in double-leaf rough hewn rubble stone masonry in Umbria and L'Aquila and another with solid brick masonry in Emilia. Two widely-known test methods: the diagonal compression test and the shear-compression test with existing confinement stress. The test results enabled the determination of the shear strength of the masonry before and after the application of the reinforcement. The panels strengthened with the GFRP exhibited a significant improvement in lateral load-carrying capacity of up to 1060% when compared to the control panels. A numerical study assessed the global behavior and the stress evolution in the unreinforced and strengthened panels using a finite element code.

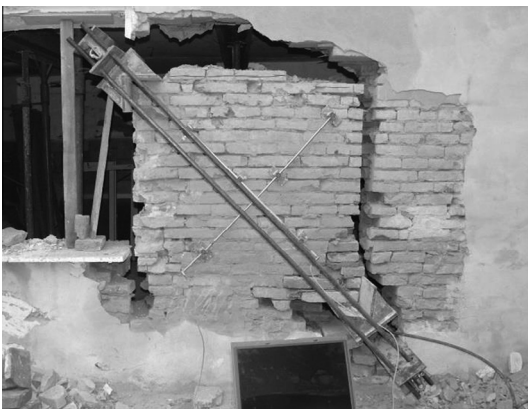
Fig. 1. On-site diagonal compression test (San Felice building).

In the diagonal compression tests, 1200 × 1200 mm panels were isolated from the surrounding walls by making four cuts with a circular saw. In cases where it was possible to obtain samples underneath existing openings, it was possible to reduce the number of cuts made to three (Fig. 1). The shear strength of the masonry at the center of the panel ( $\tau_{OD}$ ) was calculated on the basis of the interpretation of the test reported in the RILEM standards [22]:

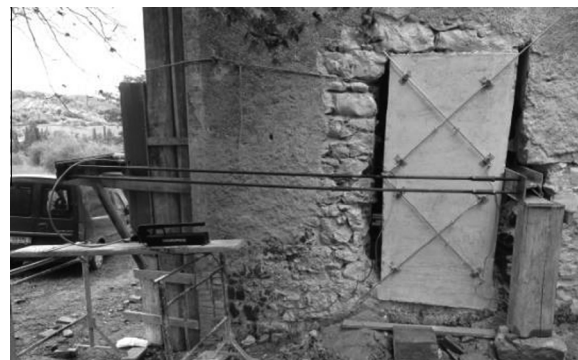
Fig. 2. On-site shear-compression test (Colle Umberto building).

For the shear-compression test, the panel, 1800 × 900 mm in size, was obtained by two vertical cuts in the masonry (Fig. 2), i.e. letting the vertical compression load from the remaining part of the building act on the top of the sample. The horizontal force is applied to the midpoint, and in this way the panel can thus be schematized as two superimposed 900 × 900 mm semi-panels. The vertical stress is estimated based on the analysis of the loads weighing on each sample:

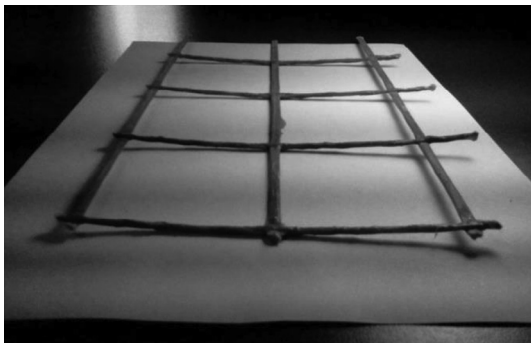
Fig. 3. Detail of the GFRP grid.

The GFRP grid used is manufactured by Fibre Net S.r.l. and is characterized by square mesh with nominal dimensions of  $66 \times 66$  mm. It is made up of AR (*Alkali Resistant*) glass fiber with a zirconium content equal to or greater than 16% pre-impregnated with thermosetting epoxy vinyl ester resin (Fig. 3). The geometric and mechanical properties, measured with tensile tests are shown in Table 1.

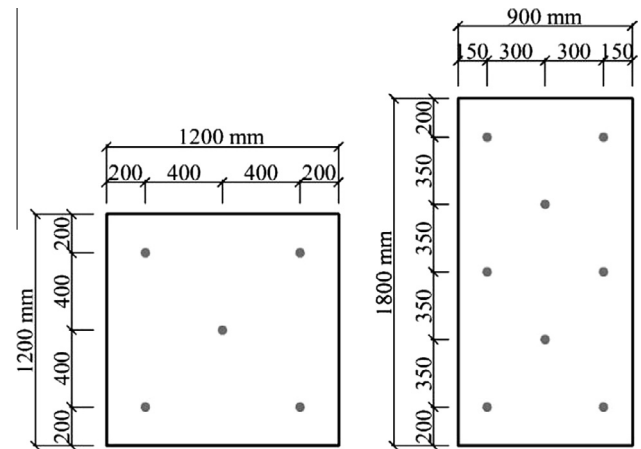
Fig. 4. Anchor position.

The strengthening of the panels obtained from existing walls called for the complete removal of the lime plaster on both sides and the elimination of any loose materials with compressed air. 12 mm-diameter holes were made through the wall for the connectors according to the scheme shown in Fig. 4. The GFRP grid and connectors were then installed. Each connector consisted of two unidirectional fiberglass L shaped bars joined together by injecting epoxy paste into the hole.

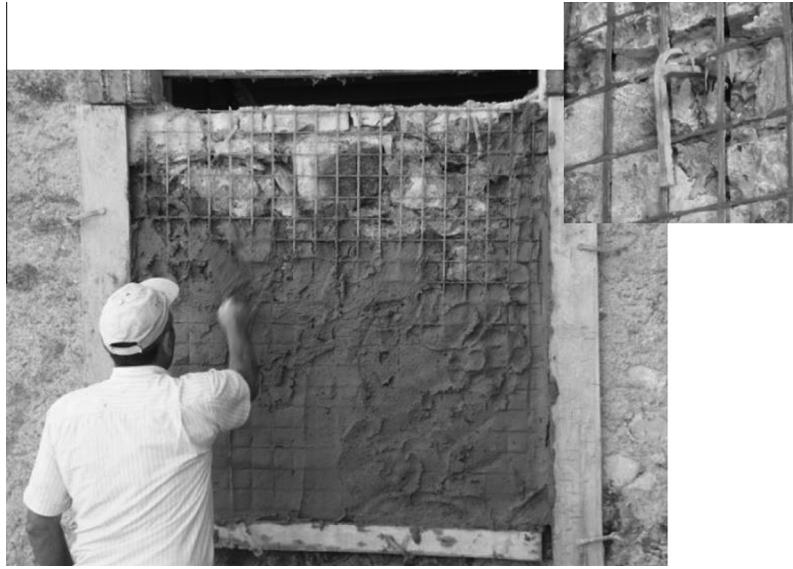
Fig. 5. Application of mortar jacketing and detail of connection between anchors and GFRP grid.

Lastly mortar was applied by hand in a thickness of about 30 mm. Despite the presence of the composite grid, the application of mortar was not difficult, thanks to the large mesh size adopted (Fig. 5).

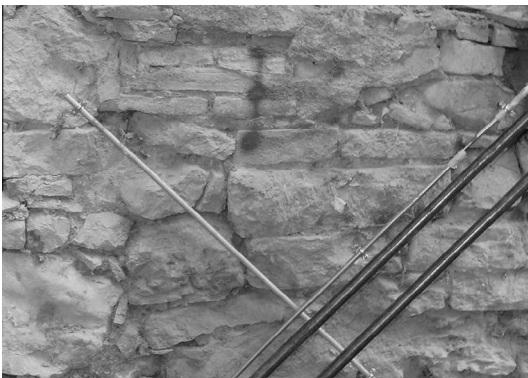
Fig. 6. Stonework of Colle Umberto farm house (19th-century).

The building is characterized on the ground floor by two types of walls built in different periods. The first type, which presumably goes back to the early 1800s, is 560–570 mm thick and was made with very poor lime-based mortar. The stones are up to 350 mm in

size, and are well squared (Fig. 6). The second type, built in the early 1900s, is 480 mm thick and has lime-based mortar with better mechanical properties (Fig. 7). However, the stones are very rough hewn and almost square in shape, with sides of not more than 250 mm. In both wall types there are no through stones.

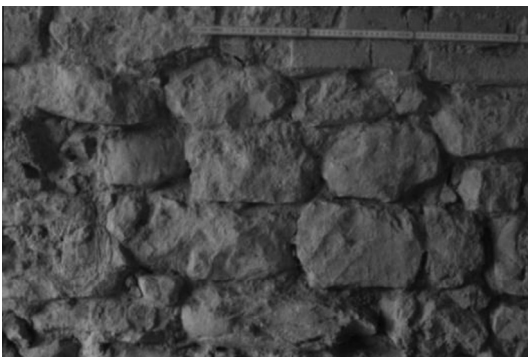
Fig. 7. Stonework of Colle Umberto farm house (20th-century).

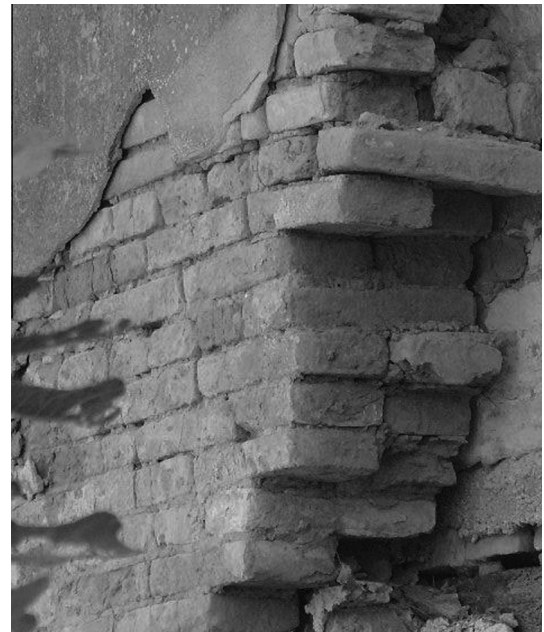
Fig. 8. Brickwork of San Felice building.

The building is rectangular in shape and completely isolated from other structures. It has three floors (ground floor, first floor and an attic) and is made entirely of solid brick masonry. The wall structure, however, is unusual in that the walls, which are about 300 mm thick, have few connecting bricks (headers) between the leaves (8–12 bricks/m<sup>2</sup>), almost as if it were a wall with two separate leaves, each made from solid bricks (Fig. 8). The floors are made with wooden beams. Three tests were carried out on this building: two compression and one shear-compression test. All tests were done on the external walls on the ground floor.

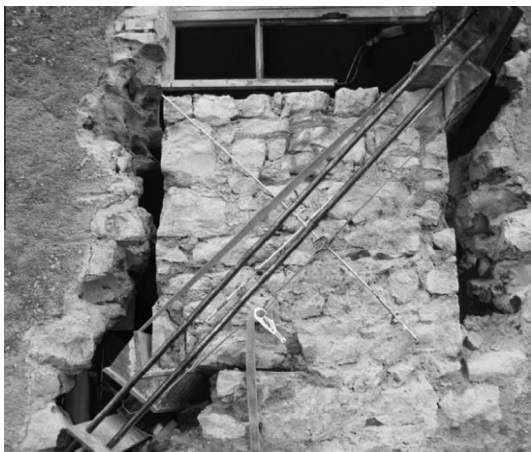
Fig. 9. Un-reinforced panel tested at Colle Umberto.

- 1) For the Colle Umberto building: (a) 5 diagonal compression tests: 2 on unreinforced panels (CD-02-U-OR, CD-06-U-OR), 1 on a panel with preventive reinforcement (CD-07-U-IP) and 2 on repaired panels (CD-08-U-IR, CD-10-U-IR) (Figs. 9 and 10) and (b) 5 shear compression tests: 2 on unreinforced panels (TC-16-U-OR, TC-17-U-OR), 2 on panels with preventive reinforcement (TC-19-U-IP, TC-20-U-IP), 1 on a repaired panel (TC-21-U-IR);

The cracks produced in the unreinforced panels were exclusively in the mortar joints and involved the entire thickness of the wall panel along the compressed diagonal. A similar shear strength (0.020 MPa) was obtained also for the unreinforced panel made with solid bricks at the San Felice building.

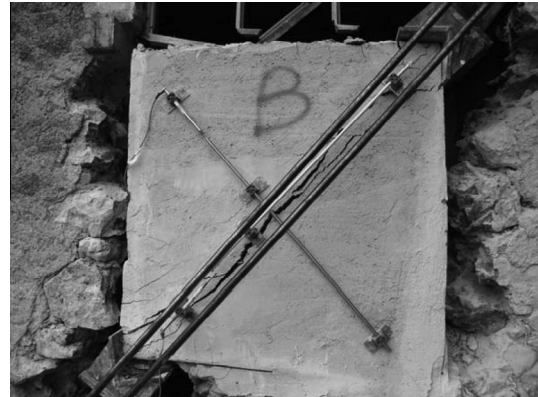
Fig. 10. Crack pattern of a reinforced panel tested at Colle Umberto.

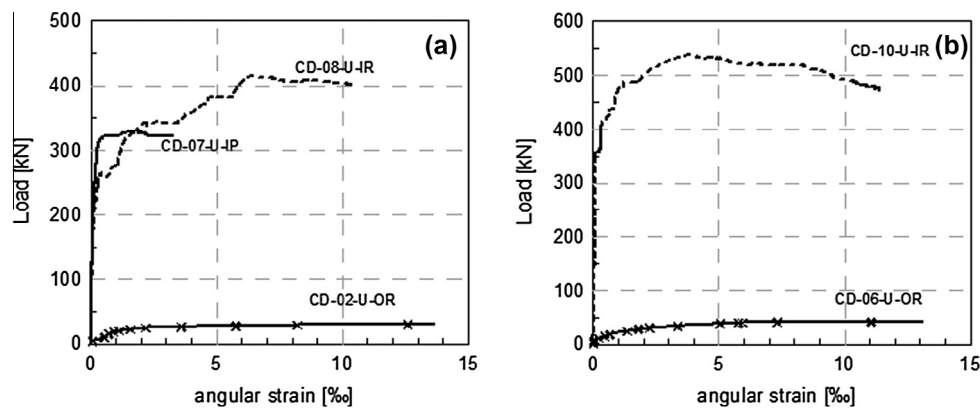
**Fig. 11.** Curves of the shear stress–angular strain response for stone masonry panels, (a) 20th-century masonry and (b) 19th-century masonry (Diagonal compression test method, Colle Umberto).

As regards the panels reinforced in advance or as a technique for repairing pre-damaged masonry, the results showed a substantial effectiveness of the technique tested. The results obtained for Colle Umberto panels (20th-century masonry wall panels) were of particular significance. In this case a shear strength of 0.162 MPa was measured for the panel with preventive reinforcement and 0.209 MPa for the repaired panel, compared to a shear strength of 0.018 MPa in the same panel unreinforced, an increase varying between the 800% and 1060% (Fig. 11).

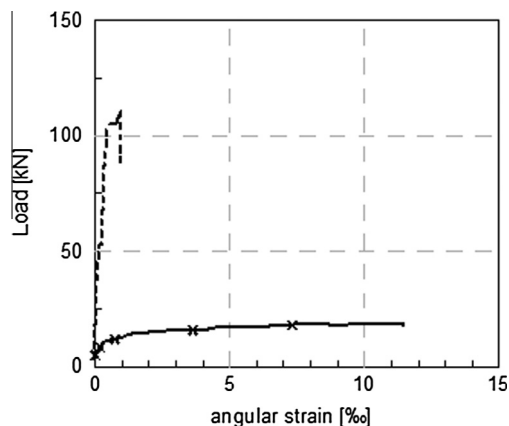
**Fig. 12.** Curves of the shear stress–angular strain response for brick masonry panels (Diagonal compression test method).

The two diagonal compression tests (one on an unreinforced panel (CD-09-S-OR) and one on a panel with preventive reinforcement (CD-11-S-IP) at the brick building in San Felice sul Panaro have essentially confirmed the results obtained on the stone panels, although the effectiveness of the reinforcement was less significant. In this case, there was an increase in shear strength from 0.020 MPa to 0.086 MPa for the reinforced panel (Table 3, Fig. 12). Due to the limited number of headers in the brickwork, the two leaves tend to separate and deform differently during the shear test.

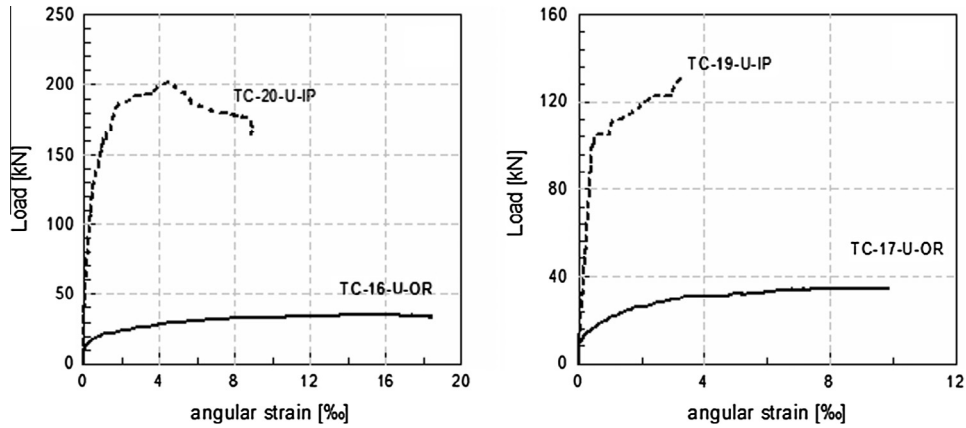
Fig. 13. Curves of the shear stress–angular strain response for stone masonry panels (shear compression test method, Colle Umberto).

For the reinforced Colle Umberto 20th-century masonry panel (with an original thickness of 480 mm), a shear strength increase of 638% was measured, going from 0.032 MPa (unreinforced) to 0.236 MPa (reinforced), while the shear strength of the panel repaired reached 0.173 MPa. Fig. 13 shows a comparison between the graphs of the maximum shear loads of the tests on unreinforced, reinforced and repaired stone panels.

The elastic phases of the curves of the reinforced panels are characterized by a steeper slope as those obtained in the case of the unreinforced ones, regardless to the type of the stonework masonry. In-plane stiffness (shear modulus,  $G$ ) increased significantly due to reinforcement (from an average value of 32 to 2622 MPa respectively for unreinforced and reinforced panels in Colle Umberto and from 83 to 765 MPa in L'Aquila). Moreover, we remark an important deformation capability of the unreinforced walls, emphasized by the presence of a relevant post-elastic plateau. The reinforced panels exhibited a smaller deformation capacity compared to unreinforced ones. However this is usual for reinforced concrete/mortar jacketing: if compare this behavior with the one of steel mesh reinforced concrete jacketing we note an important increase in the deformation capacity [15].

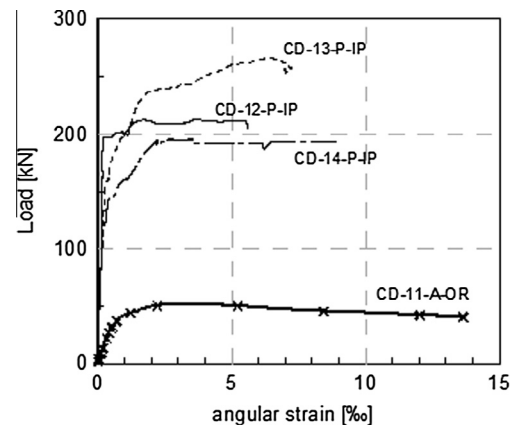
Fig. 15. Curves of the shear stress–angular strain response for stone masonry panels (Diagonal compression test method, L'Aquila).

For panels retrofitted in L'Aquila, the strengthening constrained the development of the cracks, and failure was confined by the GFRP jacketing. The average panel lateral strength increased to 0.0963 MPa (average maximum load 229.7 kN), i.e. the GFRP enhanced the lateral resistance by a factor of approximately 4.33 compared to the control panel (Fig. 15). The ultimate limit state was clearly a shear failure that was initiated by tensile rupture in grid fiber reached when the masonry cracked in tension.

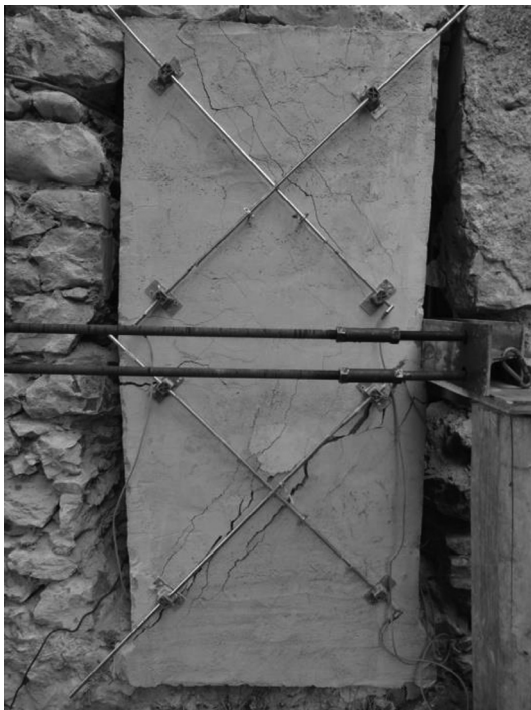
Fig. 14. Crack pattern of a reinforced wall panel tested at Colle Umberto.

Like that observed in the diagonal compression tests, this type of test as well the unreinforced samples showed cracks only in the mortar joints along the compressed diagonals. However a partial change in the type of failure was observed in the reinforced panels. The shear cracks along the compressed diagonals of the lower and upper square semi-panels were formed after evident horizontal cracks due to in-plane bending action at the midpoint of the panel (Fig. 14).

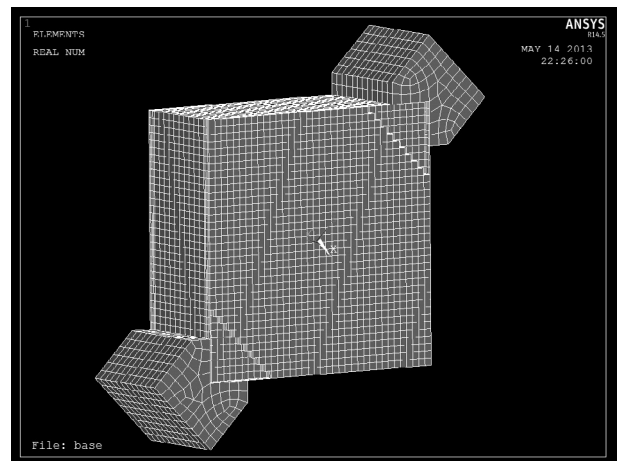
Fig. 16. Model and FE mesh adopted in the numerical simulations.

In view of this, reinforced panels are described by means of a three-dimensional finite element model, in which masonry and mortar jackets are modeled separately (the interfaces being merged with joints). The internal reinforcement (GFRP mesh) was modeled using three dimensional spar elements with plasticity embedded within the solid mesh. This option was favored over the alternative smeared stiffness capability as it allowed the reinforcement to be precisely located whilst maintaining a relatively coarse mesh for the surrounding mortar medium. The inherent assumption is that there is full displacement compatibility between the reinforcement and the mortar jacketing with no occurrence of bond slippage.

Non-linear constitutive laws are adopted for both masonry and mortar jacketing: values of the physical properties of both materials have been established on statistical analysis of experimental data obtained from characterization tests [27,28]. They have been implemented in a general purpose commercial code (ANSYS). Eight-noded hexahedron elements have been adopted. The average size of the hexahedron elements was chosen so as to have ten and four elements across the panel and mortar jacketing thickness respectively: this allows the more critical details to be captured. The complete finite element model (FEM) is shown in Fig. 16.

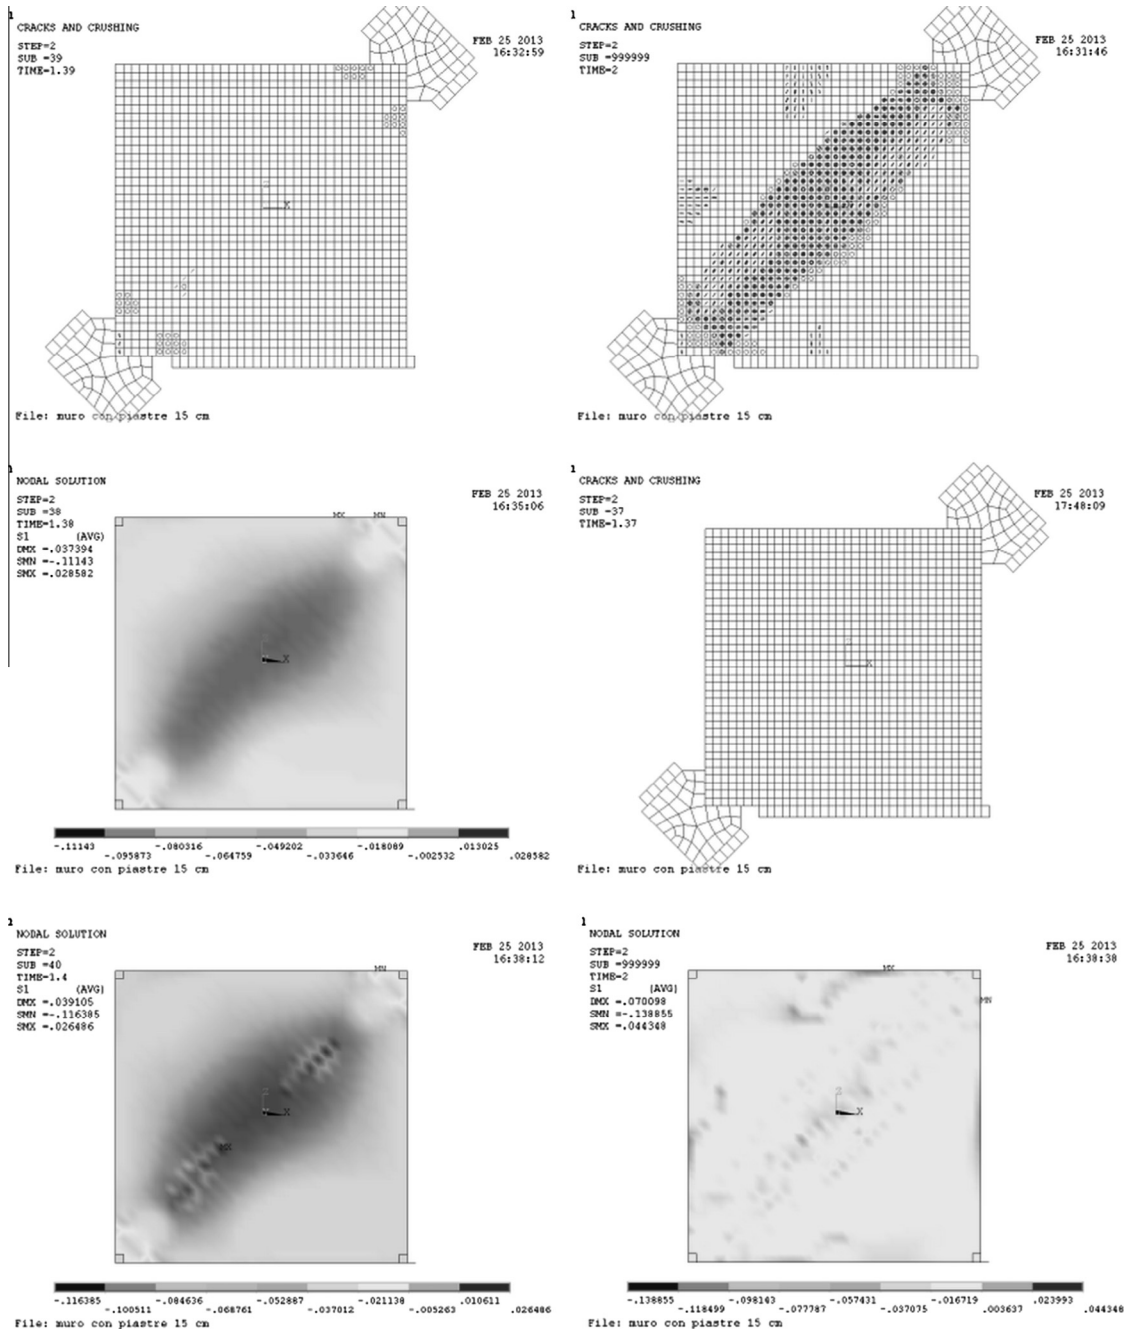
Fig. 17. Tensional results vs crushing and cracking path obtained in the non-linear analysis due to increasing shear load.

The analyses carried out on the non-linear 3D F.E. model have been used to evaluate the shear strength capacity of the tested specimens (Fig. 17).
