The Influence of Cutting Heat on the Surface Integrity during Machining of Titanium Alloy Ti6Al4V

¹⁻⁶ *Kalyani Centre of Technology and Innovation, Bharat Forge Ltd. Pune, India*

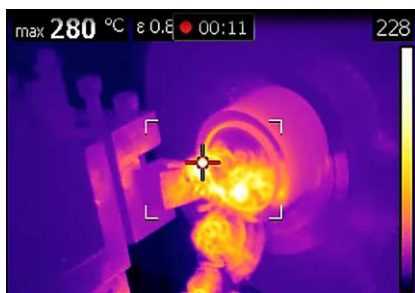
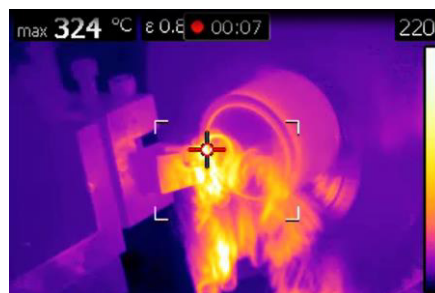
The cutting temperature generated during machining of titanium alloys plays important role in the subsequent surface integrity of the machined workpiece. The excessive heating can lead to reduction in tool life (Che-Haron and Jawaid, 2005). The cutting temperature was measured using thermal imaging camera FLIR P 640. Figure 4A-4D shows the images captured for maximum cutting temperature recorded using thermal imaging camera for during Experiment No. 1 to Experiment No.4

Figure 4A: Maximum cutting temperature Experiment 1

Figure 4B: Maximum cutting temperature- Experiment 2

Figure 4C: Maximum cutting temperature Experiment 3

Figure 4D: Maximum cutting temperature- Experiment 4

It was found that with an increase in the cutting speed; the contact between chip and tool increases which ultimately increased the amount heat generated at the cutting zone (Joshi et al., 2014). Additionally, low thermal conductivity of titanium further contributed to an increased cutting temperature during machining. It was also found that an increase in the feed rate at higher cutting speed leads to an increased amount of friction between tool and workpiece which further increased the cutting temperature (Joshi et al., 2014).

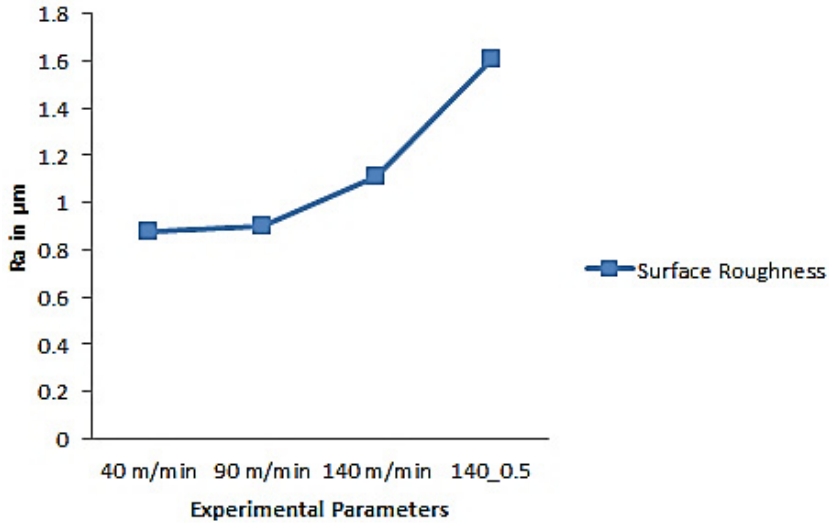
Figure 5: Effect of cutting parameters on surface roughness

Surface finish of the machined workpiece is one of the most critical parameter during machining of titanium alloy Ti6Al4V as there will be a direct effect of any change in cutting temperature, cutting forces on the subsequent surface topography (Joshi et al., 2014). The surface finish was measured along the cutting direction interns of average surface roughness R_a over the periphery where 10 readings were taken for each experiment and an average reading was used for comparative analysis. As shown in Figure 5, the surface roughness increases with an increase in the cutting speed from Experiment 1 to Experiment 3. This increase in cutting speed leads to an increase in cutting temperature and further the tendency of titanium alloy to adhere to the tool face which ultimately leads

to formation of BUE (Built-Up-Edge). All these factors affect the surface topography and hence increase the surface roughness (Che-Haron and Jawaid, 2005). An increase in feed rate from 0.2 mm/rev to 0.5 mm/rev in Experiment 4 resulted into increased amount of friction leading to higher cutting temperature which contributed to BUE formation resulting to poor surface finish (Patil et al., 2015 and Joshi et al., 2014).

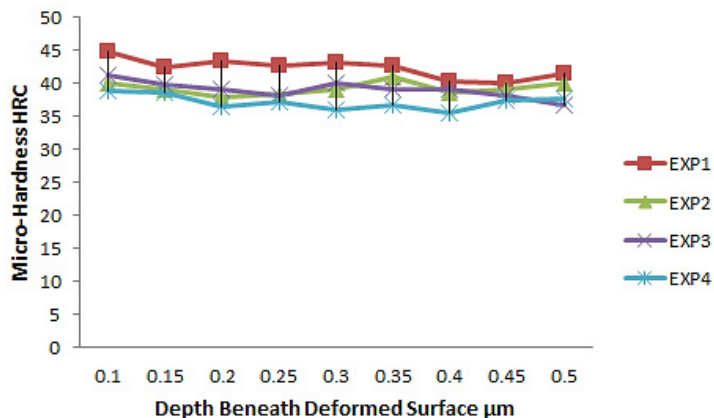
Figure 10: Microhardness at the deformed surface

As shown in Figure 9, EBSD reveals the damage with the grains at the subsurface level at extreme cutting parameters of Experiment 4. The said damage was with the single grain or similar oriented structure unit (Crawforth et al., 2012). Thus, from the recorded images it can be seen that the severity of plastic deformation beneath the machined surface can be controlled by varying the cutting parameters (Ginting and Nouari, 2009). An increased amount of cutting speed and feed rate will lead to amplified subsurface deformations during machining of titanium alloy Ti6Al4V. Work hardening phenomenon resulting from deformed grains near subsurface area resulted in higher microhardness than that of base material. The microhardness of the deformed region was measured along the depth of the deformed zone for each Experiment. As shown in Figure 10, with an increase in the level of cutting parameter, the amount heat generated at the cutting zone increases contributing to more amount of thermal softening. This thermal softening effect becomes dominating over the work hardening phenomenon which otherwise becomes more dominant at the lower level of cutting conditions (Che-Haron, 2001). However, the effect of increase in cutting speed on thermal softening and microhardness was found to be uniform only to a depth of 0.2 mm beneath the machined surface. A combined effect of low thermal conductivity and an over aging of titanium alloys can be responsible for the thermal softening at the deformed zone (Ginting and Nouari, 2009). Figure 11A-B shows the microstructure details at the machined surface for Experiment 1 which was at lowest level of cutting condition and Experiment 4 which was at highest level of cutting condition. The micrographs reveals that an increased cutting temperature and the overaging effect resulted into a coarse equiaxed microstructure during Experiment 4 which further caused a reduction in microhardness at the surface when compared to the fine microstructure obtained during Experiment 1.

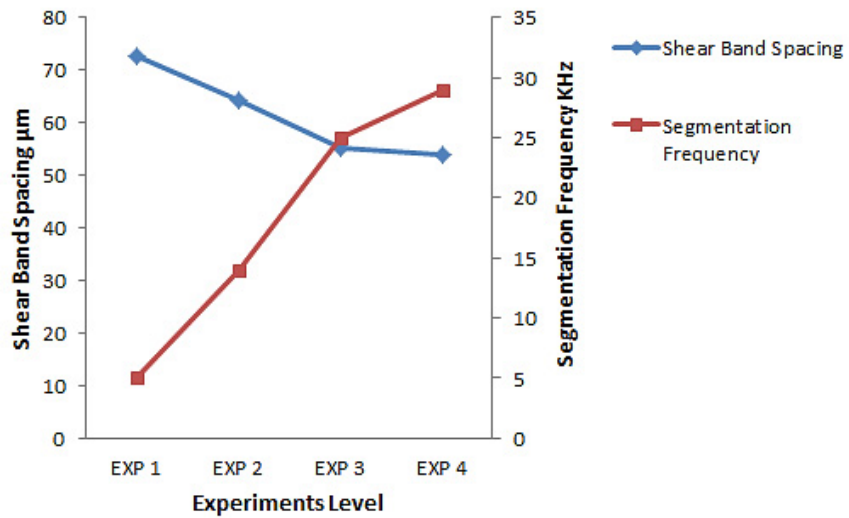
Figure 13: Shear band spacing and Segmentation frequency

As shown in Figure 13 and Figure 14, with an increase in the cutting speed the increase in tool workpiece contact ratio and with an increase in the feed rate the increase in the friction between the tool and workpiece collectively leads to an increased amount of chip thickness, cutting heat, thermal softening, shear band formation and increased chip segmentation frequency (Joshi et al., 2014).

$$f_{\text{chip}} = V/w \quad (1)$$

Where f_{chip} = frequency of segmentation in Hz, V = cutting speed in m/min, w = shear band spacing.

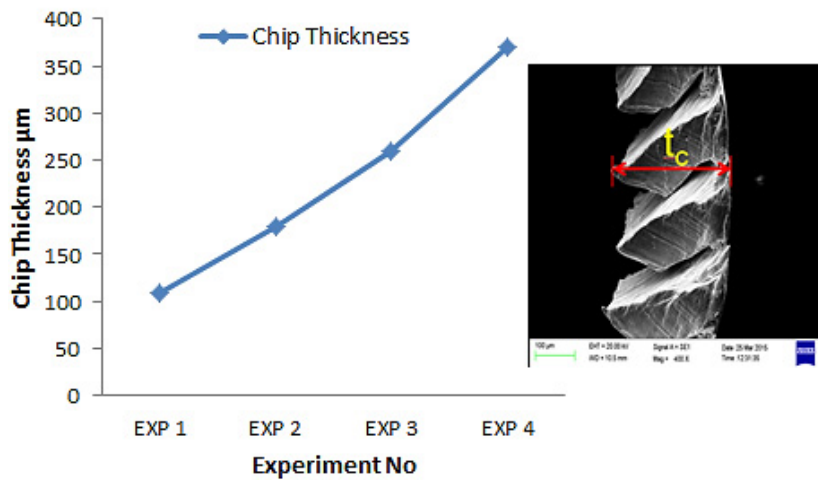
Figure 14: Chip Thickness
