Evaluation of bone response to titanium-coated polymethyl methacrylate resin (PMMA) implants by X-ray tomography

Manal M. Shalabi · Johannes G. C. Wolke ·
Vincent M. J. I. Cuijpers · John A. Jansen

Received: 22 June 2006 / Accepted: 21 August 2006 / Published online: 9 June 2007
© Springer Science+Business Media, LLC 2007

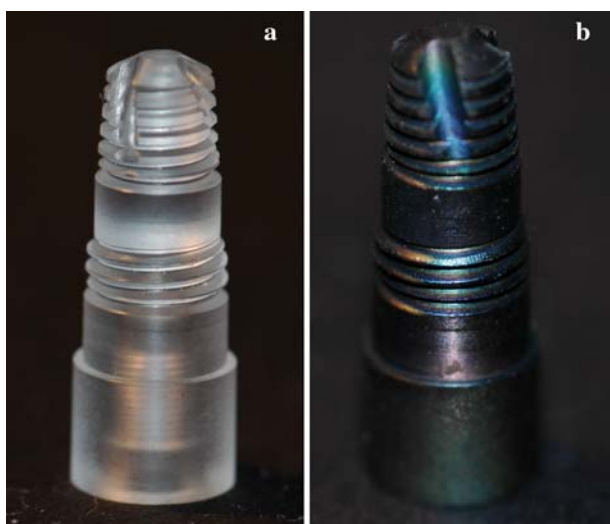
Fig. 1 Macroscopic pictures of a non-coated PMMA implant (A) titanium-coated PMMA implant (B). The titanium coating has a shiny, gray-black appearance

Ten conically-shaped screw designed PMMA implants were used. All implants measured 10 mm in length and had a diameter of 4.6 mm. The implants were copied and prepared with a lathe out of PMMA rod completely analog to metallic implants (Biocomp[®] Industries, Dordrecht, The Netherlands). Subsequently, all ten implants were coated with a 400–500 nm thick layer of titanium (Ti) (Fig. 1).

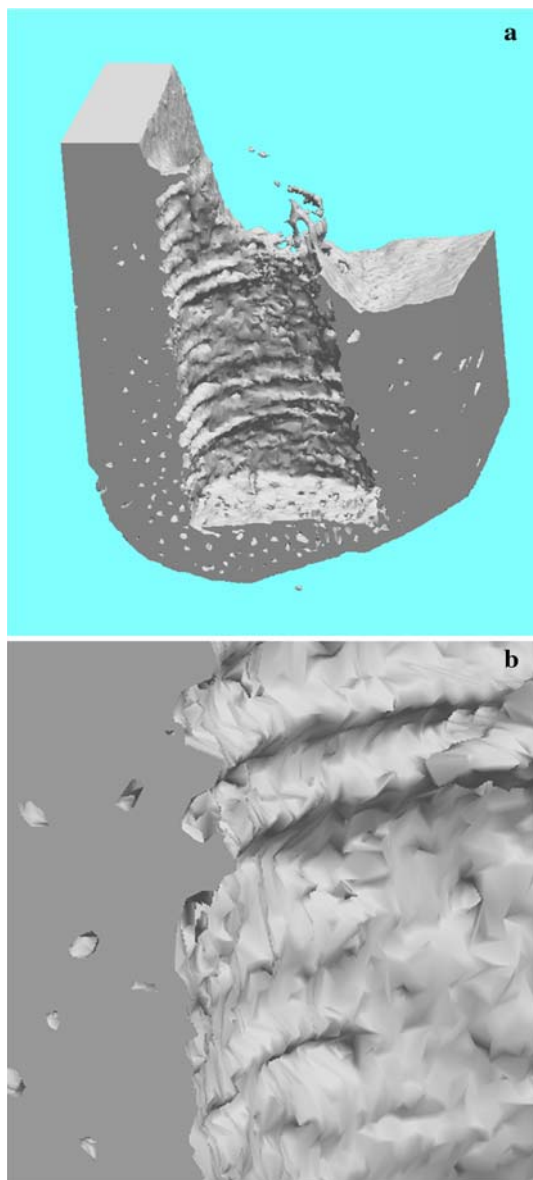
Fig. 2 Micro-computer tomography pictures showing the bone appearance after installation of the PMMA coated implant by a press-fit approach. (A) The implant penetrated into the medullary cavity and ingrowth of bone at the endosteal side can be observed. (B) The screw-threads as well as the smooth implant surface can be recognized

The 3D reconstructed representations showed clearly the implants surrounded by cortical bone. Overall, the screw-threads and typical implant configuration were well maintained through the installation procedure. No streaking artefacts were present. The bone was found to be grown into the screw-threads and bone conduction into the marrow cavity was seen (Fig. 2). Evidently, the titanium coating was not thick enough to allow visualization of the implant part that was positioned into the medullar cavity.

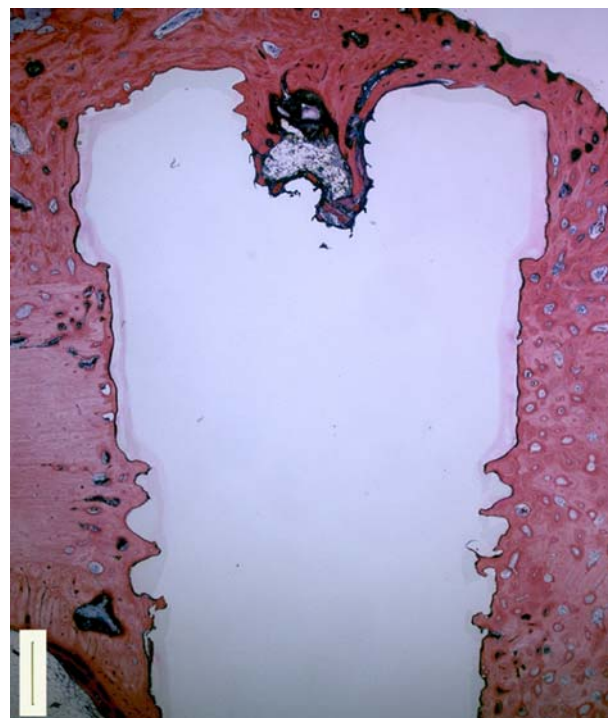
Fig. 3 Histological picture of a titanium coated PMMA implant. The implant is surrounded by bone tissue in close contact with the titanium coating, which is visible as a thin black line of the outer surface of the implant. Magnification 1.6 \times , bar = 625 μ m

The histological evaluation demonstrated that the titanium-coated implants were well tolerated by the tissues. In the cortical compartment of the tibia, bone was observed in close contact with the titanium layer, which could easily be recognized and appeared to cover the implant surface for almost 100% (Fig. 3). The bone-titanium coating contact was almost continuous (Fig. 4A) and only occasionally remodeling lacunas (Fig. 4B) or an intervening fibrous tissue layer were seen. When fibrous tissue was present in the interface, this could frequently be associated with a lacking titanium coating (Fig. 4C). The bone around the implants showed a very organized structure in which osteons could be recognized. At the crestal side, the implants were always covered by newly deposited bone. At the apical side the implants penetrated into the medullar cavity. Ingrowth of bone along the implant surface and into the medullar cavity had occurred. In the bone marrow, no sign of an inflammatory response indicating a foreign body reaction was seen (Fig. 5).

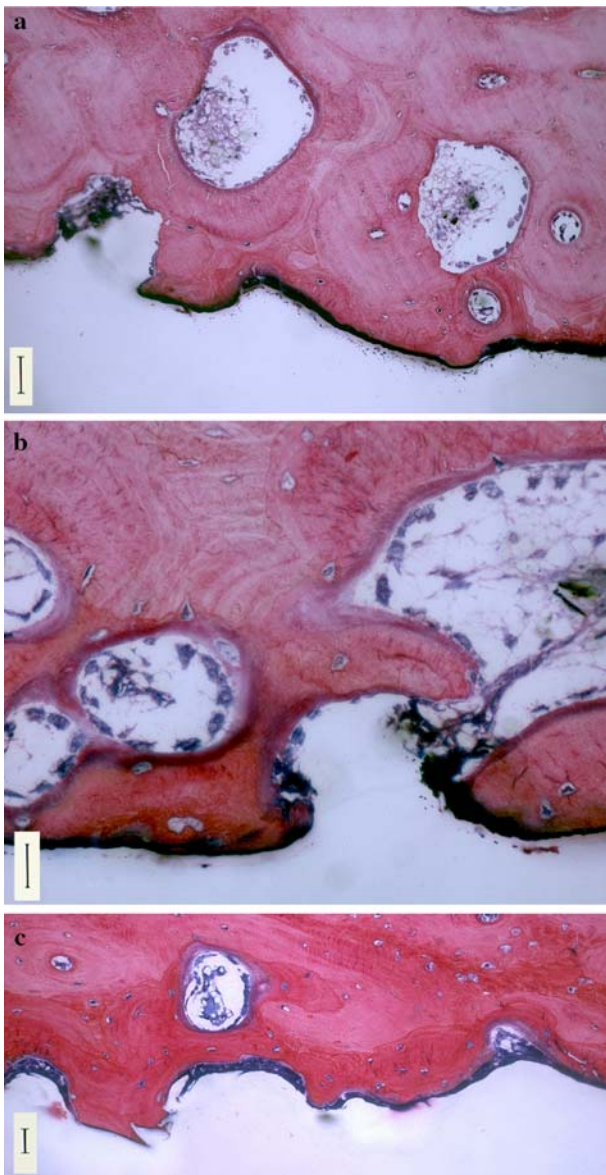
Fig. 4 Histological section of titanium-coated implant showing clearly the titanium layer. (A) the titanium layer was covered almost completely by bone, (B) occasionally remodeling lacunas were present. Original magnification 10 \times , bar = 100 μ m, and (C) in areas where the coating was lacking, the implant surface was surrounded by fibrous tissue (blue layer). Magnification 20 \times , bar = 50 μ m

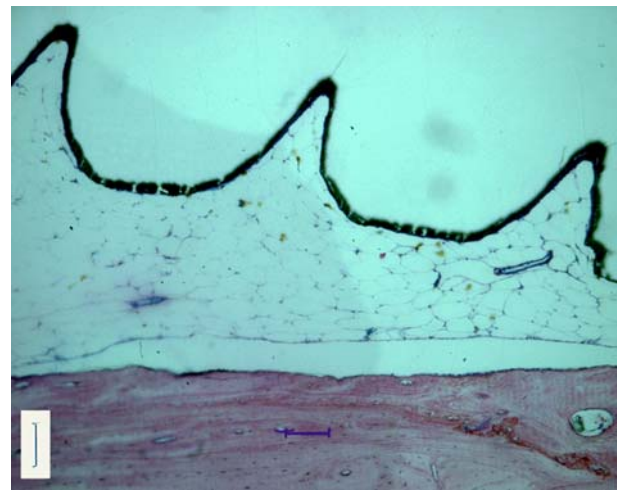
Fig. 5 The part of the implant that penetrated into the medullar cavity did not evoke any sign of an inflammatory response. Original magnification 10 \times , bar = 100 μ m

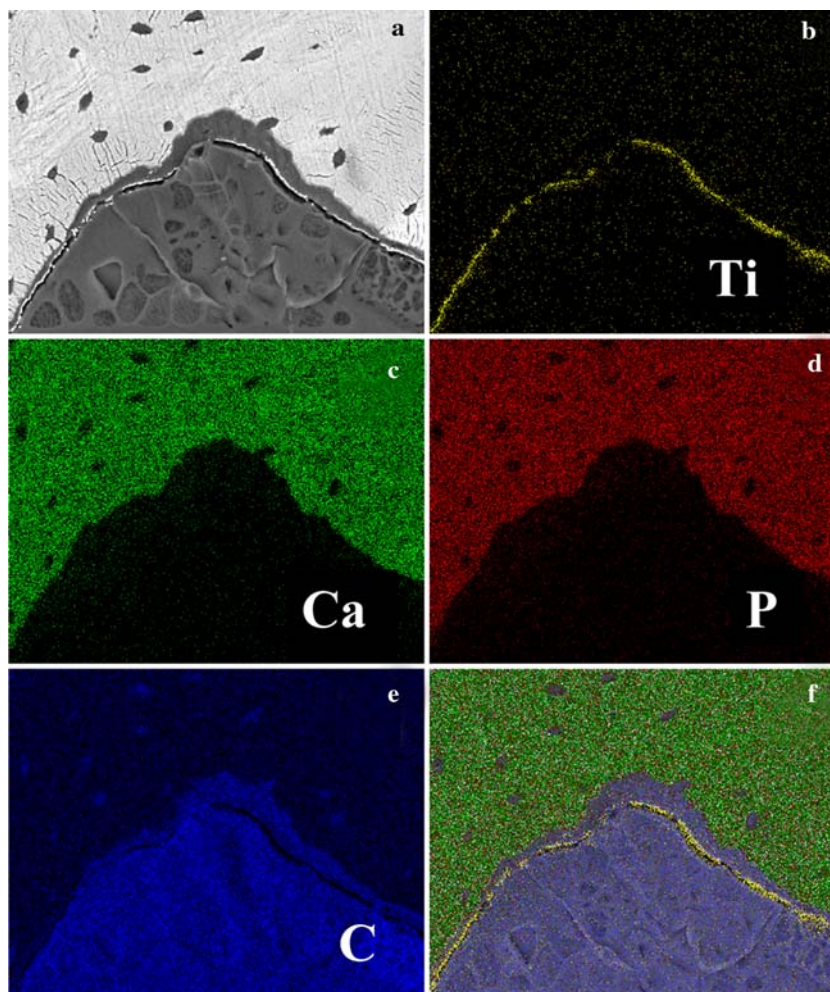
Fig. 6 Back scatter image and X-ray microanalytical mapping of a titanium coated PMMA implants. (A) The implant with the titanium coating (white line) can be recognized. Bone surrounds the implant. Mapping for titanium (B), calcium (C), phosphorus (D), and carbon (E). (F) An integral image in which all different mappings are combined shows the presence of a bone-free zone at the implant interface

Backscatter electron microscopy confirmed the light microscopical data. The PMMA material of the implant could be recognized as well as the titanium coating that covered the implant surface. Bone was seen in close contact with the major part of the implant surface. Figure 6A shows a cross-section where bone is not in direct contact with the titanium coating. Figure 6B–E show a mapping of

the PMMA implant-bone interface with regard to the presence of titanium, calcium, phosphorus, and carbon. The presence of calcium and phosphorus indicates the presence of bone and carbon indicates the coating as deposited onto the tissue block as required for backscatter electron microscopy. An integral mapping, as depicted in Fig. 6F, verifies that a gap existed between implant and bone, which indicates the presence of fibrous tissue. In areas with direct bone contact, EDS mapping confirmed that the implant was indeed in contact with the bone.
