# Investigation of Likelihood of Cracking in Reinforced Concrete Bridge Decks

**Abstract:** One of the biggest problems affecting bridges is the transverse cracking and deterioration of concrete bridge decks. The causes of early age cracking are primarily attributed to plastic shrinkage, temperature effects, autogenous shrinkage, and drying shrinkage. The cracks can be influenced by material characteristics, casting sequence, formwork, climate conditions, geometry, and time dependent factors. The cracking of bridge decks not only creates unsightly aesthetic condition but also greatly reduces durability. It leads to a loss of functionality, loss of stiffness, and ultimately loss of structural safety. This investigation consists of field, laboratory, and analytical phases. The experimental and field testing investigate the early age transverse cracking of bridge decks and evaluate the use of sealant materials. The research identifies suitable materials, for crack sealing, with an ability to span cracks of various widths and to achieve performance criteria such as penetration depth, bond strength, and elongation. This paper also analytically examines the effect of a wide range of par

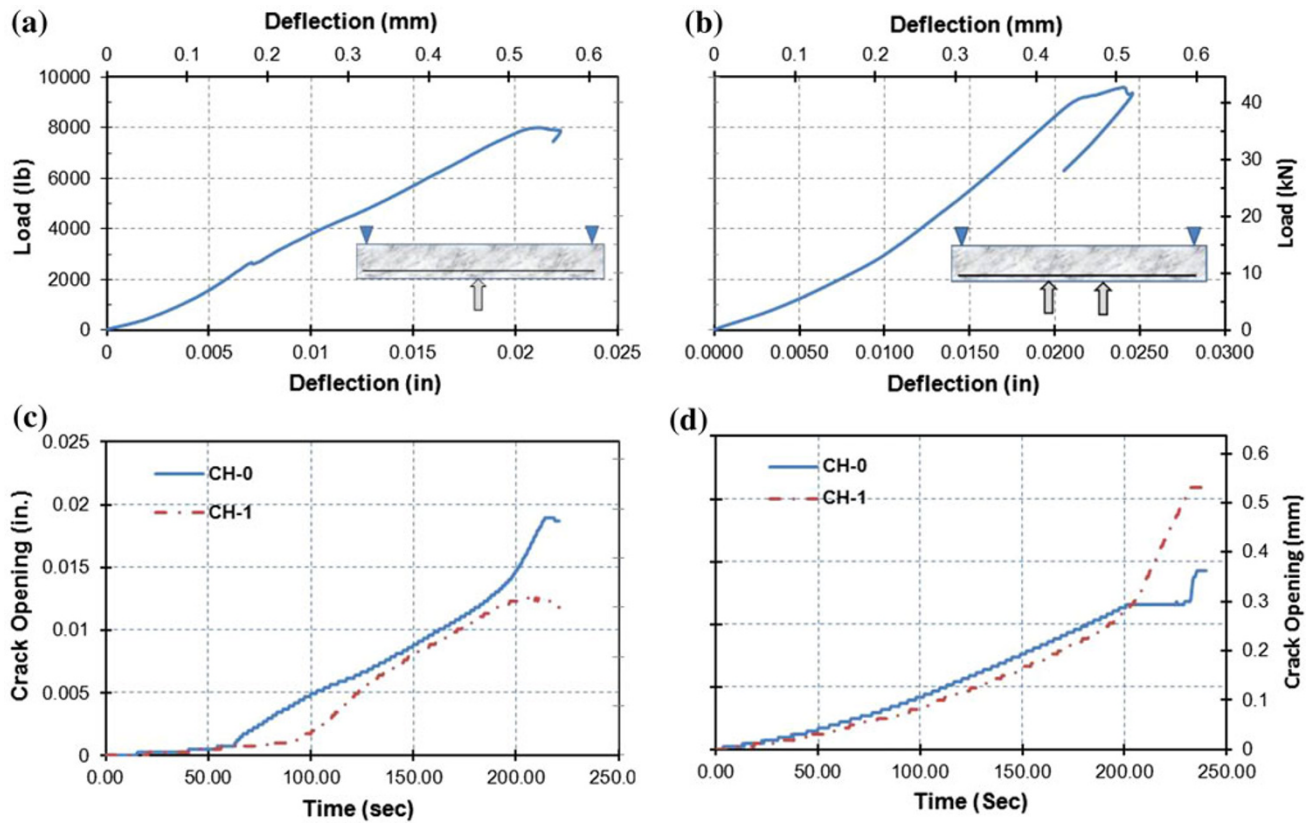
**Fig. 7** Results of Slab 1-A due to application of single load and double load. **a** Load–deflection relationship due to application of single load. **b** Load–deflection

relationship due to application of double load. **c** Crack opening due to application of single load. **d** Crack opening due to application of double load.

10.2 cm on center. Since it was determined, from the field investigation, that the crack width is not constant, a set of plates were created with two different widths and lengths to plunge into the concrete, while still in the plastic stage, and be removed before the final set of concrete. The process resulted in two different crack widths (0.25–0.50 mm) and two different crack lengths (22.9–45.7 cm) providing the opportunity to test specimens with various crack widths and lengths. The slab specimens were tested under single and double loads. When the load was applied; load, time, deflection, and crack opening were monitored for all of the specimens. It is important to note that crack opening was monitored for cracks that run through the entire slab width only. Shorter crack was monitored for only propagation of crack. The control slab, without any induced cracks, was tested to a force of 32 kN at which three cracks equally spaced at ~10.2 cm were developed. The remaining five (5) slab specimens were sealed with the assigned sealer, as per Table 3, allowed to cure, then were subjected to the single point load to examine the behavior of the sealer under load. A sample of results of the load testing of the slabs are also shown in Fig. 7. When slab 1-A was tested under a single line load, center crack sealer started to debond at 28.9 kN while other cracks did not appear to react to the applied load. Therefore, a second test with two line loads was performed to produce moment, close to the outside cracks. Under the application of the double load, the outside crack propagated without showing any evidence of sealant debonding. The test results of slab 1-A due to application of double line load are shown also in Fig. 7.

It can be observed that specimen sustained more load under the application of double load than that under the application of single load. As mentioned earlier, under single load, the center crack opened more than off-center crack, however, under double load, the off-center crack opened more. Ultimately, the total crack width, the sum of initial crack width and crack opening, of CH-0 and CH-1 due to double load were almost the same. Figure 8 shows load–deflection curves of remaining slab specimens due to application of single and double loads. It can be noted that less debonding was observed for specimens sealed with sealant materials that have larger tensile elongation percent. It seems that the use of this type of materials allows the crack to open up without failure of connection between the crack walls thus the sealant materials showed superior characteristics. The results of the testing showed that the 3-part HMWM sealer is most suitable for cracks with width between 0.25 and 0.50 mm, whereas the epoxy sealer is most suitable for cracks with wider widths than 0.50 mm.
