Monitoring of the vibration induced on the Arno masonry embankment wall by the conservation works after the May 25, 2016 riverbank landslide

Abstract

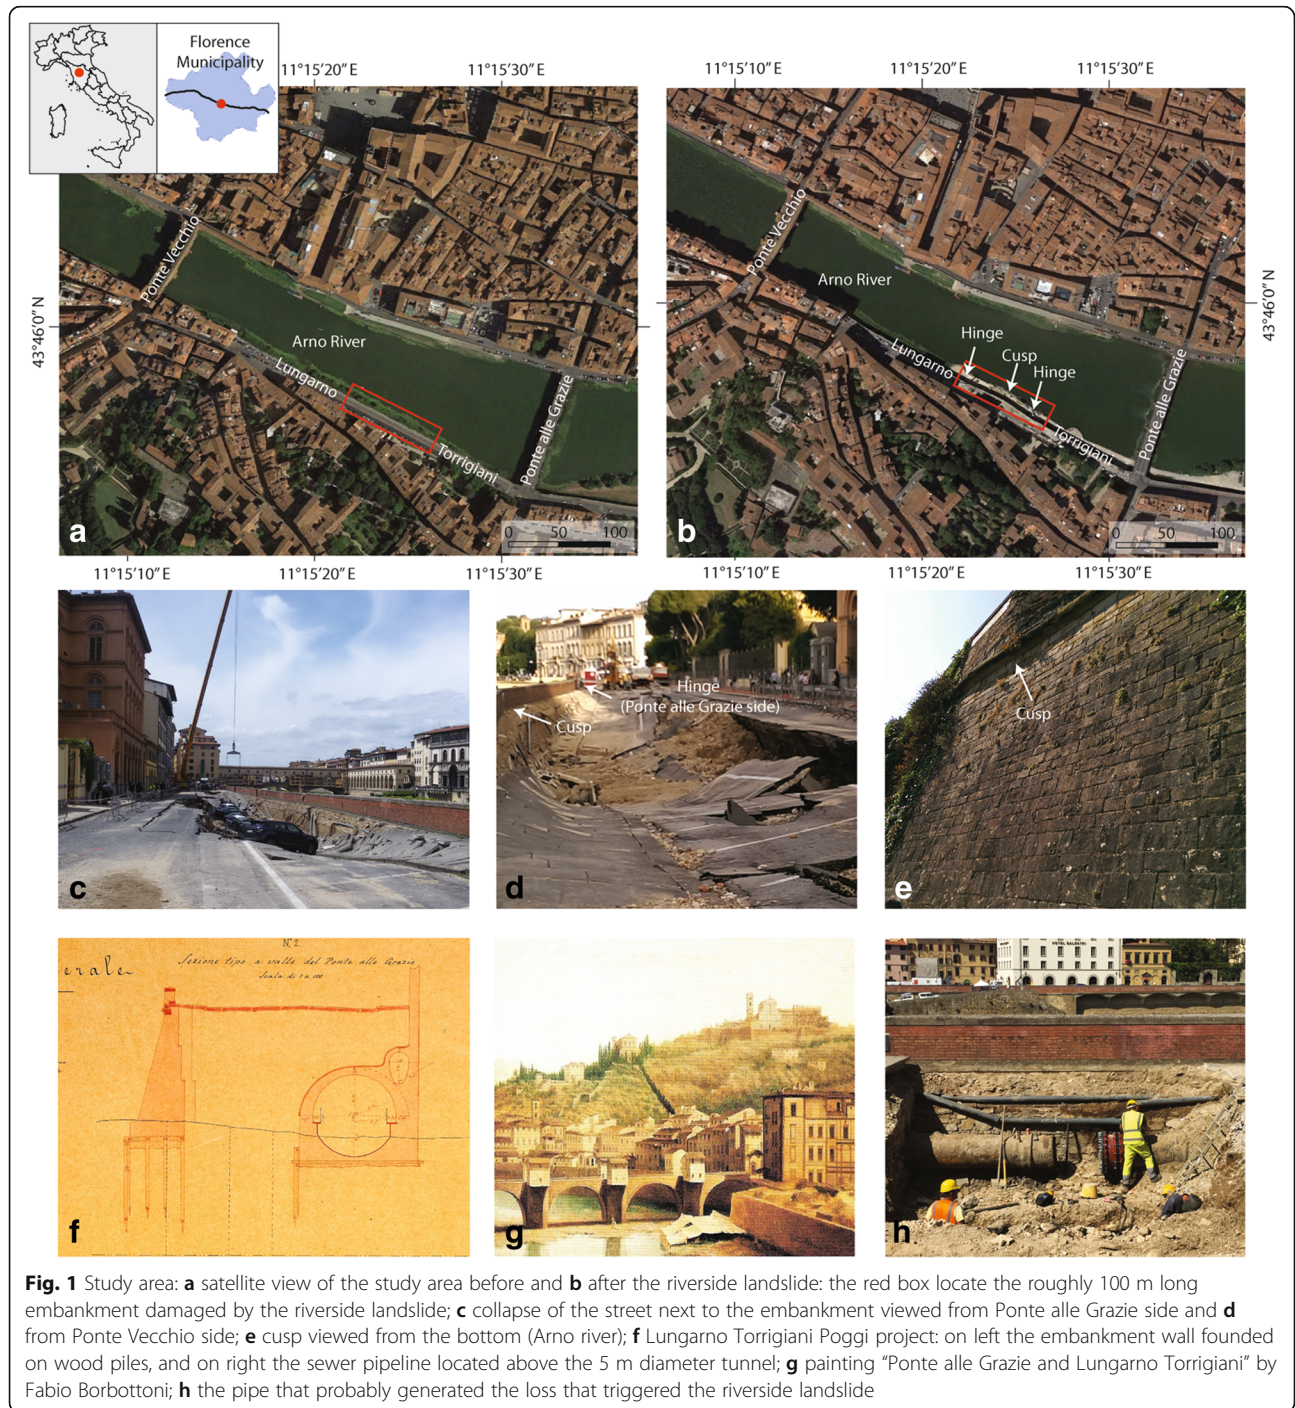
On May 25, 2016 a riverbank landslide occurred at about 6.00 a.m. because of the loss of potable water from the pipe. It was located between Ponte alle Grazie and the Ponte Vecchio on the left river bank of the Florence urban stretch of the Arno river. It involved a portion roughly 100 m long of the Lungarno Torrigiani masonry embankment wall (Fig. 1a, b). The street next to the embankment

wall collapsed (Fig. 1c), and the earth fill material was fully retained by the embankment wall that was seriously deformed towards the Arno river, fracturing itself in three main areas (Fig. 1b, d), but did not collapse. These three main fractured zones are a cusp (Fig. 1b, d, e), roughly in the middle of the damaged wall (Fig. 1b), where is also concentrated the maximum landslide pressure, and two hinges, one on the side of Ponte alle Grazie, and the other one on the side of Ponte Vecchio (Fig. 1b, d). The analysis of the landslide mechanism, of the involved volumes, and of the installed monitoring system will not be discussed in this paper.

The masonry embankment was built between 1865 and 1871 during the “Firenze Capitale” works coordinated by architect Giuseppe Poggi. According to the original Poggi’s project a) the masonry embankment is founded on piles of wood, and b) below the street level runs a 5 m diameter tunnel aimed to drainage the water also coming from the historically unstable hill of San Miniato (Fig. 1f). Above the tunnel is located a sewer pipeline (Fig. 1f). The painting “Ponte alle Grazie and Lungarno Torrigiani” by Fabio Borbottoni (1820–1902) shows that the whole embankment was further back from its current headquarters

(Fig. 1g). The pipe that probably generated the loss was installed in the late 50s – early 60s on the back of the embankment wall (Fig. 1h). Structural damages of the left river bank masonry embankment wall are reported by historical chronical. In 1965 the Lungarno Soderini embankment wall, between Ponte alla Carraia and Ponte Vespucci, collapsed because of a landslide caused by the rupture of the 700 mm water pipes. 5,000 cubic meters of earth were involved, several people were injured, and one died. In 1990 a big crack with a length of 150 m was opened in the same embankment.

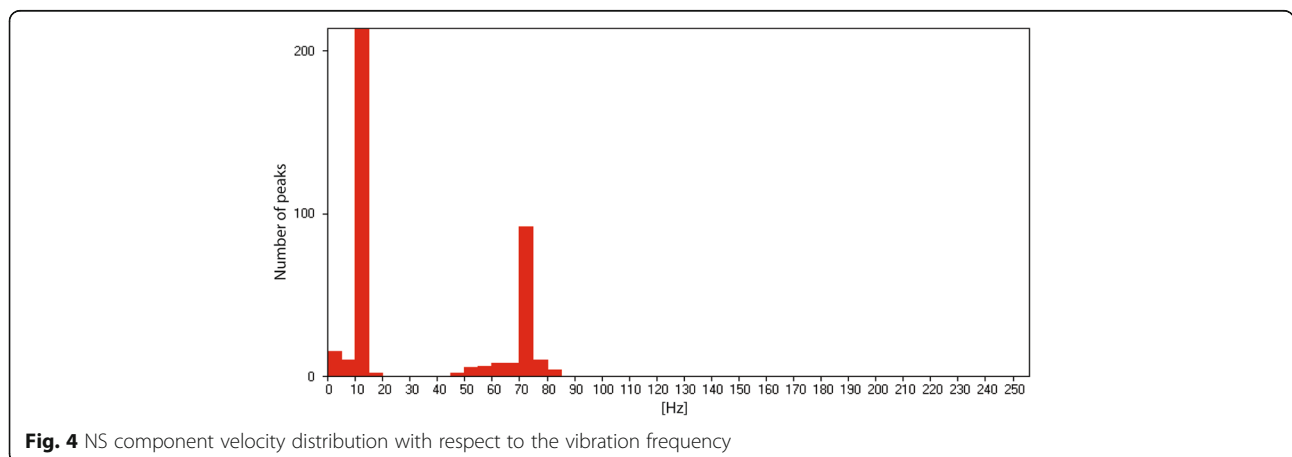
Fig. 4 NS component velocity distribution with respect to the vibration frequency

Figure 4 shows the LGT102 NS component (the most stressed) velocity distribution with respect to the vibration frequency. The most stressed frequencies (more than 300 time series) that exceed a pre-determined threshold set equal to 2.5 mm/s, according to the pcgv standard limits, are located in the range of 10–15 Hz (over 200 times) and 70–75 Hz (about 90 times). The velocity peaks > 3.50 mm/s have a frequency of roughly 5 Hz (Fig. 4).

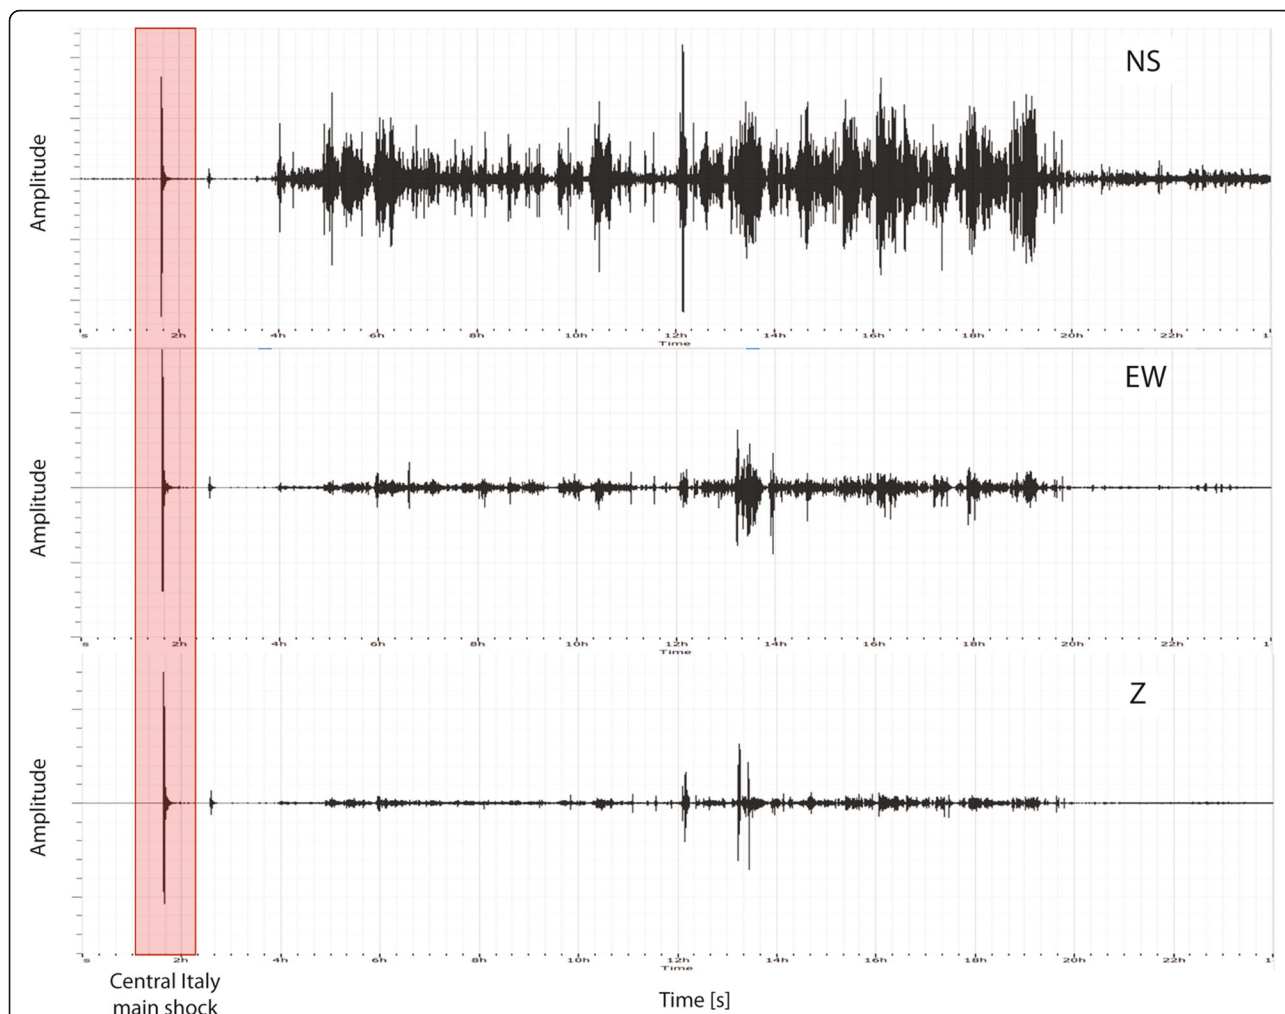
Fig. 9 The August 24, 2016 traces recorded by the Lungarno Torrigiani SVM system: red box highlight the Central Italy earthquake main shock

On August 24, 2016 at 1:36:32 UTC (3:36:32 local time) a Mw 6.0 earthquake strike central Italy. The epicentre was located in Accumoli (RI) (Lat 42.698 Lon 13.234). Despite the considerable distance from the Lungarno Torrigiani SVM system, about 200 km away, the earthquake waveform is clearly recognizable at each station (Fig. 9). It differs from the signals caused by the ordinary workings in terms of length, spectral content, and also because the solicitation affects all the components.

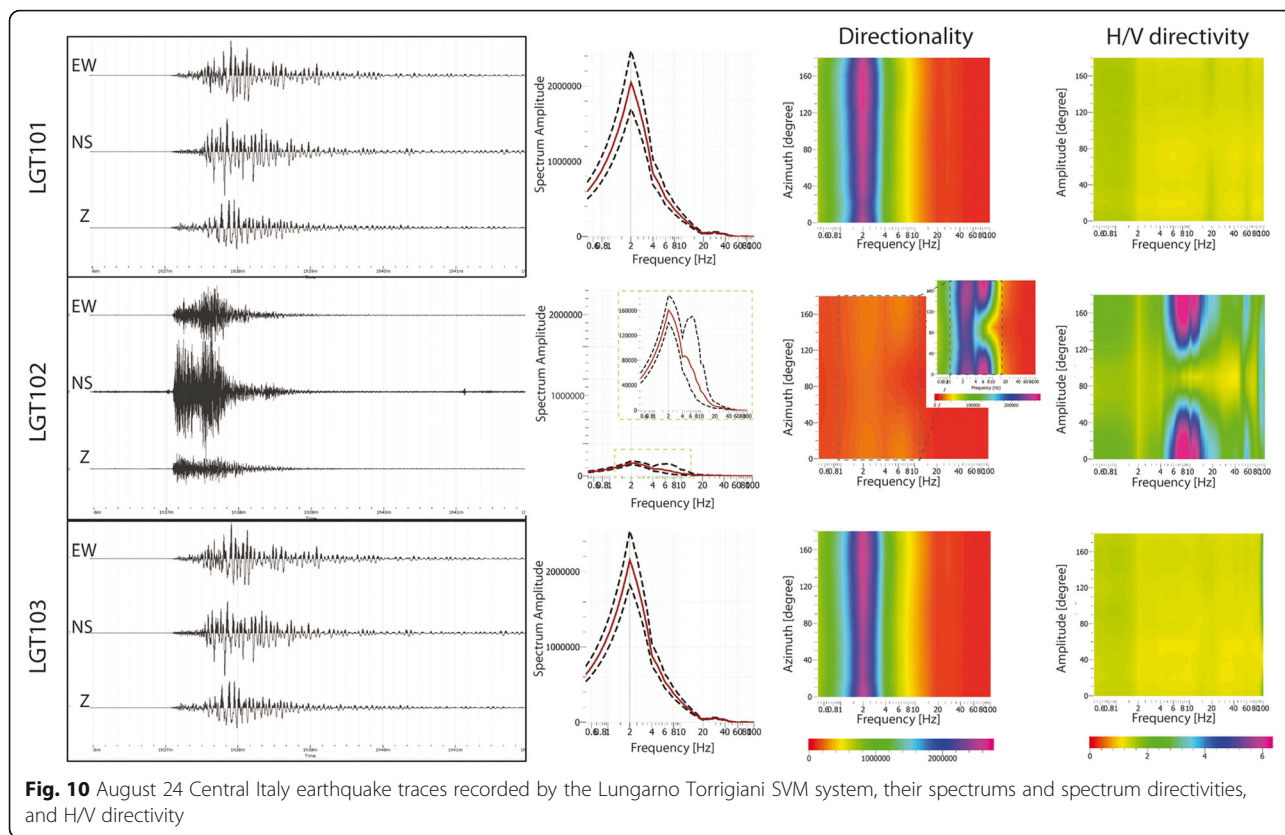
Figure 10 shows the signals recorded by the three components at each stations during the earthquake

event, the spectrums and their directivity, and the H/V directivity. All the parameters values are comparable for hinge stations LGT101 and LGT103: the energy is focused around 2 Hz and the signal shows directivity neither for the spectrum nor for the H/V. On the other

hand, the cusp station LGT102 shows a spectrum, of a lower amplitude order, with two main peaks (dashed green box in Fig. 10) suggesting that another contribute of energy is focused around 10 Hz. It can easily be seen that it is clearly polarized towards the NS direction,

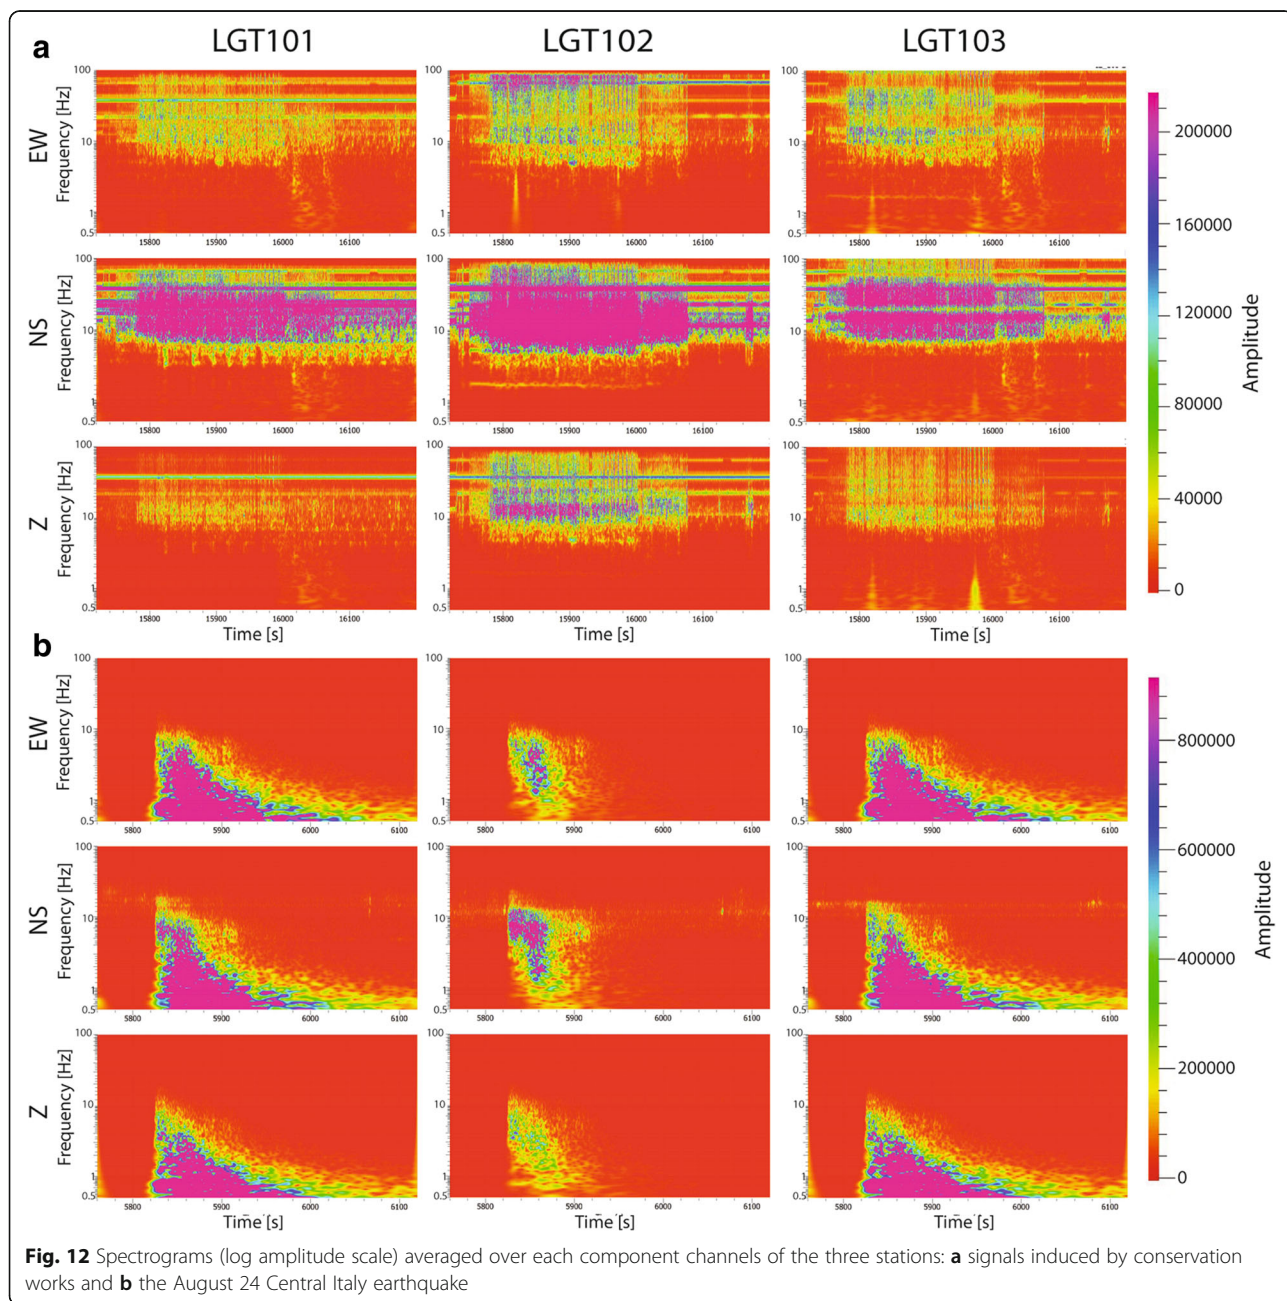
In Fig. 12 the running spectrum (RS) shows the time evolution of the frequency content for both the conservation works (Fig. 12a) and earthquake signals

(Fig. 12b); in this figure the spectral amplitude is shown by the coloured scale. The RS frequency content is constant for the signals induced by the conservation works (Fig. 12a), while changes with time for the earthquake signal (Fig. 12b). Moreover, the first type of vibrations shows lower amplitude at the hinge stations (LGT101 – LGT103) and higher at the cusp section, while for the earthquake signal is observed the opposite. This is probably caused by the different damage status at the cusp and at the hinges. It is also worth to note, as already pointed out in this paragraph, that vibrations caused by the conservation works have a higher frequency content (around 10 Hz) than those induced by the earthquake, according to the inelastic attenuation of waves propagating in the Earth with distance, which depends on the frequency (Lay and Wallace 1995).
