Landslide disaster prevention and mitigation through works in Hong Kong

Geotechnical Engineering Office, Civil Engineering and Development Department, The Government of the Hong Kong SAR, Hong Kong, China

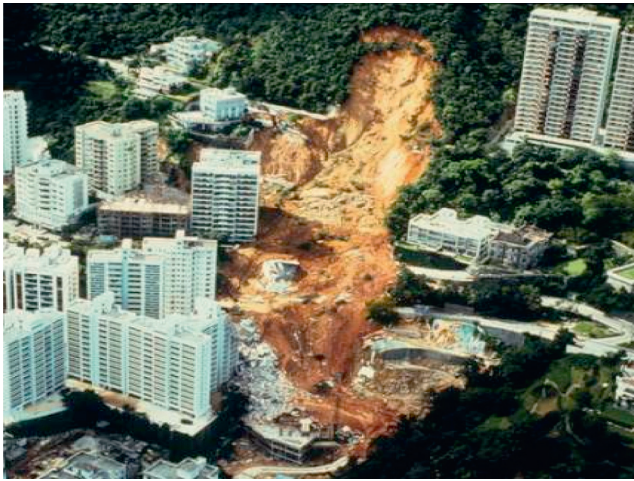
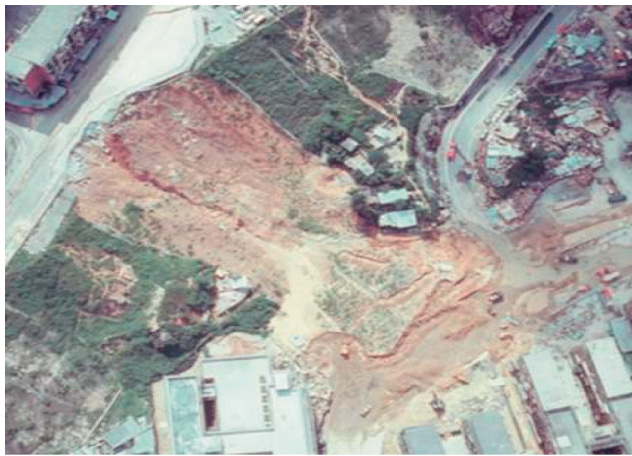
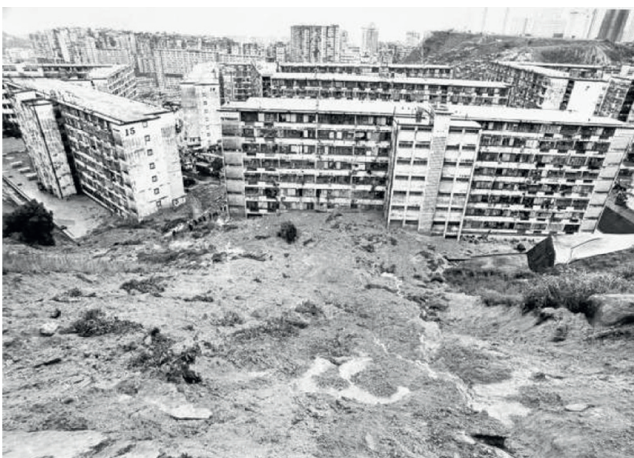
(a) 1972 Po Shan Landslide.

(b) 1972 Sau Mau Ping Landslide.

(c) 1976 Sau Mau Ping Landslide.

Fig. 1. The fatal landslides at Po Shan Road and Sau Mau Ping in the 1970s.

470 people have been killed by landslides in Hong Kong, mostly as a result of failures associated with man-made slopes. The notable incidents include two fatal landslides at Po Shan Road and Sau Mau Ping respectively on 18 June 1972 where a total of 138 people were killed, and another fatal landslide at Sau Mau Ping on 25 August 1976 where 18 people were killed (Fig. 1).

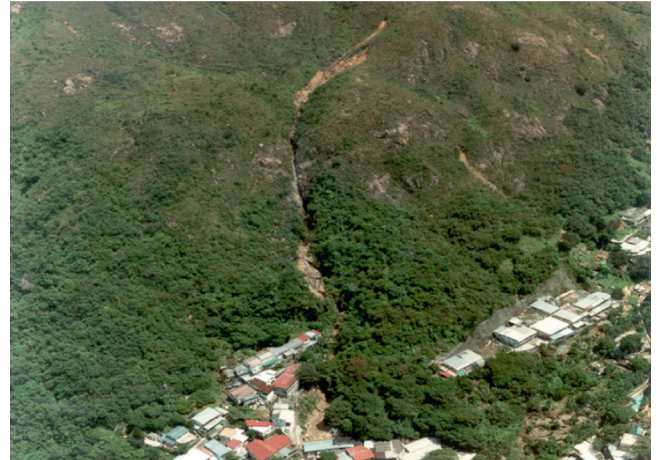
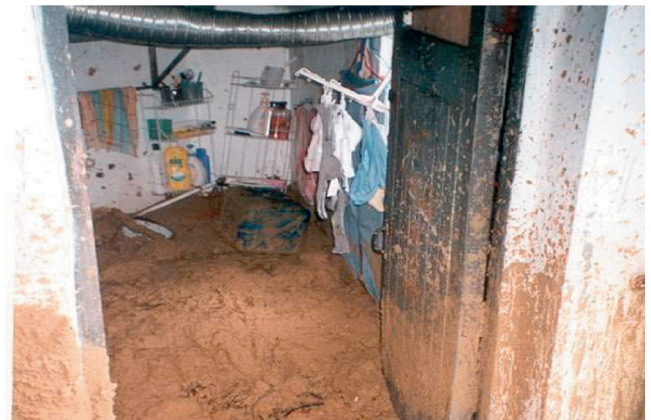
Fig. 2. The 1999 natural terrain landslide at Sham Tseng San Tsuen.

Apart from man-made slopes, Hong Kong is faced with the insidious natural terrain landslide hazards. Based on a review of aerial photographs taken from 1924 to 2006, about 100,000 past landslides on natural terrain were identified (MFJV, 2007). In the severe rainstorm of 4 and 5 November 1993, over 800 landslides occurred on the natural terrain on Lantau Island. About 2400 natural terrain landslides occurred in West Lantau during another severe rainstorm of 7 June 2008. Whilst most of these natural terrain landslides occurred in relatively remote areas, some of them had affected existing facilities including buildings and roads. For example, a channelized debris flow was triggered by natural terrain landslides above Sham Tseng San Tsuen on 23 August 1999 (Fig. 2).

The channelized debris flow had travelled down the natural hillside and demolished several squatter structures at the foothill. One person was killed and another 13 persons were injured as a result of this incident (FMSWJV, 2005). Immediate emergency measures including closure of roads and evacuation of homes were implemented to ensure public safety. These incidents highlight the hazards arising from natural terrain landslides. With the growing demand for land to meet housing needs and other purposes, there is a trend to locate developments closer to areas of steep natural hillsides with a consequent increase in landslide risk.

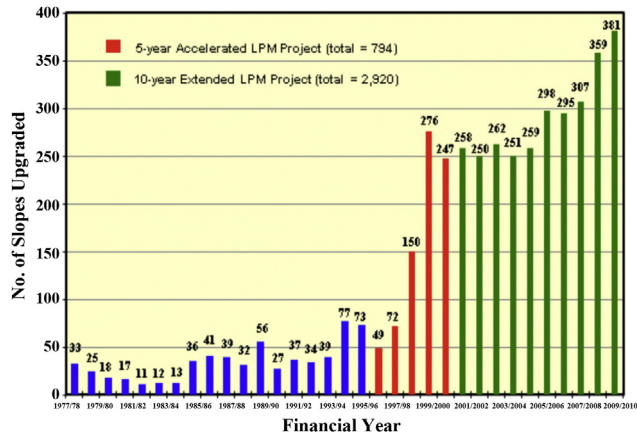
Fig. 4. Distribution of slopes upgraded under the LPM Programme from 1977 to 2010.

Over the 5 years from 1995 to 2000, a total of 794 slopes were upgraded under the LPM Programme (Fig. 4). The total expenditure involved is about HK\$ 2930 million (Fig. 5). At the end of the 5-year Accelerated LPM Programme, about 250 slopes were upgraded each year which is about five to six times the average productivity before 1995. It is worth noting that QRA has been applied at that time to evaluate and monitor the performance of the LPM Programme. An assessment made in 2000 found that the overall landslide risk posed by pre-1977 man-made slopes was reduced to 50% of the level existed in 1977 upon completion of the 5-year Accelerated LPM Programme (Cheung and Shiu, 2000).

During the period from 1977 to 2010, about 4500 substandard government man-made slopes were upgraded under the LPM Programme (Fig. 4). The average number of slopes upgraded from 1977 to 1994 was about 35 per year and this had progressively increased to 250 per year during the 5-year Accelerated LPM Programme. The average number of slopes upgraded per year under the 10-year Extended LPM Programme had further increased to 300.

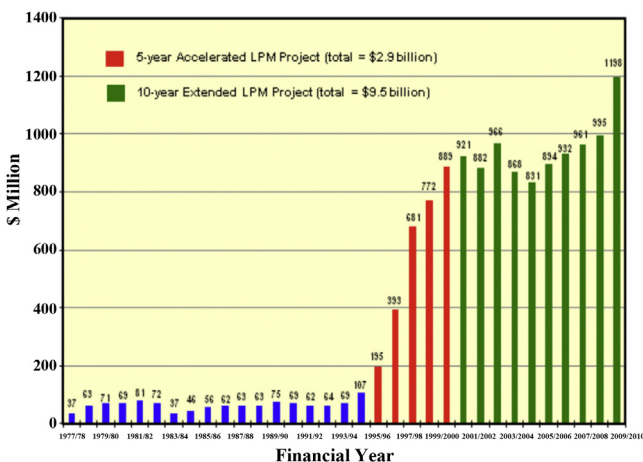
Fig. 5. Expenditure incurred under the LPM Programme from 1977 to 2010.

Initially, most of the slopes included in the LPM Programme were fill slopes affecting housing estates, schools and hospitals, mainly as a result of the two fatal landslides involving liquefaction of loose fill at Sau Mau Ping in 1972 and 1976, respectively. Since the mid-1980s, the proportion of soil cut slopes, rock cut slopes and retaining walls in the LPM Programme had increased. Up to 1994, a total of 620 slopes (Fig. 4) had been upgraded under the LPM Programme. In sum, the focus of the LPM Programme in this period, i.e. 1977–1994, was on treating man-made slopes affecting occupied buildings. The total expenditure involved was about HK\$ 1200 million (Fig. 5).

The cumulative expenditure incurred under the LPM Programme from 1977 to 2010 was about HK\$ 14 billion (Fig. 5). Before the 5-year Accelerated LPM Programme, the annual expenditure was about HK\$ 60 million. Over the 5 years from 1995, the expenditure had increased geometrically until it reached the peak of about HK\$ 900 million in 2000. In the next 10 years from 2000 to 2010, the average annual expenditure was about HK\$ 950 million.

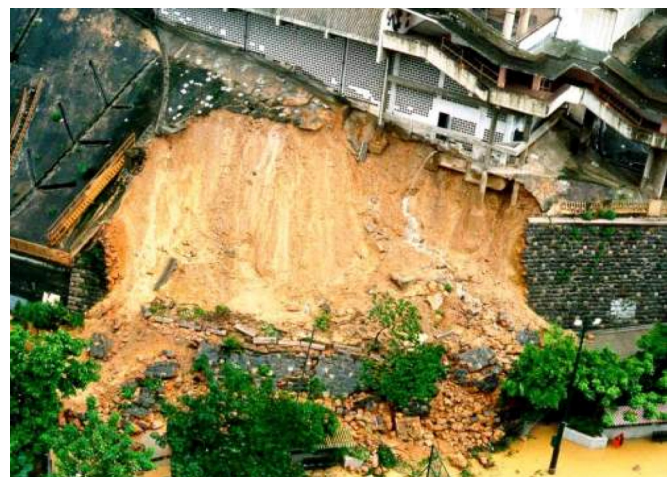
Fig. 6. The 1994 fatal landslide at Kwun Lung Lau.

On 23 July 1994, a fatal landslide occurred below Block D of Kwun Lung Lau, Kennedy Town (Fig. 6). Five people were killed and another three people were injured during the incident. In addition, about 3900 residents were temporarily evacuated overnight. A comprehensive investigation into the cause of the landslide was subsequently carried out by the GEO. An international renowned geotechnical engineering expert was engaged by the Government to conduct an independent review of the investigation (GEO, 2000a). A Select Committee was established by the Legislative Council in 1994 to inquire into matters related to the fatal landslide. Prompted by the Kwun Lung Lau landslide, the Government initiated a Slope Safety Review at the end of 1994 to examine the policy, legislation and resources related to the prevention of landslides in Hong Kong, and to recommend improvement measures.

Most of the substandard retaining walls are old masonry walls constructed during the period from 1850 to 1950. A number of fatal landslide incidents involving masonry walls had occurred in the history of Hong Kong. In 1925, a masonry wall at Po Hing Fong on Hong Kong Island collapsed, demolishing seven houses and killing over 70 people. Most recently in 1994, the failure of a 100-year old masonry wall at Kwun Lung Lau claimed the lives of 5 persons (Fig. 6). These tragic incidents have highlighted the need for

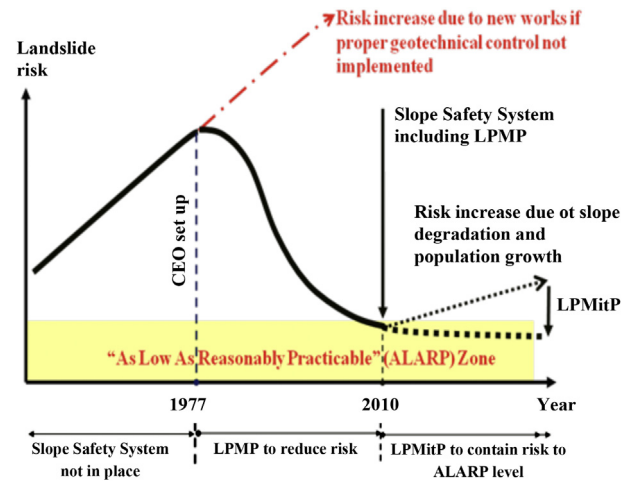
Fig. 7. Landslide risk profile of Hong Kong.

The majority of the remaining landslide risk comes from about 15,000 man-made slopes with moderate risk affecting development and about 2700 natural hillside catchments (Fig. 8) with known hazards and close to existing buildings and important transport corridors. Therefore, the Government has implemented

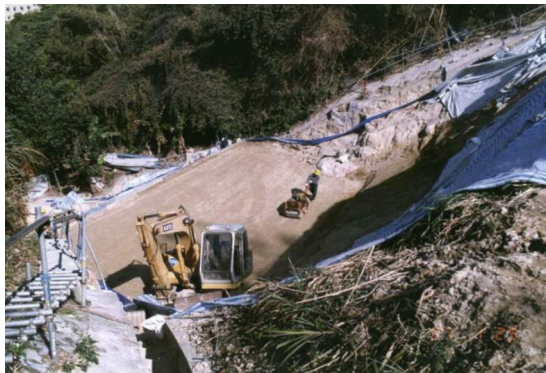
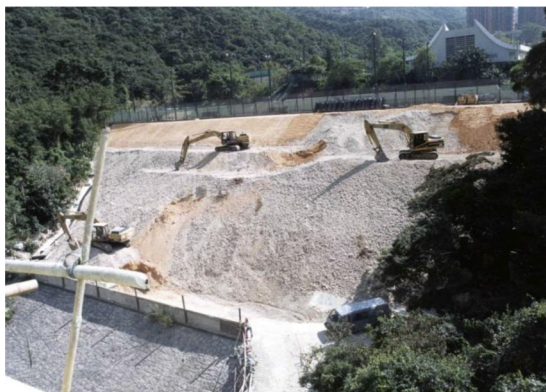
(a) Re-compaction of existing fill.

(b) Application of rock fill cap.

Fig. 9. Stabilization of fill slopes.

Substandard fill slopes, typically comprising loose fill materials, are susceptible to liquefaction when they become saturated and subjected to shearing. The conventional method of treating these fill slopes is to excavate and re-compact the top 3 m of loose fill to achieve 95% relative compaction (Fig. 9a). This is based on the recommendations made by the independent review panel for fill slopes, which was set up following the 1976 Sau Mau Ping landslide (HKG, 1977). Most of the fill slopes under LPM Programme were upgraded by means of this method because of its effectiveness and reliable performance in improving the stability of the fill slopes. A variant to this method, which entails the use of rock fill or cement stabilized soil in place of compacted soil fill to form the 3 m cap, has been adopted in some cases (Fig. 9b).

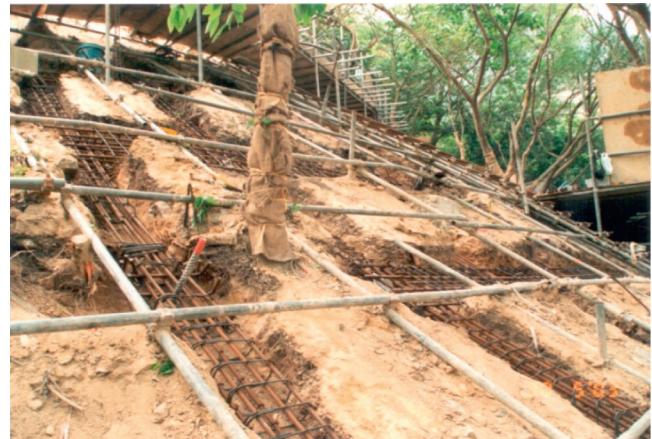
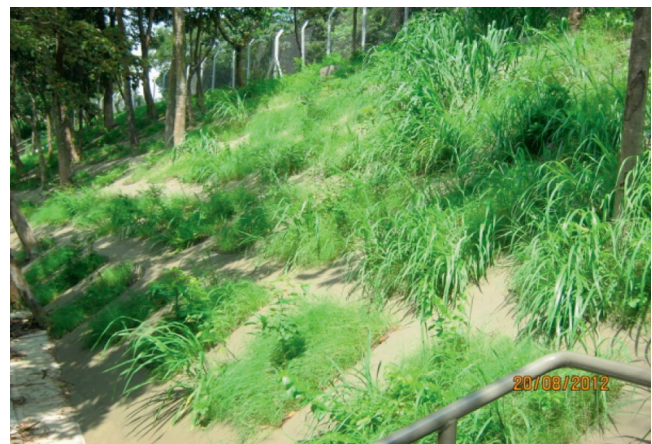
(a) Construction of soil nails and grillage.

(b) Completion of soil nails and grillage construction.

Fig. 10. Upgrading of loose fill slopes using soil nails and grillage.

technique of soil nailing was developed in the early 2000s by a working group of the Hong Kong Institution of Engineers (HKIE, 2003). It entails the installation of soil nails through the fill materials with the provision of a surface grillage connecting the soil nails head. The existing trees can be preserved during the construction process. The soil nails are embedded in competent subsurface stratum to ensure sufficient anchorage against pull-out. Because of the construction advantages offered through the use of soil nailing, the method is now commonly used for upgrading fill slopes under the LPMit Programme (Fig. 10).

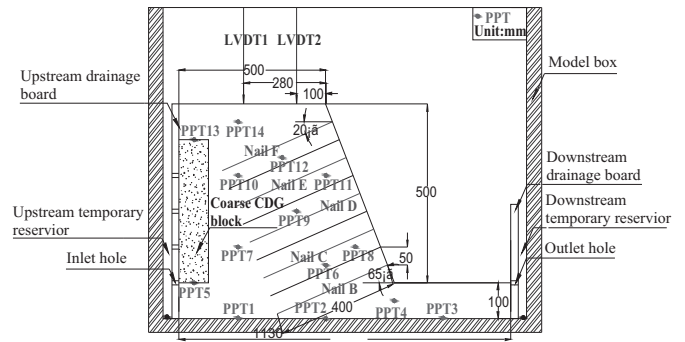
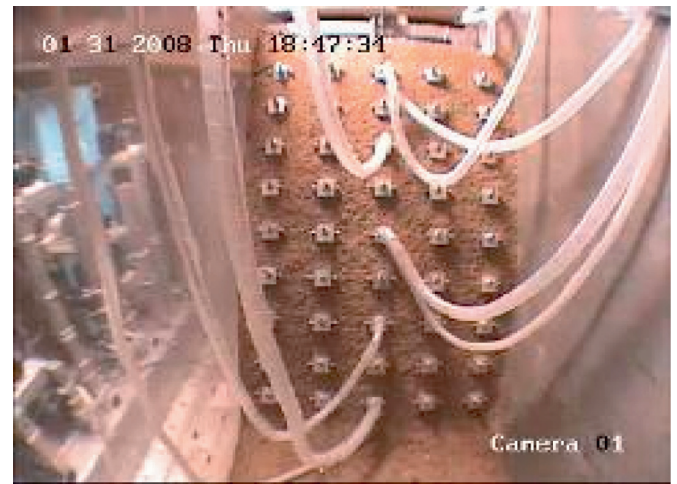
(a) Set-up of a nailed-slope model in centrifuge test.

(b) Front view of the slope model in centrifuge test.

Fig. 12. Centrifuge modelling of a soil-nailed slope.

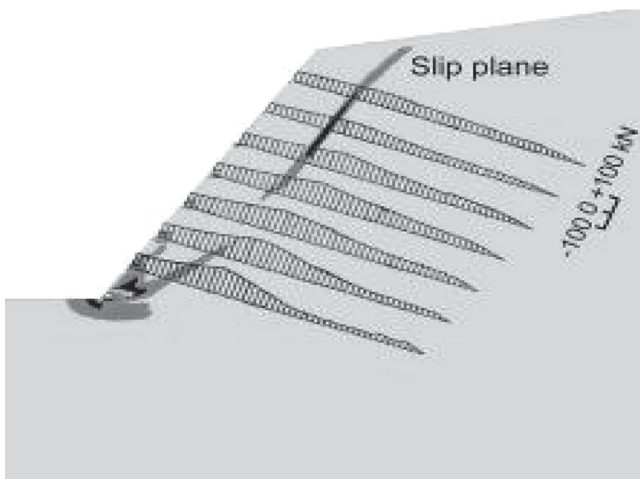
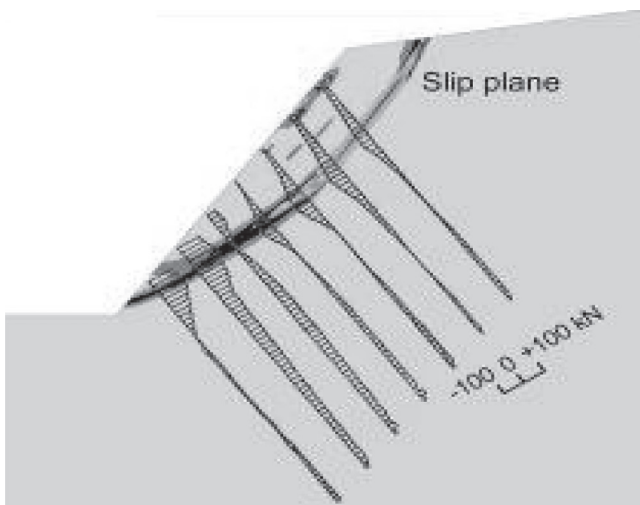
Fig. 11. Numerical modelling of soil nails with different inclinations.

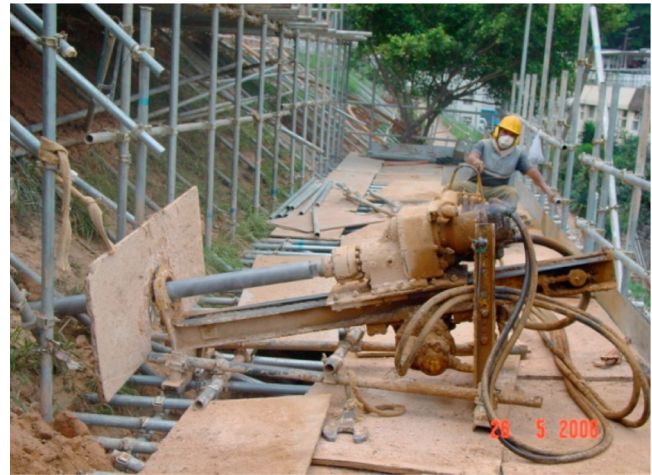
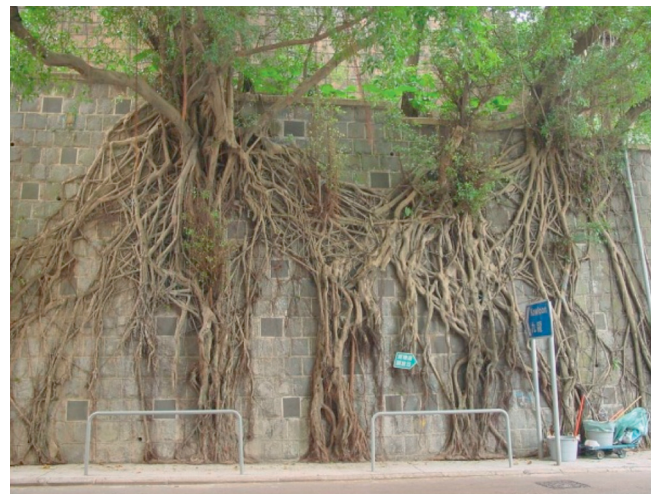
(a) Construction of soil nails in a soil cut slope.

(b) Soil nails on an old masonry wall.

Fig. 13. Application of soil nailing technique in soil cut slopes and old masonry walls.

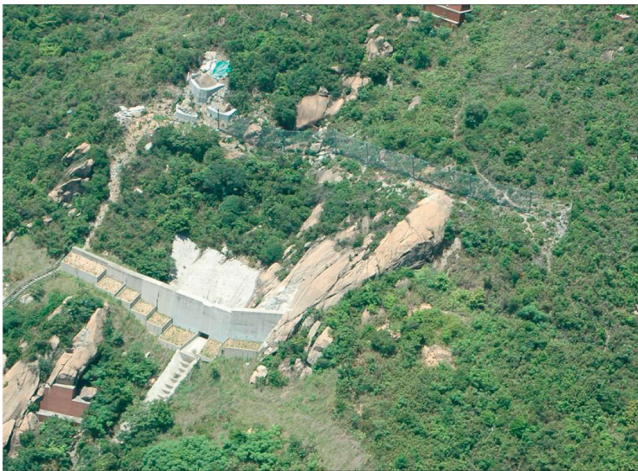
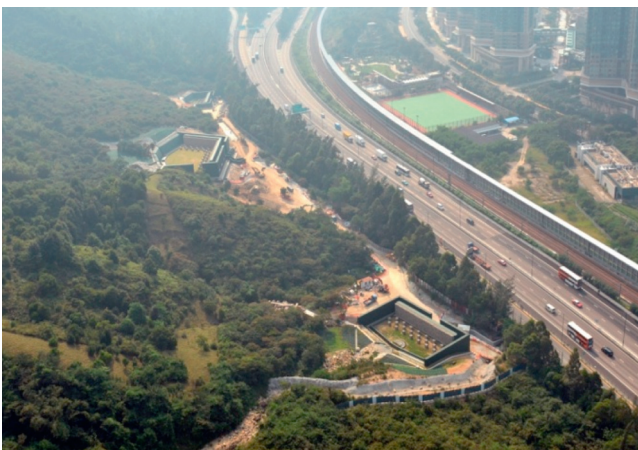
Fig. 14. Concrete barrier at the toe of a natural hillside.

In the management of natural terrain risk under the LPMit Programme, the preferred approach is not to carry out extensive stabilization works to large areas of the natural hillside, which is impractical and environmentally damaging, but to mitigate the risk through the provision of defense measures to contain the landslide debris from the natural hillside above. In most cases, the defense measures adopted in Hong Kong consist of the provision of a concrete barrier at the toe of the natural hillside (Fig. 14). A review of

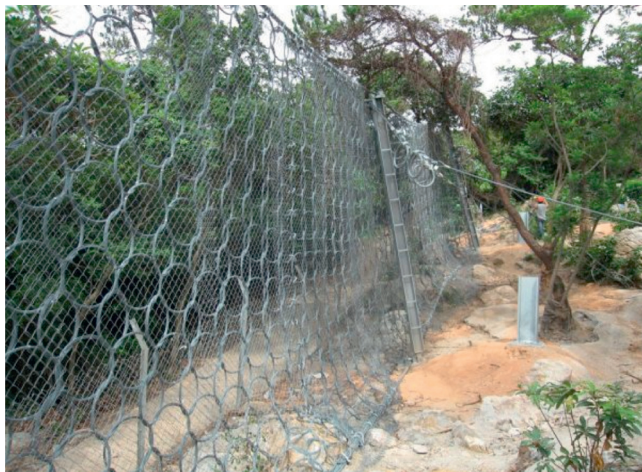
(a) Flexible barrier at the toe of a natural hillside.

(b) Establishment of numerical model for a flexible barrier.

Fig. 15. Flexible debris-resisting barrier.

Flexible barriers, which are mainly formed of steel ring nets mounted between horizontal steel ropes spanning between steel posts and anchored into the ground, are one of the techniques that can be used to mitigate natural terrain landslides (Fig. 15a). The advantages of flexible barriers are that they are relatively easy to install on steep natural terrain, less visually obtrusive and have less environmental impact compared with reinforced concrete barriers. Whilst flexible barriers have been in use for over twenty years as a protective measure against boulder falls and rock falls, the application of flexible barriers for resisting the impact of natural terrain landslide debris is a relatively new concept.

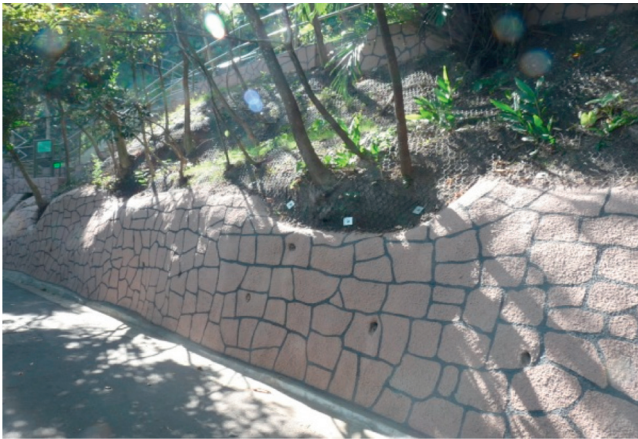
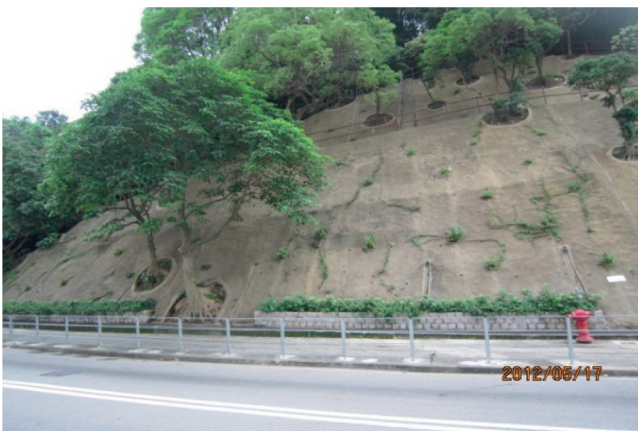
(a) Masonry-like finish on hard slope cover.

(b) Provision of planter holes and toe planter.

Fig. 17. Landscaping to man-made slope with hard cover.

It is government policy to make slopes look as natural as possible, blending them with their surroundings and minimizing their visual impact on the built environment. To pursue this policy, vegetation is used as slope surface cover in the upgrading of existing man-made slopes which are not steeper than 55° (Fig. 16). A hard surface cover such as chunam or shotcrete may be used for steeper slopes, but suitable landscape measures such as applying subdued colour, masonry facing and providing planter holes on the slope surface for screen planting are taken to minimize the visual impact (Fig. 17).

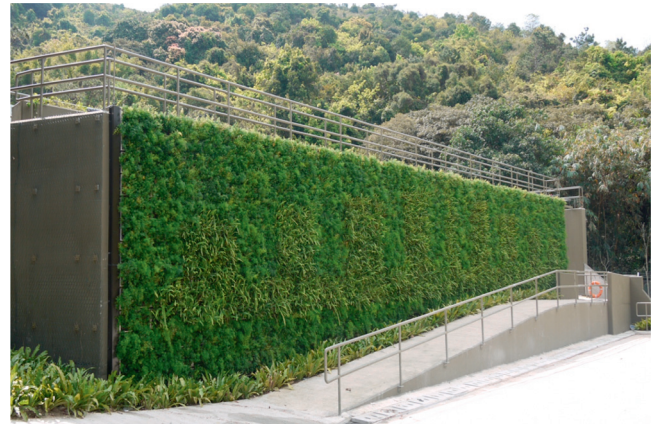
(a) Vertical greening on a concrete barrier.

(b) Screening planting in front of a flexible barrier.

Fig. 18. Landscaping to natural terrain mitigation measures.

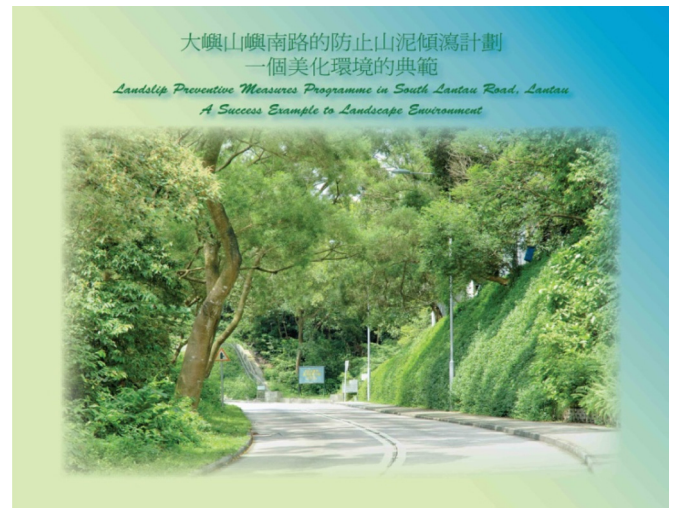
Fig. 19. A success example to landscape the slopes along South Lantau Road.
