Procedia Engineering 84 (2014) 553 – 557

“2014ISSST”, 2014 International Symposium on Safety Science and Technology

Research on fire endurance of tempered glass based on infrared imaging technology

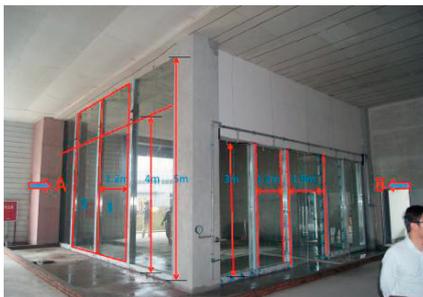
Fig. 1. Testing room.

The testing room with the size of 10 m(L)× 10 m(W)× 5 m(H) for the full-scale test of the fire endurance of the tempered glass is located at the large-space testing building in Dujiangyan City. The two walls of the testing room are constructed of concrete block of 20cm thickness, the other two walls are formed by the tempered glass assembly with the aluminum columns, which is shown in Fig. 1. The facade A is composed of 5 aluminum columns and 4 tempered glass panes with the size of 2.5m(L)×5m(W)×0.012m(T). The facade B is composed of 6 aluminum frames and 5 tempered glass panes with the size of 2m(L)×5m(W)×0.012m(T). Each of the tempered glasses of facade B is protected by the window sprinklers installed at top of the tempered glass, and the activation temperature of the sprinkler is 68 °C. The space between the tempered glass and the frame is filled with the fire sealant. The tests for the fire endurance of the tempered glass with or without the protection of the window sprinkler are analyzed respectively. And the mechanical ventilation system with the ventilation volume of 60m³/m².h is used in the combustion chamber, which complies with China's codes for building fire protection. The fresh air can be supplied into the combustion chamber through the door.

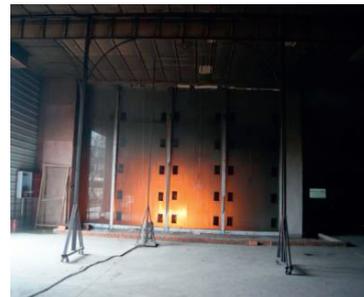
Fig. 2. Tempered glass of Façade A.

At the center of the combustion chamber and near each of the tempered glass, the thermocouples are positioned at the height of 1.8 m, 3.5 m and 4.8 m from the ground separately, so the temperature of the gas, the tempered glass and the glass edges can be measured, which is shown in Fig. 2. Two infrared (IR) cameras are positioned 11 m away from the front of facade A, so the temperature distribution on both sides of the tempered glass can be recorded. For the better application, the highest Heat Release Rate(HRR) satisfies the requirements for the ordinary places, such as shopping mall, etc. with the reference to "Technical Specification for Building Smoke Control"[1]. The maximum fire load of the shopping mall with sprinkler protection can reach 4MW, while the fire load of public hall without any sprinkler protection can reach 8 MW. The fire sources are wood cribs, which have been calibrated by the cone calorimeter according to ISO9705 and SBI before the test [2].
