Energy Procedia 4 (2011) 3330–3337

GHGT-10

## **Applying monitoring, verification, and accounting techniques to a real-world, enhanced oil recovery operational CO<sub>2</sub> leak**

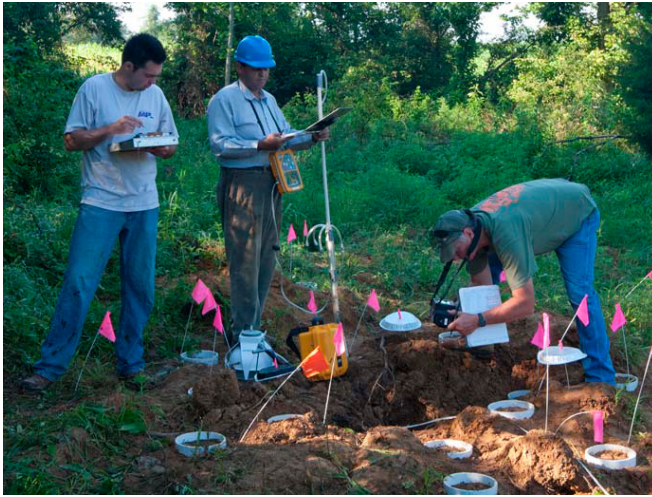
**Figure 2.** MVA personnel used multiple monitoring techniques to, characterize atmospheric CO<sub>2</sub> concentrations, soil CO<sub>2</sub> fluxes, and thermal signatures at the Sugar Creek EOR leak. Disturbance of the land surface was caused by the leak.

The Sugar Creek EOR site is located just southwest of Madisonville, Kentucky, USA (Fig. 1). CO<sub>2</sub> injection began in May, 2009 at a rate of 20 tons/day, with a sustained surface pressure of 89.6 bar. In July, 2009, personnel at the Sugar Creek site reported a leak from the fibreglass pipeline buried about 1 m underground that was supplying CO<sub>2</sub> to the injection well. The leak was detected when site personnel observed dust being propelled into the air and layers of water vapour hovering near the ground surface in the vicinity of the leak. CO<sub>2</sub> injection ceased upon discovery of the leak, and it was determined that a faulty connection in the supply pipe was the leak source. The MVA team saw this as a unique opportunity to test the performance of monitoring equipment in a real-world situation.

In order to provide a spatially accurate characterization of a three-dimensional CO<sub>2</sub> release, a grid system was established around the leak. The leak occurred in bare soil amongst some dry grass and growing vegetation. The nearest vegetation was located approximately 3 m to the east, southeast, and northeast in the form of shrubs and bushes. The surface expression created by the leak was a hole approximately 1.9 m long by 1.7 m wide and 0.7 m deep. This hole was the center of a grid system for 26 polyvinylchloride (PVC) rings used to measure soil fluxes. These rings were oriented around the leak radially (Figure 3). Rings were named according to their corresponding direction, i.e. NE-1 and NE-2 for the two northeastern rings closest to the leak. Rings were 20 cm in diameter and generally located at distances of 1, 1.5, 3.5 and 5.5 m away from the leak. That grid spacing was used for rings extending in eight radial directions with the exceptions that the 3.5 and 5.5 m distances were not monitored to the southeast or northeast, and the 5.5 m distance was not monitored to the east.

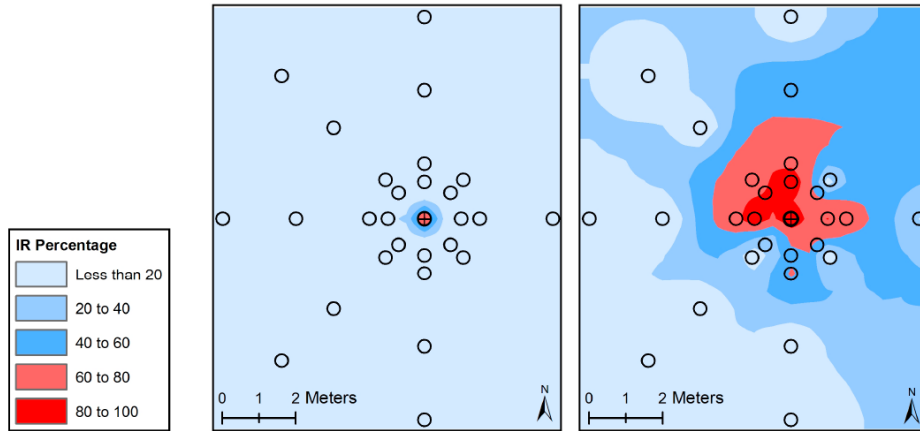
**Figure 3.** Monitoring grid and representative atmospheric CO<sub>2</sub> concentrations at 2.5 cm above ground level during initial conditions on 7/6/09 (left; with no injection) and on 7/7/09 (right; after injection resumed).

Atmospheric concentrations and soil CO<sub>2</sub> fluxes detected in and above the leak opening were much greater than anticipated on 7/6/09 after injection was terminated. It was later determined that backpressure from the formation was causing CO<sub>2</sub> to flow to the leak because of a malfunctioning check valve at the injection well. Atmospheric CO<sub>2</sub> measurements indicated for the initial condition that CO<sub>2</sub> concentrations were less than 20% CO<sub>2</sub> at 2.5 cm above the ground surface except directly above the leak (Fig. 3). For subsequent readings, elevated CO<sub>2</sub> concentrations were not detected at heights greater than 2.5 cm above the ground surface. Our findings were consistent with Wielopolski and Mitra [5], who concluded that CO<sub>2</sub> buildup occurs mostly near the soil surface-atmosphere interface up to 2.5 cm above the ground and spatial distribution of CO<sub>2</sub> varies greatly depending on weather conditions influencing vertical and lateral mixing.

After CO<sub>2</sub> injection was terminated, initial conditions indicated small soil CO<sub>2</sub> fluxes and atmospheric CO<sub>2</sub> concentrations on all grid points except at the leak. Atmospheric CO<sub>2</sub> concentrations measured on July 6 were less than 0.1% at each grid point. At the hole, where the leak was visible, CO<sub>2</sub> concentrations ranged from 86.6% at 2.5 cm above the leak to 0.2% at 75 cm above the leak. Due to the constant (and sometimes violent) activity created by CO<sub>2</sub> pressure buildup in the subsurface, flux data were not collected directly on top of the leak. The grid point in the middle of each image, shown as a target (in Figures 3 and 4), represents the actual leak. Contour intervals represent averaged concentrations or soil CO<sub>2</sub> flux values. As expected, CO<sub>2</sub> fluxes and concentrations were greatest on top of and directly around the leak. For example, at NW4 (5.5 m northwest of the leak), CO<sub>2</sub> concentrations were less than 0.1% and the flux values ranged from 1.97 to 9.05 μmol/m<sup>2</sup>/s. In contrast, at SE1 (1 m southeast of the leak), 77.6% CO<sub>2</sub> was measured at 2.5 cm above ground surface on the morning of 7/6/09. Fluxes at SE1 ranged from 10.89 to

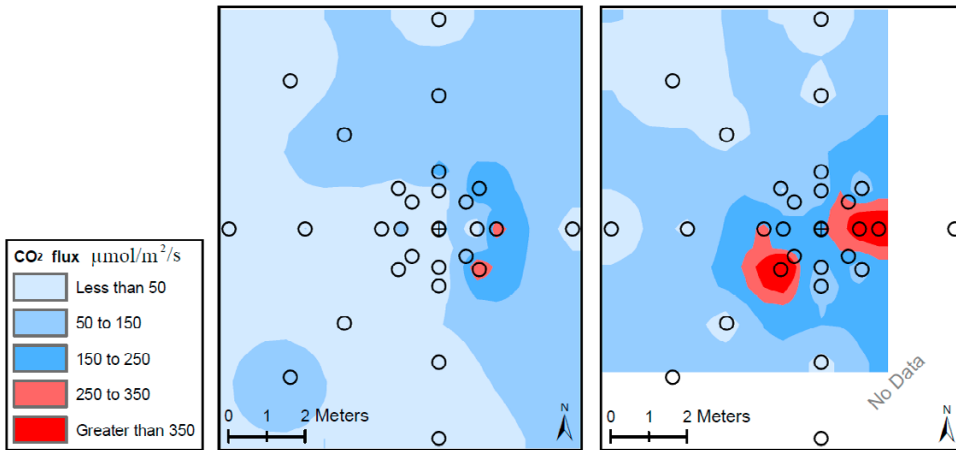
**Figure 4.** Monitoring grid and representative soil CO<sub>2</sub> fluxes during initial condition on the morning of 7/7/09 (left; with no injection) and on the afternoon of 7/7/09 (right; after injection resumed).

267.98  $\mu\text{mol}/\text{m}^2/\text{s}$  during the experiment. The LI-8100 system has an operational range of 0-3000 ppm  $\text{CO}_2$ . If  $\text{CO}_2$  concentrations during the entire measurement period were more than 3,000 ppm, then the flux value could only be qualified as ‘high.’ However, if the  $\text{CO}_2$  concentration started within the operational range and then exceeded it during the measurement period, data collected within the operational range could still be used to make a quantitative flux estimate.

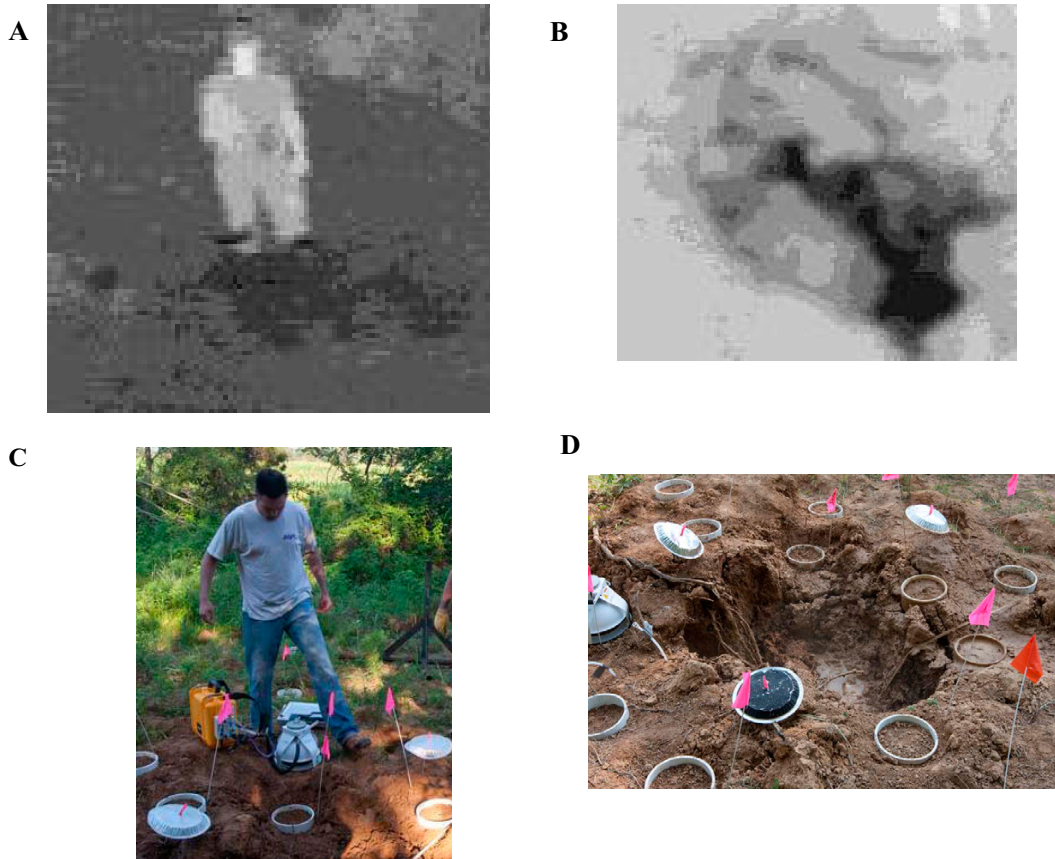
**Figure 5.** Thermal image A shows the contrast between the warm body (light gray) standing above the cold soil (dark gray) of the leak. Thermal image B was taken looking directly into the hole, with the black representing the coldest thermal signatures in the soil. Photographs C and D depict areas similar to the thermal images for visual orientation.

Because the rapid release of CO<sub>2</sub> from the ground surface caused extensive freezing of the soil and subsurface water immediately above the leak, thermal imagery was captured using an IR Snapshot model 525™ by Infrared Solutions, Inc. Two aluminum pans were placed about 1.5 m apart from each other on the south side of the leak opening. A third aluminum pan was painted black and placed about 30 cm north of the leak opening. The pans were used as thermal reference points for the thermal images. The unpainted pans displayed a colder thermal signature resulting from their reflectivity, and the painted black pan showed a warmer thermal signature resulting from heat absorption of solar radiation. Thermal images were taken at various times and locations surrounding the leak. Soil temperature was measured by an Omega 865 thermometer to compliment the thermal images. A soil-temperature probe was placed approximately 10 cm into the soil in order to obtain an accurate temperature.

Thermal imagery detected the contrast in temperature between the warmer soil not affected by the leak from the colder water and soil inside the leak (Figure 5). In the thermal imagery, cold temperatures are shown as darker colors and warmer temperatures are shown as lighter colors. Soil temperature readings showed the coldest temperatures inside and directly adjacent to the hole. On 7/6/09, while air temperature was 27.6° C (81.6° F), the soil in the bottom of the hole was -0.28° C (31.5° F) and soil at the top of the hole was 16.6° C (61.9° F). Table 1 lists soil temperatures collected on 7/7/09 and 7/8/09 to indicate the extent of the thermal influence of the leak on soil temperatures. Even though the soil temperatures were collected on two different days, the data show similar
