## Case Studies in Construction Materials

Monitoring in situ performance of pervious concrete in British Columbia—A pilot study<sup>☆</sup>Rishi Gupta<sup>\*</sup>*Civil & Environmental Engineering Program, Department of Mechanical Engineering, University of Victoria, Canada*

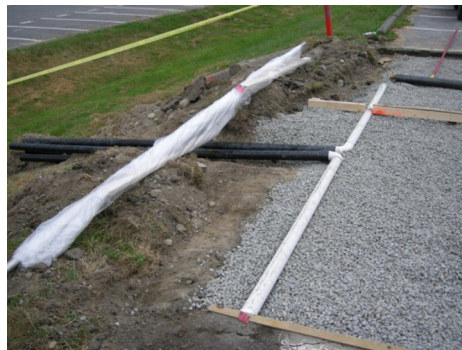
Photo 2. Perforated pipes on top of crush connecting to ABS pipes.

The existing asphalt was saw cut to form straight edges and 12 in. deep excavation was done. The soil below the asphalt pavement consisted of sandy soil for the top 6 in., and sandy clay in the lower 6 in. Sets of perforated pipes were placed below lanes 795 and 796 located at west end of the test slab (Fig. 1b). One set was placed at the bottom of the clear crush and one at the bottom of the 6 in. thick pervious concrete slab (Photos 1 and 2). Separate pipes were used at each level under lot 795 and 796 to study the reduction in percolation capacity (if any) by not maintaining (power washing) one section of the pavement. In this study, lot 795 will be maintained and lot 796 will be left unmaintained. A small portion of the ditch north of the placement (outside the test slab) was also excavated to accommodate a water collection system for testing purposes (Photo 3). The perforated pipes were 3 in. in diameter, 7 ft in length, and made from PVC.

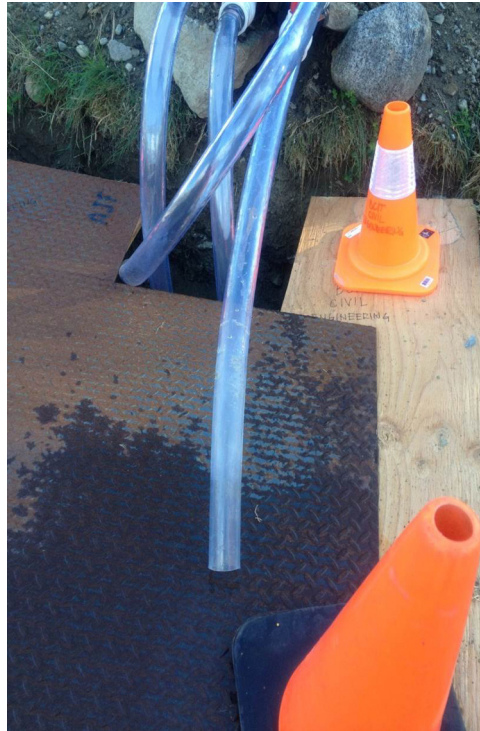
Photo 3. Downstream end of pipes feeding into a collection chamber.

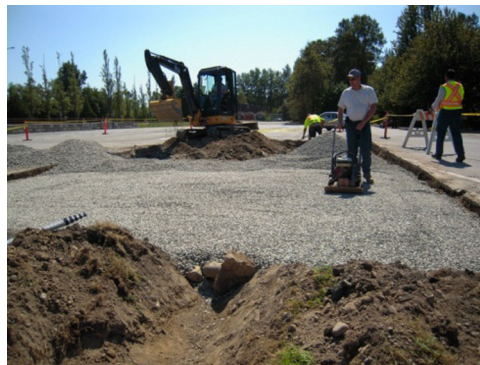
Photo 4. Compaction of clear crush and simultaneous excavation.

throughout the placement. [Photo 4](#) shows the clear crush being compacted by the vibratory compactor. The background of [Photo 4](#) also shows the simultaneous excavation of soil and the transportation of clear crush from a nearby deposited pile. The clear crush is necessary for pervious concrete as it acts as a storage medium and a filtration system for water passing through the pervious concrete. The crush also acts as a subbase for receiving the pervious concrete layer.

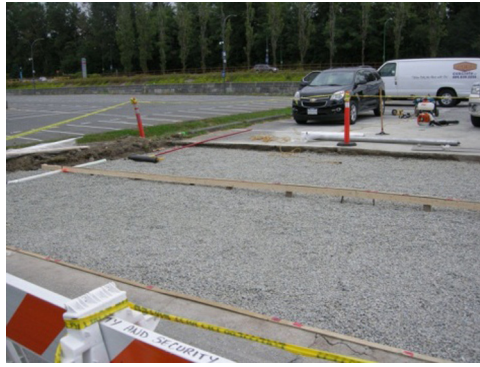
Photo 5. Compacted crush ready to receive pervious concrete.

of 10 ft approximately matched the width of half the placement, or one bay. The site was prepared by adding minimal formwork to split the placement and to create straight edges along the sides, as cracks occurred in the existing asphalt surface during the excavation process. Photo 5 shows the compacted subbase prior to receiving the concrete placement.

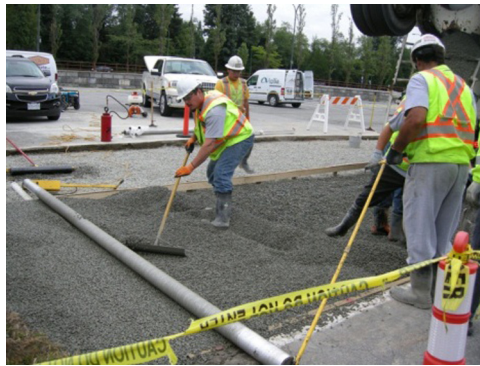
Photo 6. Roller screed and leveling of pervious concrete.

Six inches of pervious concrete was placed on top of the compacted clear crush. The pervious concrete was then immediately leveled using rakes and an aluminum roller screed for consolidation. Photo 6 shows a construction worker leveling the pervious concrete with the roller screed in the foreground. The roller screed is essentially a hollow tube that is

filled with water for additional weight. The roller screed was approximately 50 pounds empty, and approximately 100 pounds when filled with water.

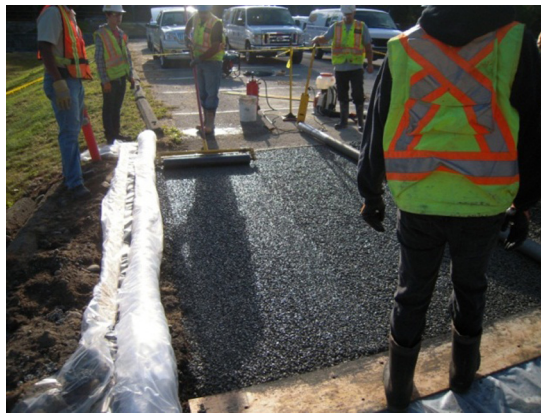
Photo 7. The second roller giving the desired finish of the concrete.

The estimated speed of rotation of the screed was approximately 250 rpm. A smaller second roller was also used in the transverse direction to get the desired finish and compaction. [Photo 7](#) shows the second roller in operation. The edges of the placement were further lightly compacted by using a flat metal plate. This was done to form a level surface between the existing asphalt and the pervious concrete. This process was also done to create level surfaces between the two placements of the concrete. Once the concrete was placed and consolidated, the concrete was mist sprayed with water before being protected by a thick sheet of polyethylene. This was done in accordance with the CSA A23.1-09 specifications for curing. [Photo 8](#) shows the finished placement with the polyethylene covering the pervious concrete. The second bay of the placement was placed seven days after the initial placement. The inside edge of the concrete was saw cut to provide a smooth

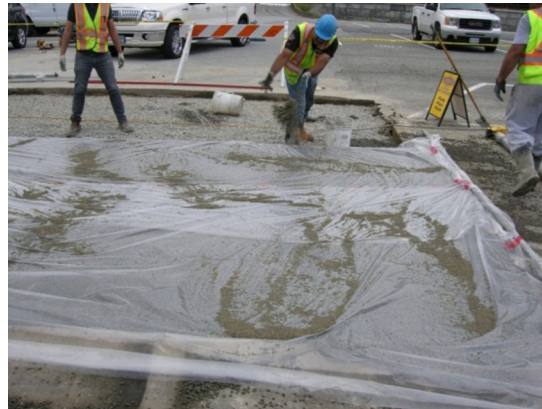
**Photo 8.** Finished concrete slab (Bay 1) covered with polyethylene sheet.

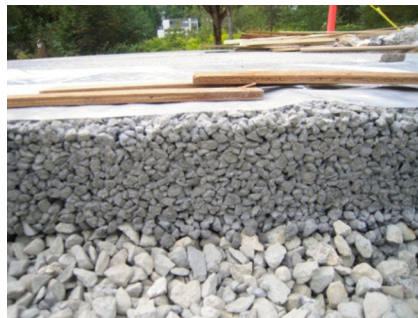
**Photo 9.** Pervious concrete cross-section after saw cut.

edge prior to the second placement. [Photo 9](#) shows the cured cross-section of the pervious concrete in Bay 1 (after 7 days of concrete placement). The second placement had similar procedures to the first placement. Once the first concrete placement was cured for 15 days and the second cured for 7 days, saw cuts were carried out. One saw cut was made to reduce the length of the placement to half (20 ft).

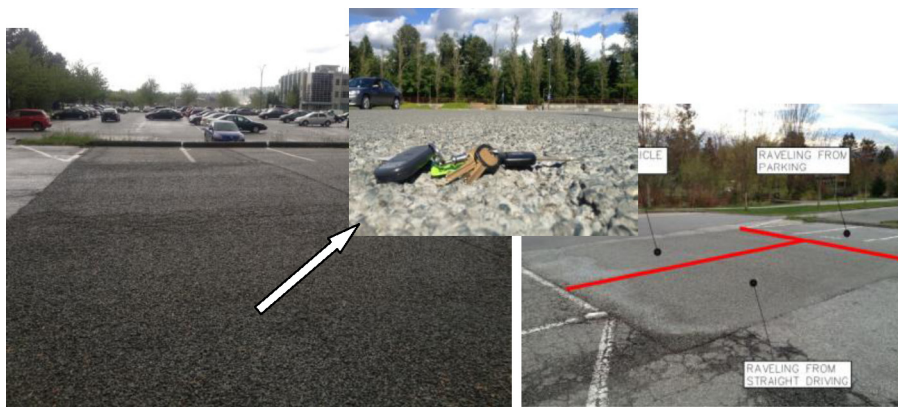
**Photo 10.** Current state of raveling in pervious concrete after 40 weeks in service.

The pervious concrete placement has been divided into various zones: turning, driving, and parking. Visual observations after 40 weeks of exposure has indicated noticeable wheel travel paths in the vehicle turning zone. The turning zone is expected to experience high stresses and raveling forces from the turning vehicles. The paths appear to have lost between 1 and 3 aggregate layers. In the region of straight vehicle motion a uniform loss of aggregate has occurred and the parking region shows little or no sign of raveling. [Photo 10](#) shows the current state of the pervious concrete placement. The rate of raveling observed during the first two months since placement seems to have reduced over time. As described earlier, one of the factors that may have contributed to early raveling is the fact that the placement was opened to traffic within 7 days and that a full 28 day cure was not allowed. Research is on-going to quantify the extent of raveling by using image analysis and other non-destructive techniques. It should also be noted that the extent of raveling in the turning zones at the moment is not severe enough to make the drive uncomfortable.

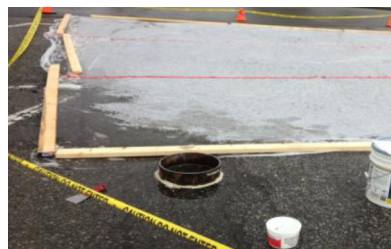
**Photo 11.** Ring used for the in-place percolation test.

In-place filtration rates were measured according to [ASTM C1701/C1701M](#), “Standard Test Method for Infiltration Rate of in Place Pervious Concrete”. This test method determines the field water infiltration rate of in-place pervious concrete. Maintenance of the pilot slab will only be done on a specific side of the slab (40 ft length of stall 796, West side of Bay 1), thus, filtration rate tests results will determine the extent of post maintenance recovery of percolation capacity. The ring used for the percolation test along with the putty during a test is shown in [Photo 11](#). The diameter of the steel ring is 300 mm and a water head of 10–15 mm was used during the test as specified by the ASTM standard. [Photo 1\(b\)](#) shows the locations of the tests conducted so far. The location of each of the tests will remain the same for any future tests to determine the change of

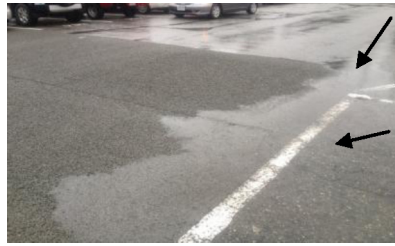
Photo 12. Run-off being captured by pervious concrete.

The average percolation capacity of the placement after 30 weeks of service is still quite high at 60,000 mm/h for most of the slab. The portion of the pavement downstream of the rest of the asphalt parking lot is in direct contact of the surface runoff (shown by arrows in Photo 12). This portion of the pavement receives high sediment load and deleterious substances. Due to this, the percolation capacity in this south side of the pavement is 1500 mm/h which represents more than 95% reduction in the percolation capacity. However, this area represents a very small portion of the total area of the pavement. Moreover, as is evident from Photo 12 during a measured 48 mm/h 15 min storm, the pavement was effective in capturing the entire surface runoff and surface water within 2 ft of coming in contact with the pavement.
