## VASCULAR IMAGES

# Duodenal perforation and vertebral body erosion by a Greenfield filter

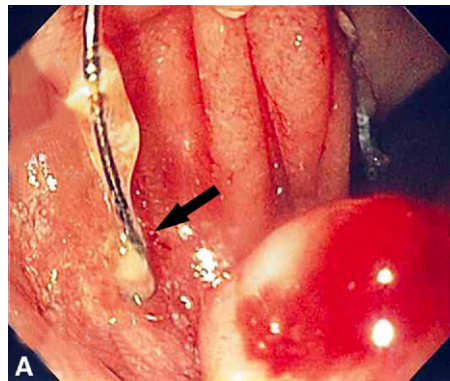
An esophagogastroduodenoscopy revealed metallic foreign bodies projecting into the lumen of the duodenum (A, *arrow*). A computed tomography scan demonstrated perforation of three filter struts (B, *small arrows*) through the full thickness of the duodenal wall. An additional strut perforated through the caval wall, without invading adjacent structures (B, *white arrow*). A single fractured strut migrated and then eroded into the third lumbar vertebral body, causing an intense sclerotic reaction (B, *large arrow*; Cover).

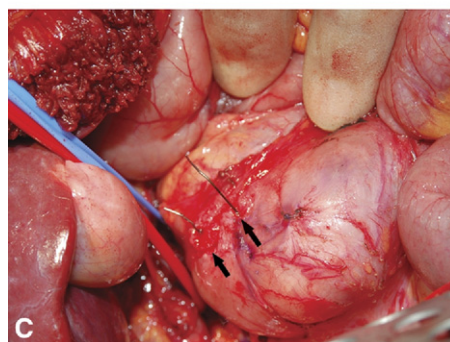
The patient underwent abdominal exploration through an extended right subcostal incision. The duodenum was mobilized with a Kocher maneuver, and the vena cava was controlled above and below the renal veins. Cicatricial areas of inflammation were present at the sites of strut penetration (C).

Each strut was cut to separate the intraduodenal segment from the intracaval segment, and the hooks were gently rotated to ease removal from the lumen of the duodenum (C, *arrow*). The fractured strut poised in the lumbar vertebral body was localized with a clip using fluoroscopy. The surrounding sclerotic tissue was divided and the strut removed. Finally, a longitudinal cavotomy was made, and the truncated filter was extracted from the caval endothelium. The duodenum and cava were repaired primarily, and an omental flap was placed between them. The patient recovered uneventfully and is free of abdominal pain in long-term follow-up.
