# Performance of R.C. slabs with lap splices using headed bars

Department of Structural Engineering, Alexandria University, Alexandria, Egypt

Concrete slab;  
Headed bars;  
Lap splice;  
Ductility

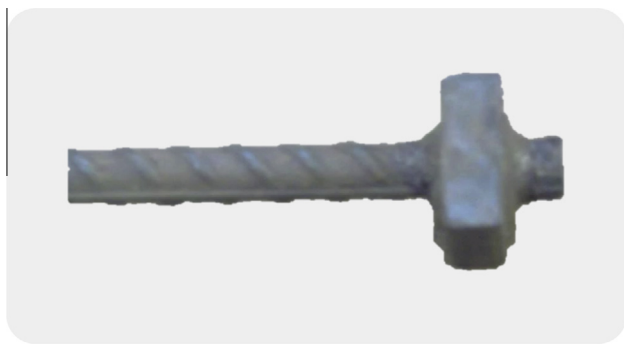
**Figure 1** Shape of the prepared headed bar after welding.

Headed bars were fabricated using the method suggested by Yassin [12]. This suggested bar head detail was obtained by fixing a square steel plate with size (25 × 25 × 10 mm) with a hole

in the middle to the main reinforcement bar by passing the bar through the hole and welding the bar from the two sides of the plate as shown in Fig. 1. Three specimens were tested by direct tension to ensure that the welded connection between the bar and the head did not fail before the ultimate strength. Results of these trials are given in Table 1. Failure occurred in the bar after reaching yielding of the bar outside the welded connection.

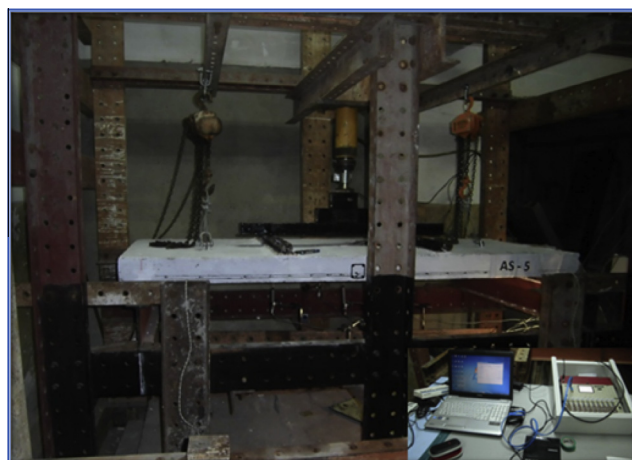
**Figure 2** Test setup.

The details of the setup of the experiment and loading system are shown in Fig. 2. The load was applied using a hydraulic jack of 200 kN capacity and the load value was monitored using a calibrated load cell. A stiff spreader beam was used to transfer the vertical load to the tested slab at two transverse lines 800 mm apart. Three Linear Variable Displacement Transducers (LVDTs) of 0.01 mm accuracy were utilized to

measure vertical deformations at the center of the slabs and under the positions of the two applied line loads. For each slab, two electrical strain gauges of 10 mm length were used to measure the strain of the bottom steel reinforcement. Strain gauges were fixed at the end (near the head of the bar if existing) and at the start of the splice joint for all slabs. The vertical load was applied in 2.5 kN increments in a low rate. All measurements of loads, deflections and strains were recorded automatically using data acquisition system.

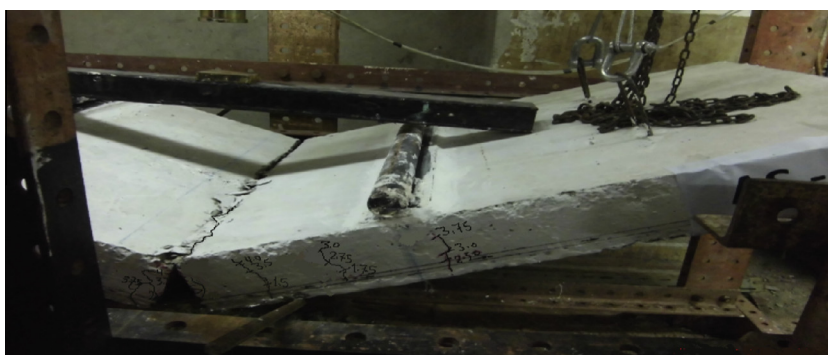
**Figure 4** Brittle failure of slab AS-3.

All slabs in *Group 1* were with no confinement arrangement in the lap zone and 100% cut-off ratio. For slab AS-1 (reference slab), flexural cracks appeared between the two line loads in the constant bending moment zone at a load of 30.0 kN. With the load increase, flexural cracks propagated to the compression zone and became wider. Bottom main steel yielded at a load of 50.0 kN. Flexural failure of the slab took place at a load of 55.0 kN. For slab AS-2 with lap splice length equal to  $45 d_b$  and without headed bars, flexural cracks appeared at the constant moment zone at a load of 25.0 kN. With the load increase, flexural cracks propagated to the top of the slab, and cracks became wider. Yielding of bottom longitudinal tension steel occurred at a load of 52.5 kN. Failure of the slab occurred by crushing of concrete in top of the slab at a load of 55.0 kN. For slab AS-3, with  $15 d_b$  lap splice length provided with headed bars but without any confinement at the splice zone, flexural cracks initiated at the constant moment zone at a load of 15.0 kN. As the applied load was increased, flexural cracks formed and appeared along the position of the

heads at each end of the spliced bars at a load of 20 kN. With load increase, flexural cracks propagated to the compression zone at the top of the slab and became wider. No yield of steel reinforcement was recorded in the bottom longitudinal steel bars up to failure. Failure of this slab was sudden with the loss of bond between concrete and steel which resulted in pushing down the bottom cover. Pullout of bars occurred at a load of 42.5 kN and the failure was brittle as shown in Fig. 4. Slab AS-7 with  $27 d_b$  lap splice length provided with headed bars without confinement, flexural cracks initiated at the constant moment zone at a load of 25.0 kN. With the load increase, cracks appeared at the lap-splice zone at a load of 27.5 kN and started to propagate to the compression zone and the width of cracks became wider. Yielding of main steel occurred at a load of 48.0 kN. At a load of 60.0 kN, flexural ductile collapse of the slab took place.

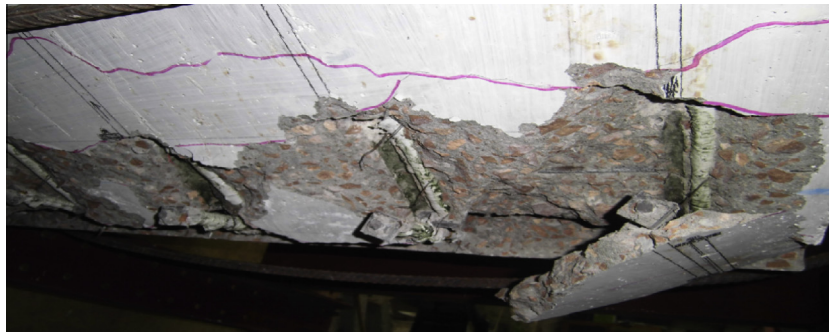
**Figure 5** Brittle failure of the lap splice on the bottom of slab AS-4 (debonded bars).

In *Group 3*, all slabs were not provided with any confinement in the lap zone and the splice length =  $15 d_b$  with headed bars. In slab AS-4, with debonded headed bars in the spliced zone, flexural cracks appeared at the constant moment zone near the head of the spliced bar at a load of 12.5 kN. This value was less than that recorded for the bonded slab AS-3. The width of cracks was wider than that of slab (AS-3). Transverse crack in the slab (AS-4) occurred close to the position of the bar head. Distinct longitudinal cracks formed between the two opposing heads in the lap zone. These cracks appeared at a load of 37.5 kN. In Slab (AS-3) with bonded headed bars, the intensity and number of cracks along the lap joint zone were observed. This behavior was not evident in the debonded slab (AS-4) because there was no contribution from bond in load transfer. As the load was increased, flexural cracks propagated to the compression zone and cracks along the line of heads at each end of the lap became wider and extended to upper face of the slab covering the lap zone. No

yield of steel reinforcement was recorded in the tension steel up to failure. Failure of the slab was a brittle failure occurred suddenly as the heads of bars pushed down the bottom cover and cover separated from the slab at a load of 40 kN as shown in Fig. 5. This failure action could be described as a prying action as the ends of the lapped spliced bars moved outside the bottom of the slab, pushing the bottom concrete cover in lap joint zone.

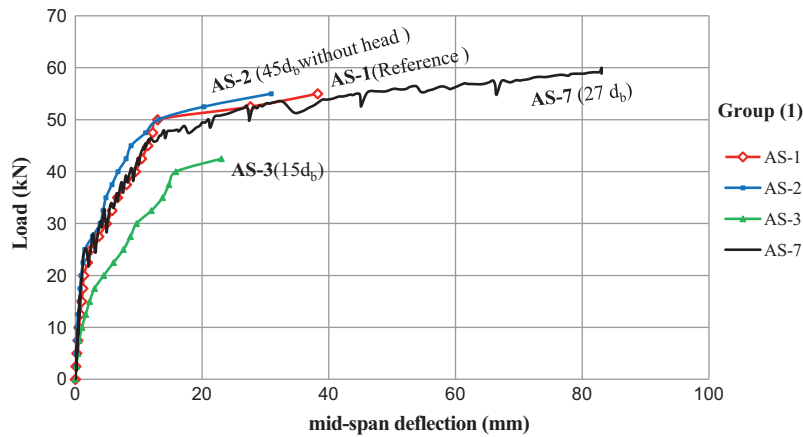
Figure 11 Load-deflection curves for Group 1.

Fig. 11 shows the applied load-deflection at mid-span relations for slabs AS-1, AS-2, AS-3, and AS-7. It can be shown that the load-deflection curve for slab AS-1 (reference slab) and slab AS-2 (with 45 d<sub>b</sub> lap splice without headed bars) was very

close. Slope of load-deflection curve of slab AS-3 was less than that of slabs AS-1 and AS-7 after the cracking loads which indicates that AS-3 is less stiff than other slabs in the Group 1 due to the short unconfined lap splice length. The area under the load-deflection curve was calculated to measure the total energy absorbed by the tested slabs which is called strain energy or toughness. The strain energy ratios achieved by the tested slabs were 81%, 40%, and 243% for slabs AS-2, AS-3, and AS-7 respectively, of that of Slab AS-1 (reference slab). The ultimate load values of slabs AS-2, AS-3, and AS-7 of 100%, 77%, and 109%, respectively, of that of Slab AS-1 (reference slab). Fig. 12 shows the relationship between measured steel strain (at point A) near the head of bar and load for slabs of group (1). For all slabs in this group except AS-1, strain data indicated that the steel did not yield until failure. It is clear that without using confinement in the lap zone, the strength and ductility of the reference slab can be maintained if the lap splice length is  $27 d_b$  with headed bars, or  $45 d_b$  with straight bars with no head. On the other hand, slab AS-3 with  $15 d_b$  had less strength and ductility.

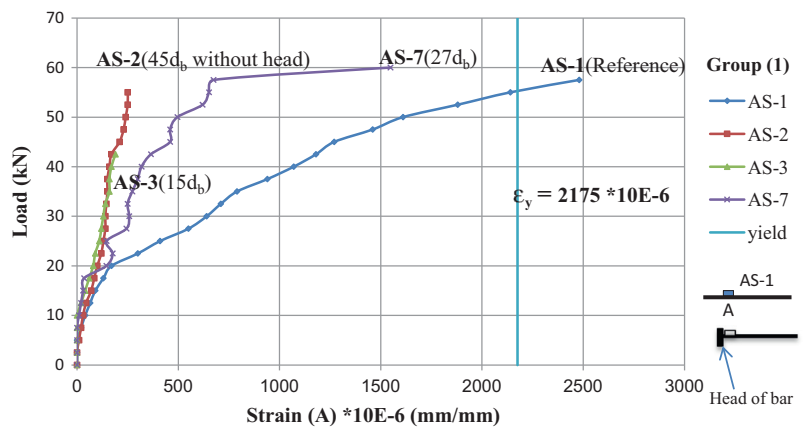
Figure 12 Load-steel strain curves for Group 1.

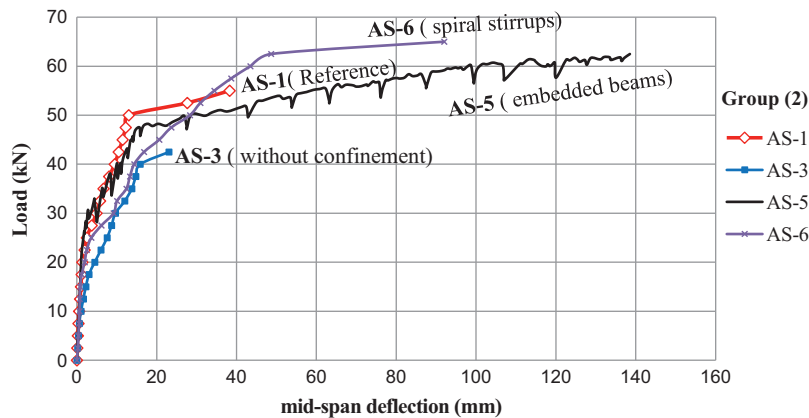
Figure 13 Load-deflection curves for Group 2.

Fig. 13 presents load-mid-span deflection relations for slabs of this group. The figure indicates that at all load value, the recorded mid-span deflection of slabs provided with confinement at the splice zone was less than that of slab AS-3 provided with no confinement. The strain energies calculated for the slabs of this group were 81%, 414%, and 284% for slabs AS-3, AS-5, and AS-6 respectively, of that of slab AS-1 (reference slab). Slabs AS-3, AS-5, and AS-6 failed at an ultimate load equal to 77%, 114%, and 118%, respectively, of that of slab AS-1 (reference slab). This indicates the enhancement of ductility and energy dissipation of slabs with confined lap splices. Fig. 14 shows load-strain at point A relation for the tested slabs in group (2). Strain readings indicated that steel did not yield until failure of slabs AS-3 (without confinement) and AS-5 (with embedded beams confinement), while for slab AS-6 (confined with spiral stirrups around lap splice) yield was recorded at a load value equal to 62.5 kN just before failure.

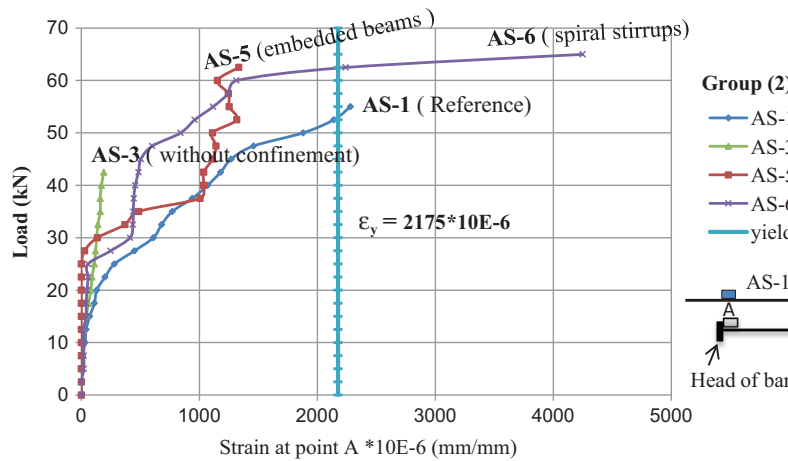
Figure 14 Load-steel strain curves for Group 2.

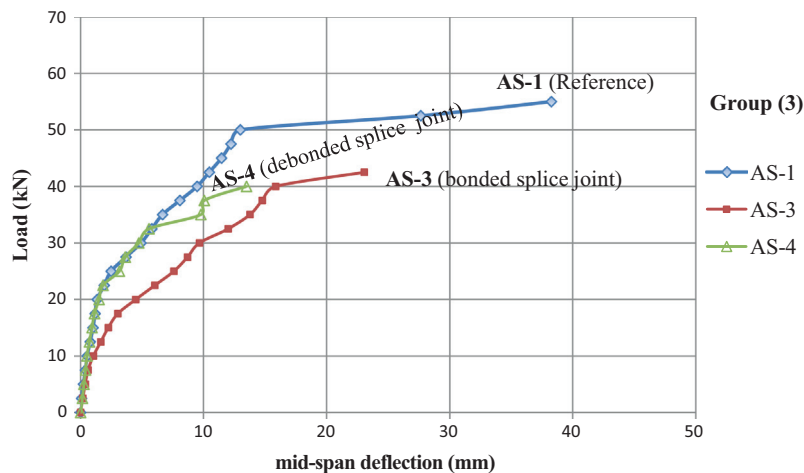
Figure 15 Load-deflection curves for Group 3.

Fig. 15 displays applied load–deflection at the mid-span relations for the tested slabs AS-1, AS-3, and AS-4. The figure shows that deflection of slab AS-4 (with debonded bars in splice zone) at failure was about 58% of that of slab AS-3 (with bonded bars in splice zone). These results indicated that elimination of bond between steel reinforcement and concrete in the lap splice zone decreased the maximum deflection at failure load and decreased the ductility. The strain energies calculated for the slabs of this group were 40%, and 24% for slabs AS-3, and AS-4 respectively, of that of slab AS-1 (reference slab). Slabs AS-3 and AS-4 failed at an ultimate load of 77%, and 73%, respectively, of that of slab AS-1 (reference slab). Fig. 16 shows the relationship between values of strain (at point A) near the head of bar and load for the tested slabs in group (3). Main steel bars did not yield till failure of the spliced slabs of this group. Although only one slab was tested

in this group, the head could not develop the force of the bars through the lap splice joint and the failure was sudden and brittle when compared with the bonded slab AS-3 with the same splice properties.

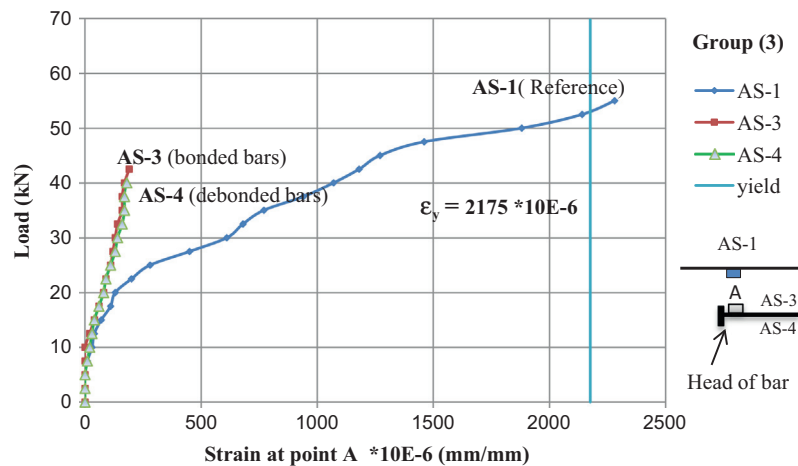
Figure 16 Load–steel strain curves for Group 3.

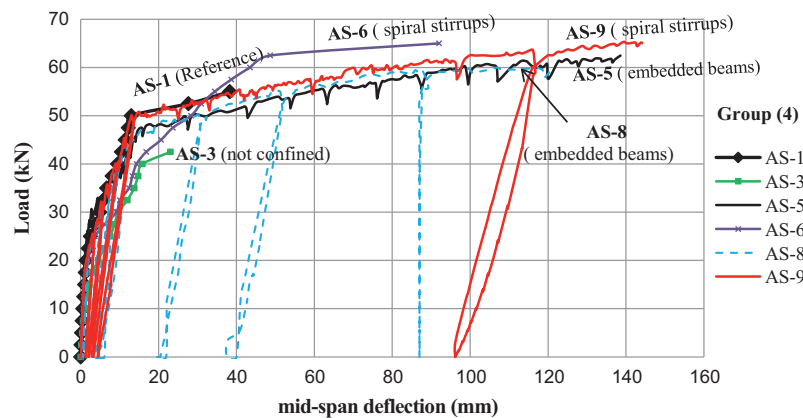
Figure 17 Load–deflection curves for Group 4.

Fig. 17 shows load–deflection at mid-span for the tested slabs AS-1, AS-3, AS-5, AS-6 (with monotonic loading), and AS-8, AS-9 (subjected to repeated gradually increasing loading). The figure shows that at any load level, the recorded deflection at mid-span of slabs provided with confinement at the splice zone and subjected to repeated loading was less than that of slab AS-3 without confinement and loaded monotonically. The calculated strain energies for each of the tested slabs were 40%, 414%, 284%, 423%, and 468% for slabs AS-3 (without confinement), AS-5, AS-6, AS-8, and AS-9 respectively, of that of Slab AS-1 (reference slab). Specimens AS-8 and AS-9 were able to properly dissipate energy, exhibited good ductility, and showed almost stable hysteric loops. The ultimate load values for these slabs were of 77%, 114%, 118%, 109%, and 124%, respectively, of that of slab AS-1 (reference slab). Fig. 18 shows the relationship between values of strain (at point A)

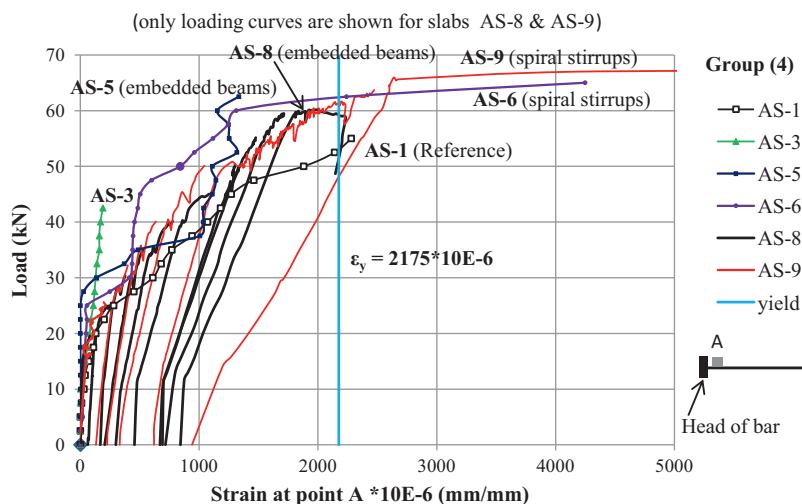
Figure 18 Load-steel strain curves for Group 4 (only loading curves are shown).

near the head of bar and load for the tested slabs of group (4). For Slab AS-8 (confined with embedded beams around the heads of the bars and subjected to repeated loading) yielding was recorded near the head (stain gauge at point A) just before failure at load value = 59 kN (about 98% of the ultimate load) in the last cycle, while for slab AS-9 (confined with circular spiral stirrups around lap splice), yielding was recorded near the head (stain gauge at point A) before failure at 61 kN (about 90% of the ultimate load) in the fifth cycle. This indicates that the confined head was capable of developing the full strength at the lap splice joint.
