XXIII Italian Group of Fracture Meeting, IGFXXIII

Innovative experimental techniques in the service of restoration of stone monuments - Part I: The experimental set up

S. K. Kourkoulis^{a,*}, E. D. Pasiou^a, D. Triantis^b, I. Stavrakas^b, G. Hloupis^b

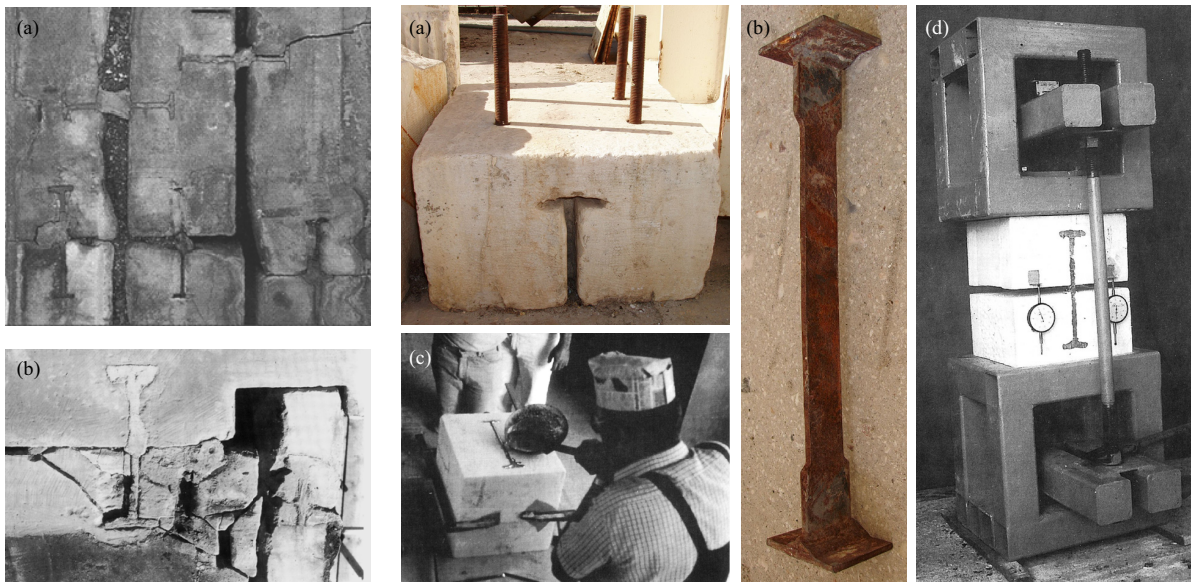
Fig. 1. (a) Typical “I”-shaped connectors; (b) fracture of the marble volume surrounding a typical connector.

During the passage of centuries, and as a result of the action of both corrosion and mechanical straining, the connections were damaged, leading the marble surrounding them to fracture (Fig.1b). Inevitably the restoration of damaged joints became one of the most serious problems that had to be confronted by the team of scientists working for the restoration/conservation of the monuments of the Acropolis of Athens [2,3] under the aegis of the “Committee for the Conservation of the Acropolis Monuments” (ESMA). Following the pioneering work of Angelides [4] and Skoulikidis [5] it was decided to substitute the steel connectors by new ones made of titanium, for a series of reasons covering the whole range of compatibility from chemical to physical and mechanical. The specific choice for the connectors’ material prohibits the use of lead as filling material of the grooves since the “titanium-lead” pair of metals forms strong galvanic element. As a result it was decided that in new connections a special cement-based product should be used as filling material [5]. Therefore in the restored connections the “Steel-Lead-Marble” (SLM) complex of the ancient Greek stonemasons is substituted by the “Titanium-Mortar-Marble” (TMM) one.

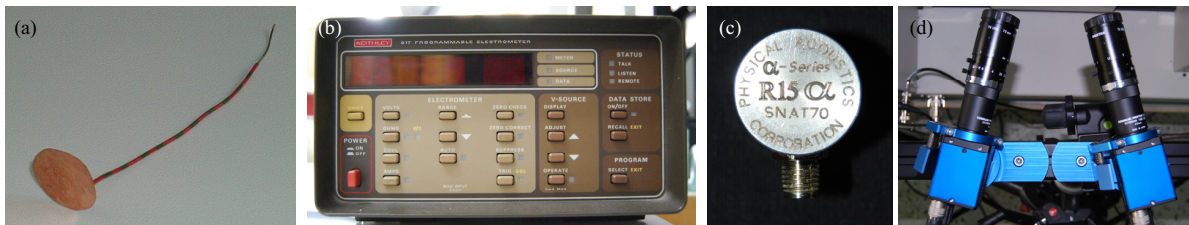
Fig. 3. (a) Typical electrode and (b) electrometer Keithley, 6517A used for the PSC technique; (c) typical R15 α acoustic emission sensor; (d) the two cameras of the digital image correlation technique.

In the present study, a pair of electrodes (Fig.3a) was attached on the front surface of the specimen very close to the region where marble's fracture is expected according to previous preliminary tests [7] and in-situ observations [2]. The measuring system employed consisted of a very sensitive programmable electrometer (Keithley, 6517A), Fig.3b, capable of resolving currents as low as 0.1 fA, and as high as 20 mA in 11 ranges. The data output from the electrometer were stored in a computer using a GPIB interface.

For the needs of the present protocol eight R15 α acoustic emission sensors (Fig.3c) with 150 kHz resonant (Physical Acoustics) were attached on the specimen with the aid of silicone. Preamplifiers with 40 dB gain were used. The specimens tested consist of three different materials however a uniform wave velocity vector was considered. This velocity was determined equal to about 1000 m/s and 500 m/s along the connector's axis (x-axis) and normal to it in the xy plane (y-axis) (Fig.4b), respectively, according to the results of a series of preliminary breakings of a pencil lead pressed against the specimen. The equipment and the software used were by Mistras Group, Inc.

A novel three dimensional DIC system (LIMESS Messtechnik & Software GmbH, Germany) was used in the present study (Fig.3d). The resolution of the cameras is equal to 1624x1234 pixels with an accuracy for displacements equal to 0.01 pixel. Since the full field displacement field on the front surface of the specimen was to be determined the 3D DIC active field was a rectangle of dimensions 53.0x37.5 cm² and the size of the pattern's dots was calculated equal to about 1 mm. The sampling rate was set equal to 1 photo per 6 s.

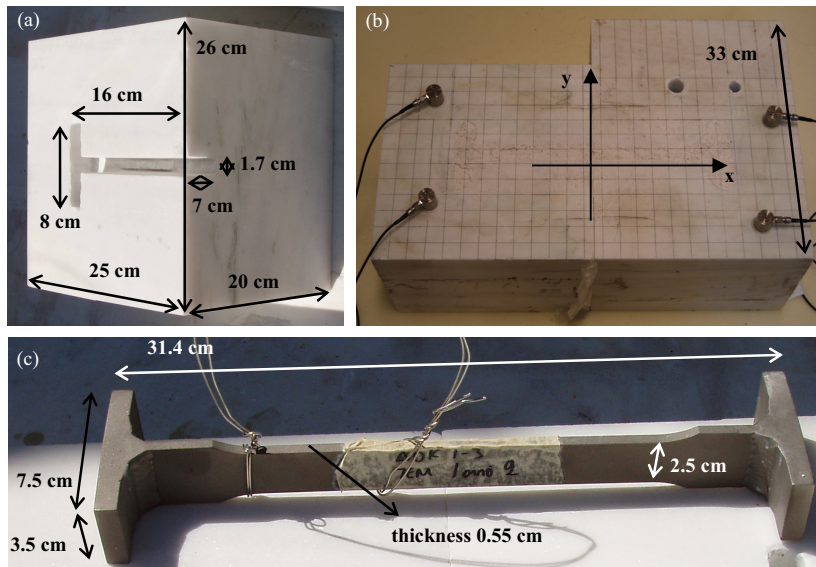
Fig. 4. (a) One of the two marble blocks and its dimensions; (b) typical specimen; (c) "I"-shaped connector.

The specimens used in the present study were prepared by the technicians of the Parthenon work-site on the Acropolis of Athens. They consisted of two parallelepiped marble blocks of dimensions equal to 25x26x20 cm³ and 25x33x20 cm³ (Fig.4a), one "I"-shaped titanium connector (Fig.4b) and suitable (cement-based) filling material. The construction of the specimens was realized according to the following procedure:

- A groove (mortise) of depth equal to 7 cm was sculptured in the blocks (Fig.4a)
- The connector was placed in the groove
- The cement-based material was prepared
- The groove was saturated with water, in order for the cement-based material not to lose water
- The filling material was poured in the volume between the connector and the marble blocks
- Two holes were drilled on the one marble volume for exerting the shear force. The holes were drilled on the block which is larger in its vertical dimension (along y-axis) compared to the other block. This asymmetry was considered necessary in order to avoid undesirable parasitic marble's fracture, around the holes during loading. In other words attention was paid for the distance between the holes and the block's upper surface to satisfy the requirement of a minimum distance from the free surface.

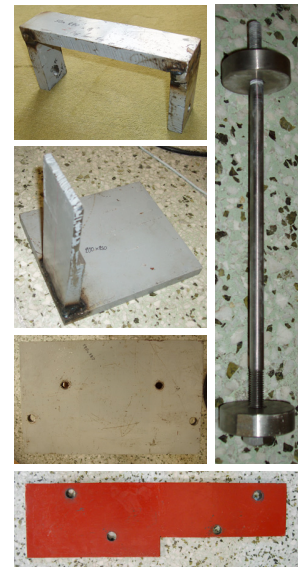
Fig. 5. Custom-made metallic devices.

For the minimization of the above parasitic phenomena non-commercial gripping and loading fixtures had to be designed and constructed. The solution favoured consisted of (Fig.5): (i) A rectangular rigid holding plate and two "T"-shaped metallic elements restricting the motion of the one volume of the specimens with the aid of six rigid threaded metallic bars (or tie rods). (ii) A "T"-shaped loading platen designed in such a way that the load to be exerted at the level of the metallic connector in an effort to reduce torsional moments. (iii) Two "IT"-shaped metallic elements keeping the loading platen in contact with the loaded volume of the specimen. (iv) Two titanium bars.

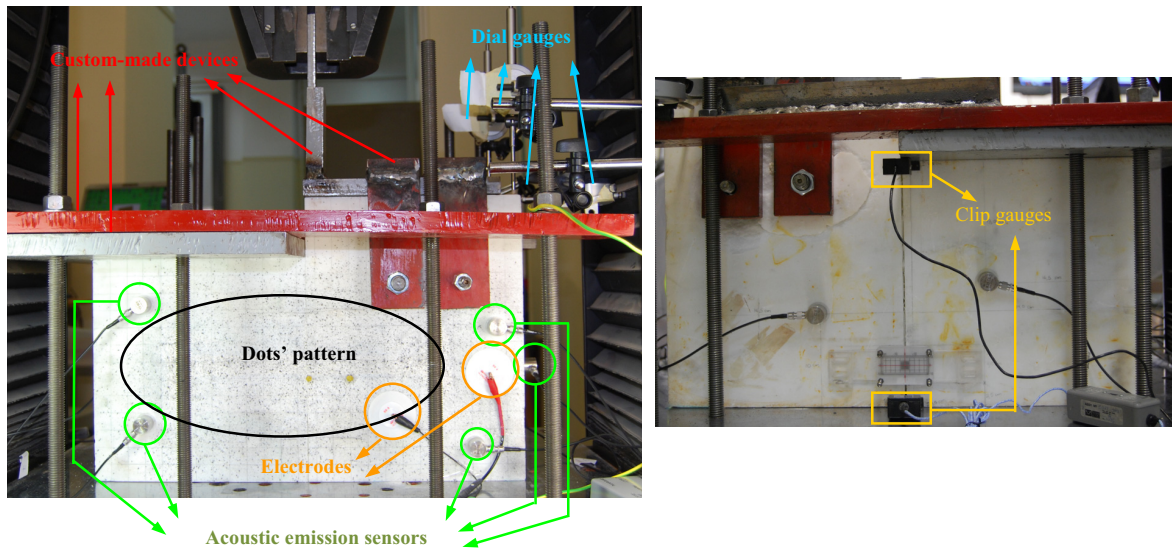
Fig. 6. The front side of a typical specimen on which the AE sensors, the electrodes and the dots' pattern can be seen (left); the back side of a typical specimen and the positions of the clip gauges (right).
