Procedia Engineering 154 (2016) 317 – 325

12th International Conference on Hydroinformatics, HIC 2016

# UAV photogrammetry for monitoring changes in river topography and vegetation

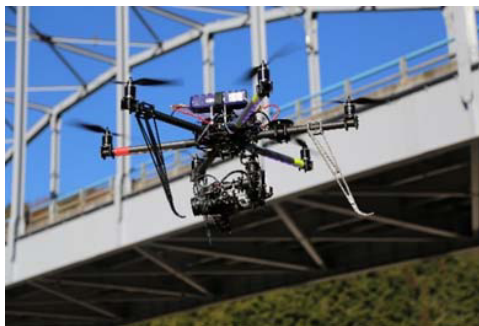
Fig. 1. UAV used in this study.

The UAV employed in this study is shown in Fig.1 and its specifications are explained in Table 1. It has six arms and rotors with a GPS and a gyro, which support autonomous flight. The UAV flew over a study area at 100 m above the ground at a speed of 4 m/s. It carried a camera of Sony alpha 7R with a 16 mm plastic lens, 35 mm glass

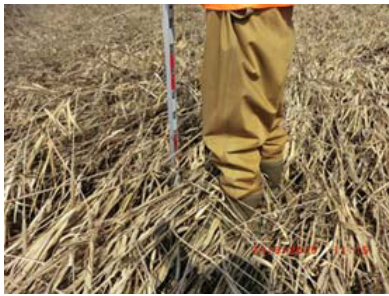
(b) Withered plants over sandbars.

We carried out UAV-photogrammetry in March 2015 before and after a man-made flood in the Jyoge River in Hiroshima Prefecture, Japan. Fig. 2 shows the location of the observation reach located downstream of the Haizuka dam. Fig. 2 explains that the reach consists of a main channel with sandbars covered with dense withered plants and a floodway with short grasses along the left bank. Two small irrigation channels run along the main channel.

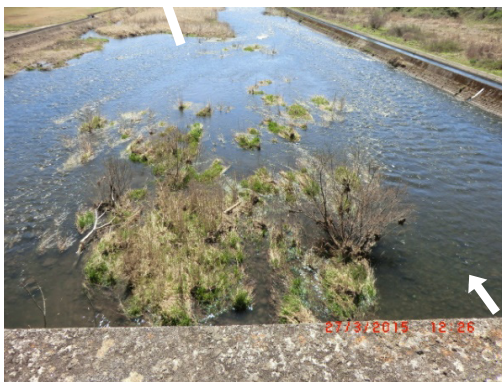
(a) Flow with emergent vegetation before the flood peak.

Fig. 3. The change in water depth and plants depending on the flood stage.

Fig. 3 (a) shows the flow conditions at the initial stage of flood, when the plants downstream of a bridge are emergent, whereas most of the vegetation in the main channel are submerged at the flood peak (Fig. 3(b)). It should be noted the flood did not inundate the floodway.

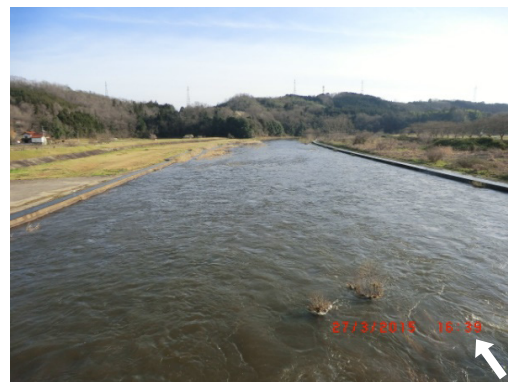
(b) Flow with submerged vegetation at the flood peak.

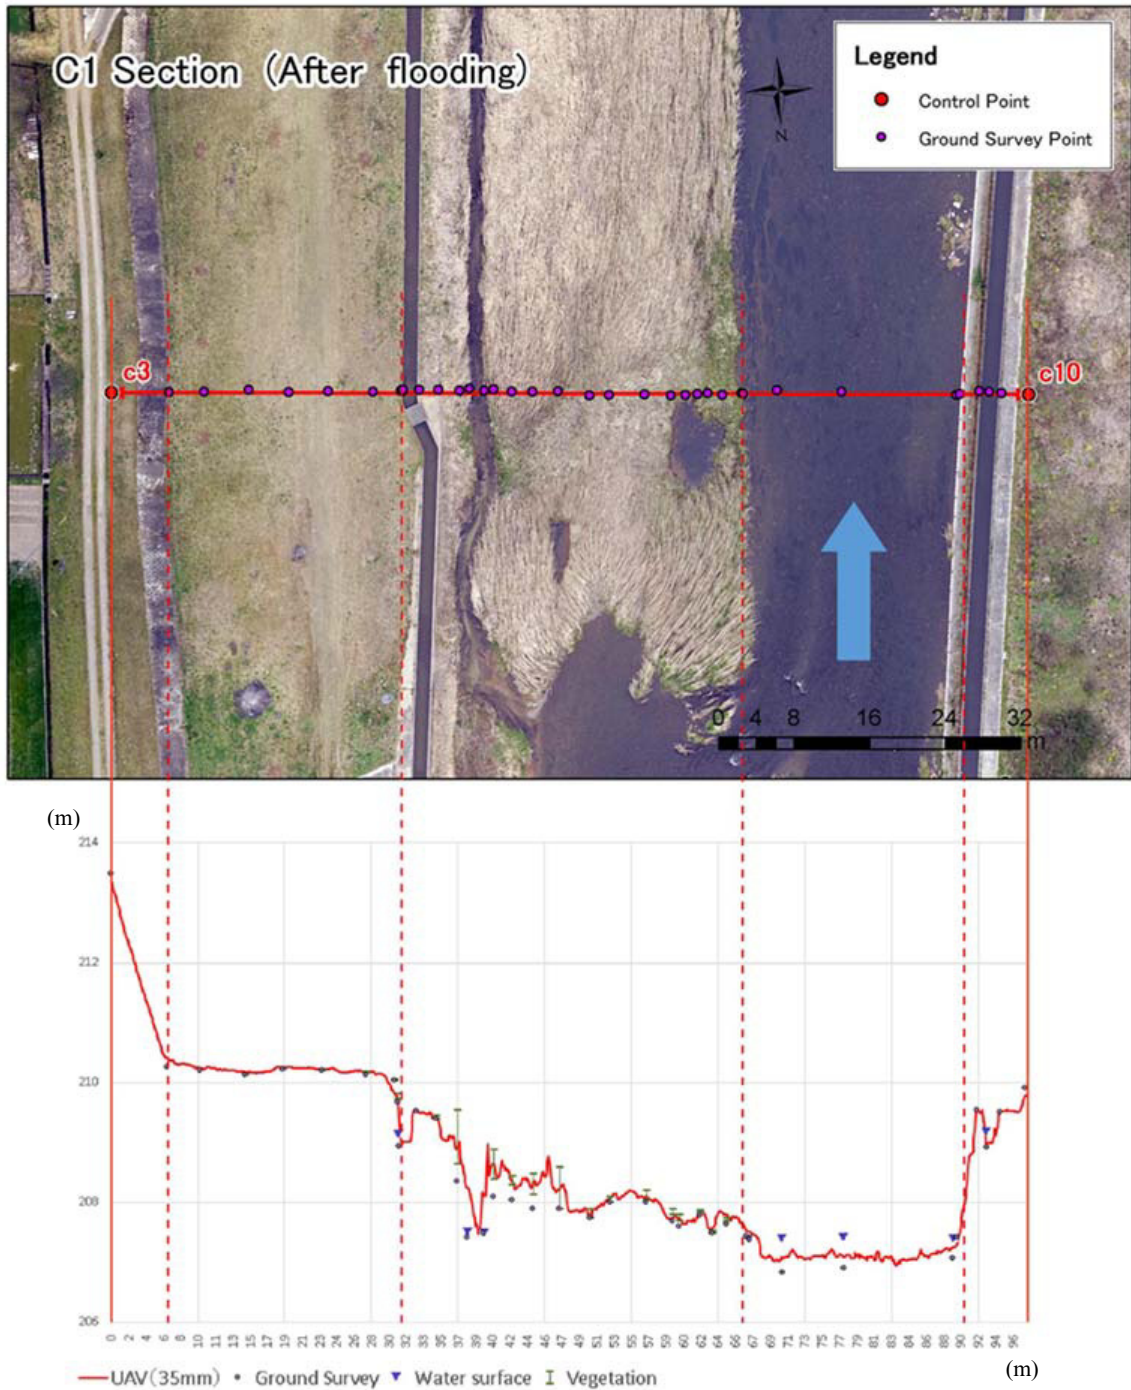
Fig. 4. Orthorectified image and comparison of the cross-sectional shape in C-1 section. The DSM by UAV-photogrammetry precisely captures the floodway ground and gives the level which lies between the vegetation top and bottom. The DSM fails to measure the submerged river bed elevation.

Fig. 4 provides a plan view of the target area and compares the river cross-sectional shape in C-1 section. The orthophoto in Fig. 4 gives a clear and detailed image of the river reach after the flood. The image of submerged river bed is clearly captured due to low concentration of suspended sediment. The comparison between the photogrammetric survey and the ground survey shows that the UAV-DSM creates nearly the same results by ground survey over the floodway where the vegetation grows short and less dense. The maximum difference was 7 cm with the averaged difference of 4 cm. The UAV-DSM, however, fails to detect the ground level over the bar simply because the vegetation was too thick, as shown in Fig. 2 (b). The vegetation height changes from place to place, which are represented in Fig. 4 using bars showing the highest vegetation and the shortest one. The comparison explains that the UAV-DSM gives the level of some vegetation top. The calculated bed level under water shows

reasonable profile with consistent difference from the reality.

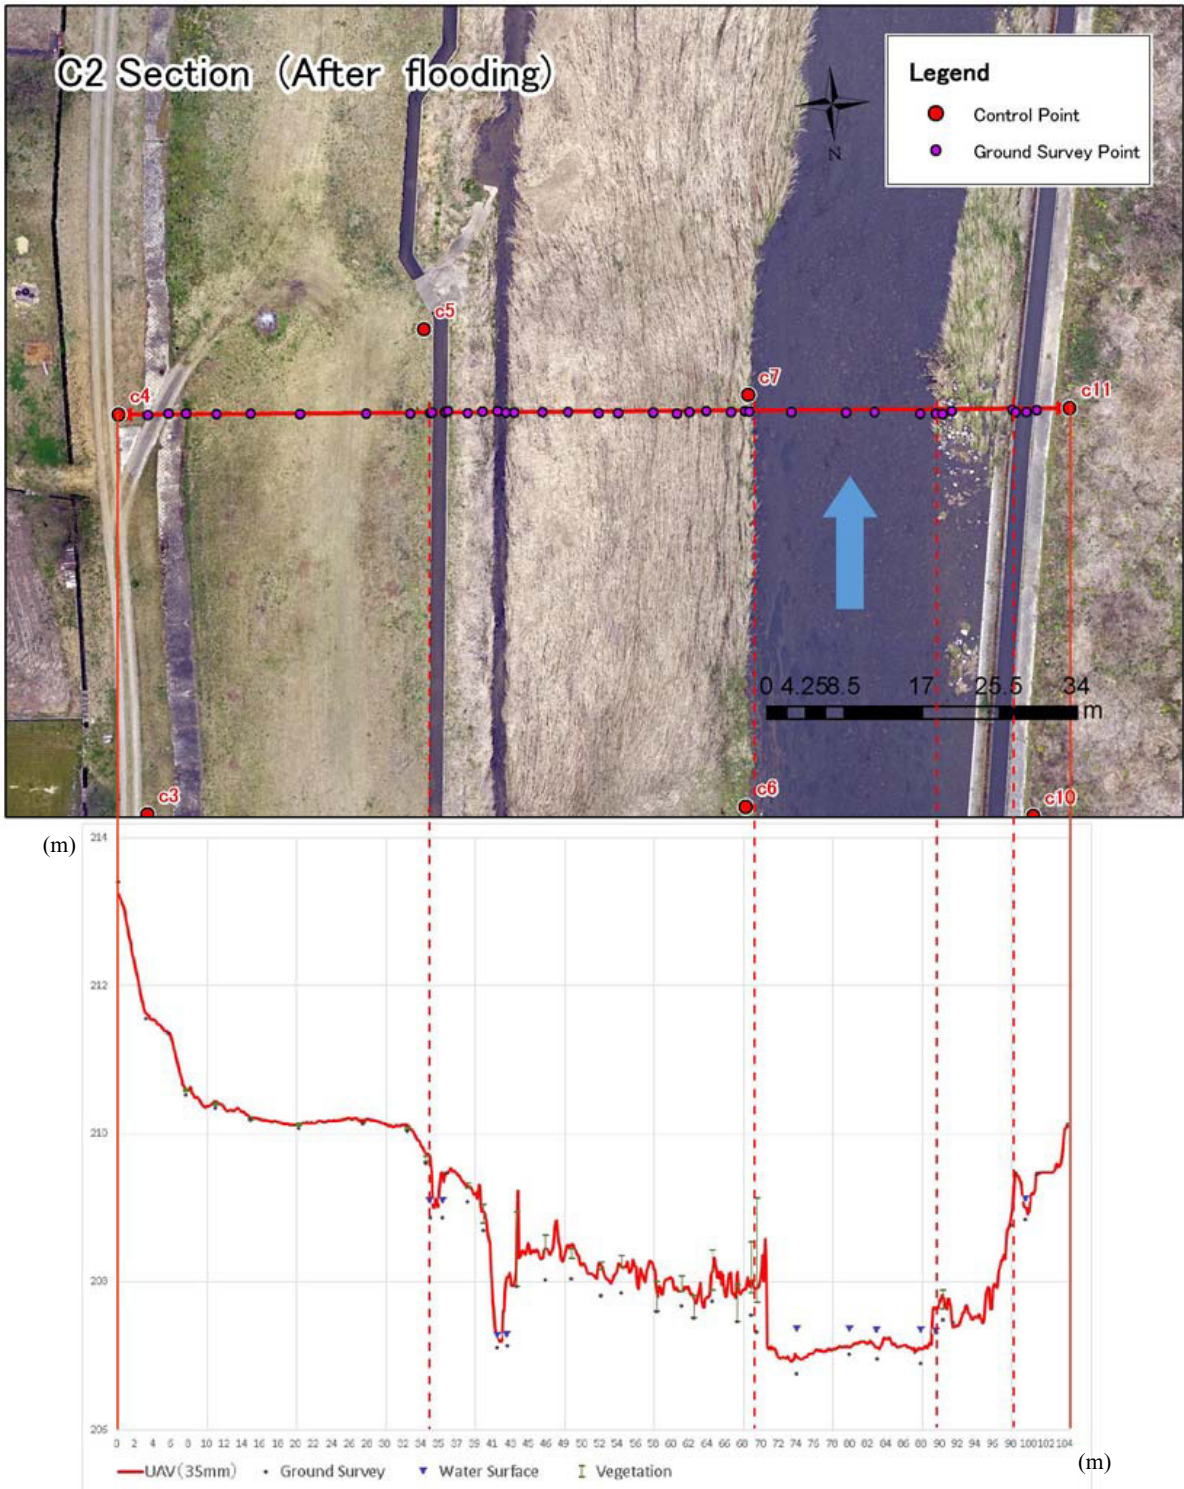
Fig. 5. Orthorectified image and comparison of the cross-sectional shape in C-2 section.

Fig. 5 gives an orthoimage of the reach and a detailed comparison on the river cross-sectional shape in C-2 section. The orthoimage in Fig. 5 is again obtained after the flood. The clear image shows nearly the same characteristics as in Fig. 4. Thus it can be said that UAV-DSM can give accurate ground level unless the vegetation hinders the ground from being detected by photogrammetry. Judging from the difference in elevation over the vegetated bar, the vegetation density is too high for UAV-photogrammetry to capture the ground level.
