# Shear Strength of Ice-Filled Rock Joints

Friederike K Günzel  
University of Brighton, Brighton, UK

## Abstract

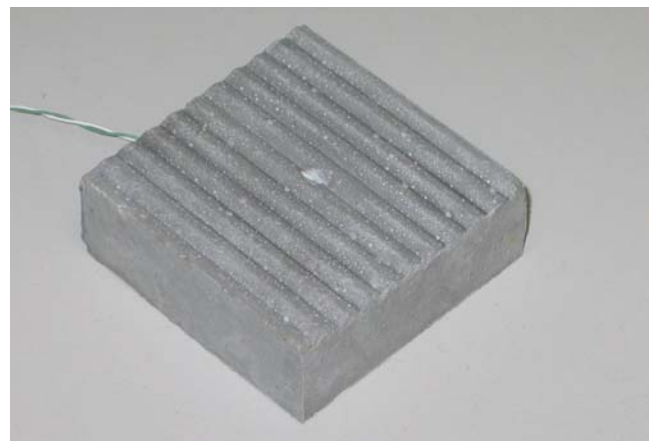
Figure 2. Concrete block with cast saw-tooth surface; the small cavity in the center holds the tip of the thermocouple.

A thermocouple was cast into the concrete samples with the sensitive tip in a small cavity at the centre of the sample surface (Fig. 2). This allowed the temperature of the ice to be measured during the shear tests.

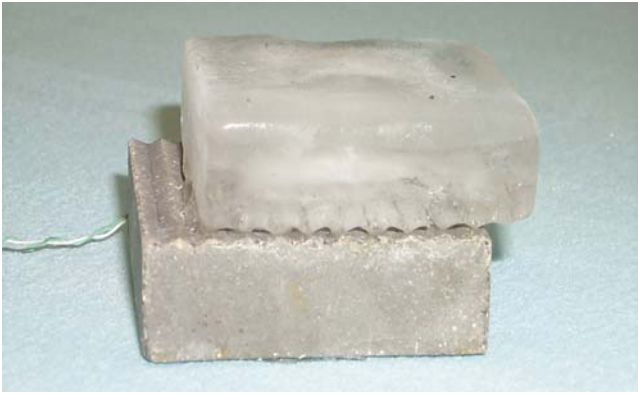
Figure 3. Concrete-ice sample after a constant strain test with normal stress = 207 kPa.

The concrete-ice samples consist of a concrete block with saw-toothed surface overlaid by an equally thick ice block (Fig. 3). This sample type simulates an ice-filled joint, with

interpreted as the ice becoming detached from the concrete surface, and the behaviour of the sample is mainly defined by the friction between surfaces of the ice and the concrete (Fig. 3). However, at high normal stresses, no dilation of the sample was observed (Fig. 11). Here the deformation of the sample is mostly due to a shear deformation of the ice itself rather than the sliding of ice over concrete. At the end of these tests, the ice was still firmly attached to the concrete surface (Fig. 12). No granularisation of the ice comparable

In the constant strain tests with concrete-ice samples at low normal stresses, the first type of deformation is predominant. Indicators for this type of failure are the extent of the dilation of the samples during the test (Fig.10) and the visual examination of the sample after the test (Fig. 3) that clearly shows the ice being detached from the concrete surface. However, the same sample type shows ductile deformation of the ice at high normal stresses. Here the samples show no net dilation during the test (Fig. 11); any local dilation that may be present in the sample is counteracted by the ductile deformation of the ice, which is clearly visible in the sample after the test (Fig. 12).

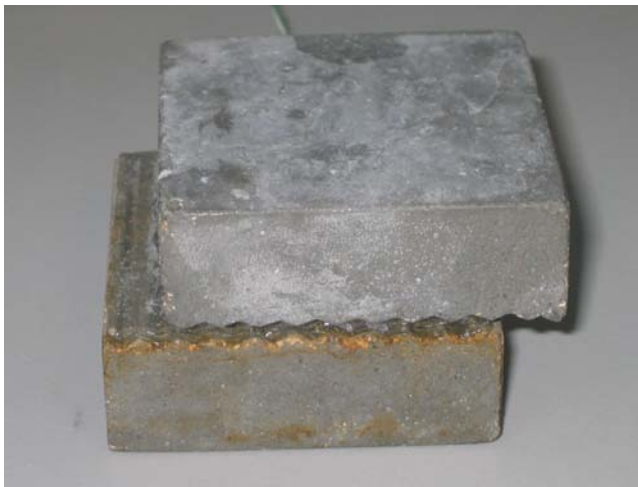
Figure 4. Sandwich sample after a constant stress test with normal stress = 207 kPa.

The sandwich samples consist of two saw-toothed concrete blocks with a 1mm thick layer of ice in-between

(Fig. 4). This sample type simulates an ice thickness equal to the amplitude of the surface roughness. These samples are prepared as illustrated in Figure 5. The two concrete blocks are immersed in water in a mould. A bolt is glued to the top block. The top block is then lifted by turning the nut against the lid of the mould while the movement is measured with an LVDT (Linear Variable Displacement Transducer). After that, the surplus water on top of the sample is drained, and the sample is frozen.

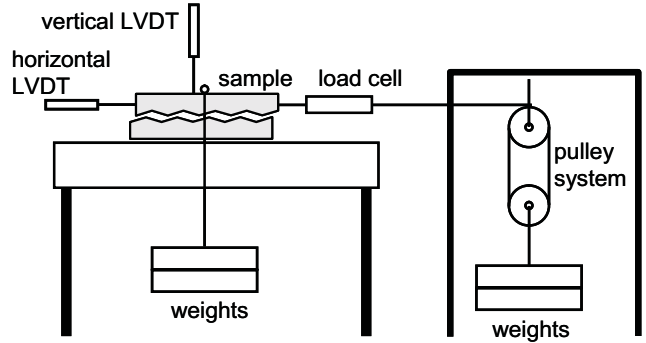
Figure 6. Schematic overview over experimental set-up of the constant strain test.

Two different modes of direct shear tests were carried out in this study: constant strain tests and constant stress tests. Schematic overviews of both testing modes are shown in Figures 6 and 7. Normal stress is provided by hanging weights. Horizontal and vertical displacements are measured with LVDTs.

In the constant strain tests, shear stress is applied by an electric motor pushing the upper part of the sample while the lower part remains stationary. The shear stress is measured with a load cell. These tests were carried out at -2°C and -4°C, with normal stresses ranging between 135 kPa and 620 kPa. This is equivalent to a depth of 5–25 m below ground. This depth is above the range of the annual freeze-thaw depth of 5±2 m in the Alpine periglacial belt reported by Matsuoka et al. (1998). However, with increasing air temperatures, the freeze-thaw depth can be

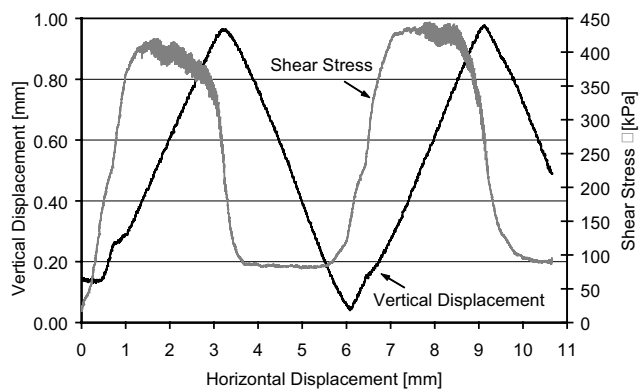
Figure 8. Vertical displacement and shear stress vs. horizontal displacement of a shear experiment without ice (normal stress = 207 kPa).

To establish the frictional resistance of the concrete samples without ice, direct shear tests were carried out with normal stresses between 135 kPa and 620 kPa. The typical response of a sample is shown in Figure 8. Here the shape of the saw tooth surface is clearly visible from the vertical displacement. The development of the shear stress follows the same pattern with the maximum shear stress during the uplift of the top sample.

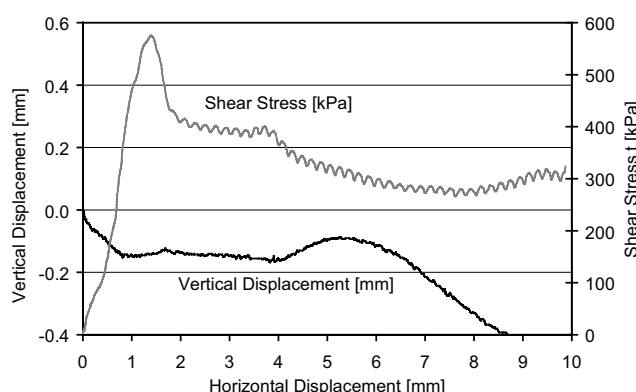
Figure 11. Results of a shear experiment at constant strain with a concrete-ice sample. Temperature = -4°C, normal stress = 562 kPa.

A total number of 26 constant strain tests were carried out at two different temperatures: -2°C and -4°C. Depending on the normal stress, the vertical displacement during the test showed different behaviour (Figs 10,11): at low normal stresses, the vertical displacement clearly reproduces the shape of the saw-toothed surface, albeit with a slightly reduced amplitude (Fig. 10). This behaviour can be

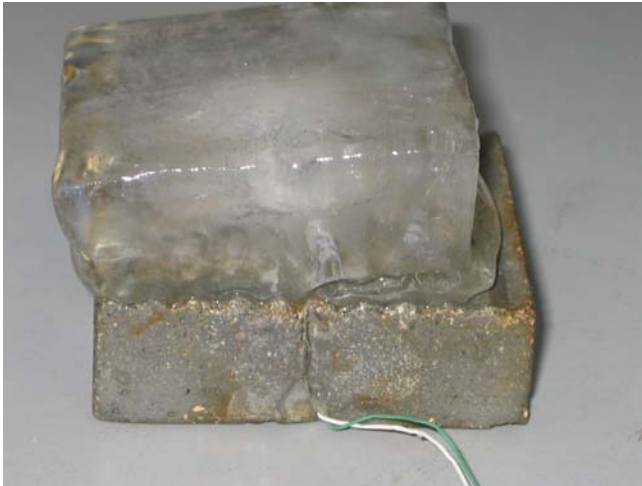
Figure 12. Shear deformation of a concrete-ice sample after a constant strain test with normal stress = 490 kPa.

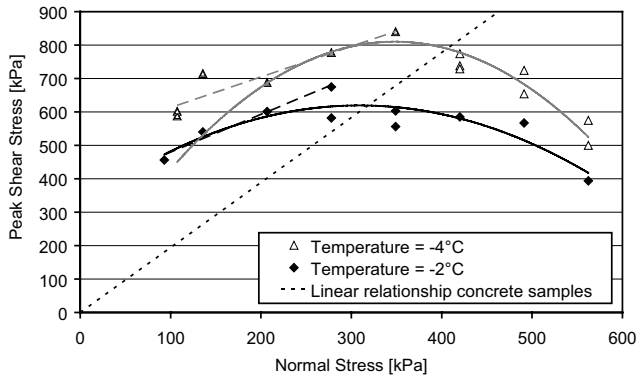
Figure 13. Peak shear test results from concrete-ice samples in constant strain tests.

The two different mechanisms of deformation also become apparent in the relationship of maximum shear stresses and normal stresses at failure (Fig. 13): at low normal stresses, the relationship between maximum shear stress and maximum normal stress appears to be linear (dashed lines in Fig. 13), which is in agreement with the behaviour of mineral-filled rock joints (Barton 1974). However, at normal stresses, above 220 kPa and 300 kPa for -2°C and -4°C, respectively, this relationship becomes parabolic. This result agrees with the parabolic strength envelopes of ice found by Fish & Zaretsky (1997).

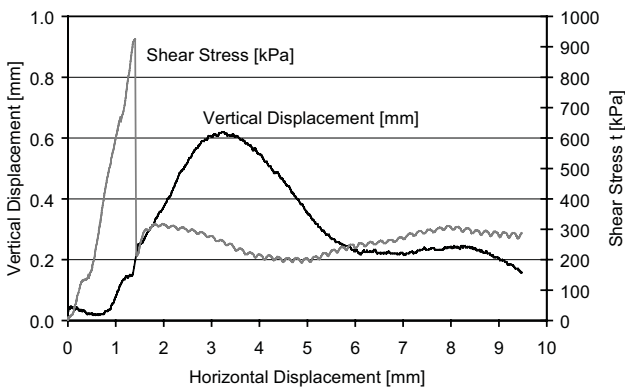
Figure 14. Results of a constant strain shear experiment with a sandwich sample at -5°C (normal stress = 490 kPa).

The constant strain tests with sandwich samples were carried out at -2°C and -5°C. Unlike the concrete-ice samples, the sandwich samples dilated even at high normal stresses (Fig. 14). It is also noticeable that the shear stress maximum forms a very sharp peak with a sudden drop when the ice becomes detached from the concrete surface. Again, the initial stiffness of the sample is very similar to the stiffness of the concrete-ice samples. Due to the sharp peak, a considerable scatter of the maximum strength at failure is to be expected (Fig. 15). It is unlikely that the scatter is enhanced to a large extent by the sampling rate: the shear stress increased with a rate of approximately 10 kPa per minute, so that with a one-minute sampling rate, the error would be not more than 10 kPa. Despite the large scatter, a decrease of the maximum shear stress with increasing normal stress can be observed.

combination of the first two failure modes is observed. Visual examination of the samples showed the ice detached from one of the concrete surfaces. However, these samples show a reduced dilation of 0.4mm–0.6mm (Fig. 14) indicating that sliding of the ice over the concrete surface is not the only type of deformation in these samples. The other type of deformation may be shear deformation of the ice itself. The maximum shear strength reduces with increasing normal stress (Fig. 15), again indicating shear deformation of the ice.

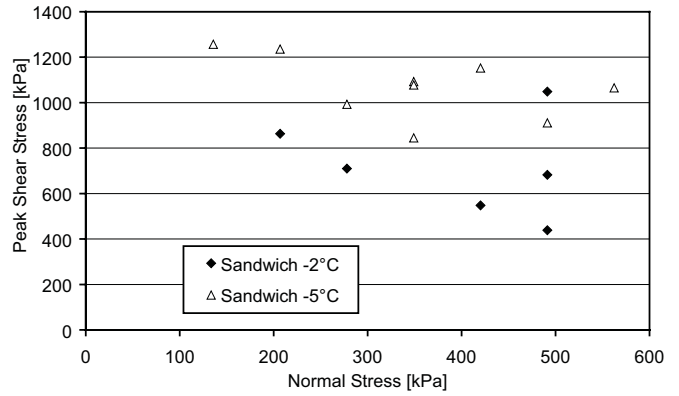
Figure 15. Overview of peak shear test results of sandwich samples in constant strain tests.
