9th International Conference „Bridges in Danube Basin 2016“, BDB 2016

Loading test of the Rákóczi Danube bridge in Budapest

Nauzika Kovács^{a,*}, Balázs Kövesdi^a, László Dunai^a, Bence Takács^b^a*Budapest University of Technology and Economics, Department of Structural Engineering, Műegyetem rkp 3., Budapest, 1111, Hungary*^b*Budapest University of Technology and Economics, Department of Geodesy and Surveying, Műegyetem rkp 3., Budapest, 1111, Hungary*

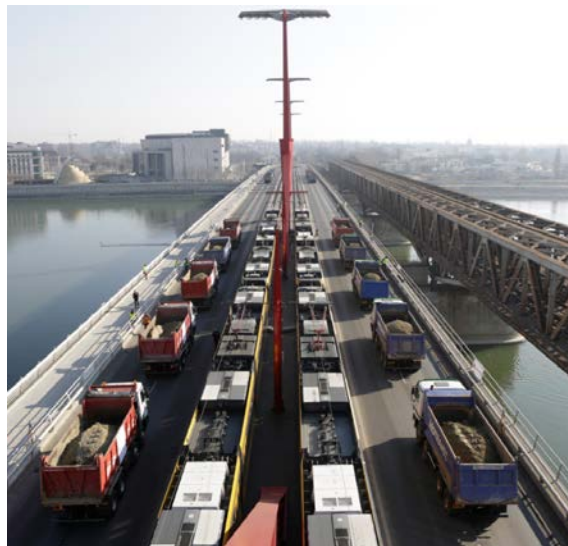
The applied trams have been loaded by sand bags simulating the effect of passengers. The applied sand bags substituted the effect of 221 people (maximum allowed on this tram) with the average weight of 70 kgs. The sand bags were uniformly distributed along the trams, therefore the maximum axle loading did not exceed $100 \text{ kN} \pm 5 \text{ kN}$. The loading of the trams and the trucks represented in one span of the bridge 17 kN/m uniformly distributed load over the tramway lanes and $12 \times 350 \text{ kN}$ (4200 kN) concentrated loads on the traffic lanes. The applied static load level during the loading test was 67% of the design traffic load level of the bridge. The bridge had a previous loading test in 1995. That time the applied load level was 75% of the design traffic load, but concentrated above the carriageway. In the current test program the loads are concentrated in the region of the tramway lanes, above the structural elements which were not tested at the previous loading test program. A typical load case can be seen in Fig. 2 focusing on the combined loading of trams and trucks in the same time.

Fig. 2. Typical loading situation during the loading test using 12 trucks and 4 trams in one span.

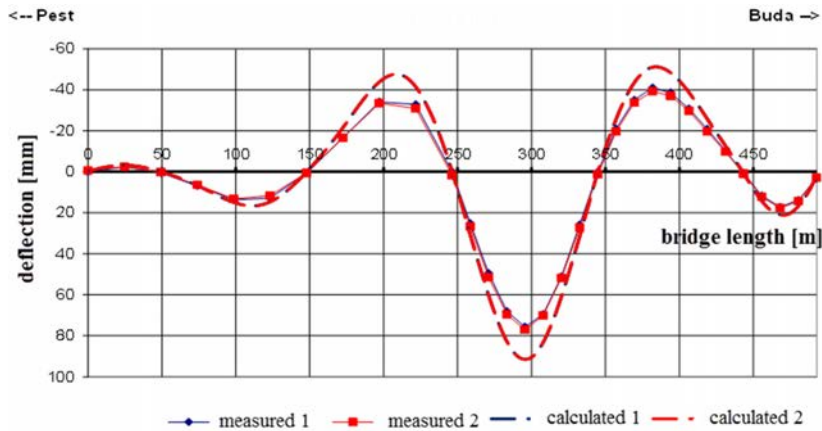
To be able to compare the measured results to the calculated values a detailed finite element model was developed. All the structural elements contained on the shop-drawings are implemented in the numerical model (all the stiffeners, ribs, diaphragms) using shell elements. On the detailed and realistic FE model the deformations and stress distributions under the applied loads were determined and studied. Based on the measured deflections it was concluded that the measured tendencies gives good agreement to the calculated results. The measured deflections in all load cases were smaller than the calculated values, its ratio varied between 70-88%. The maximum deflection of the cross girders is 9,2 mm and the maximum deflection of the side spans is 19,4 mm, while the maximum value for the internal spans is 78 mm. The maximum residual deformation of the superstructure did not exceed 10% of the measured maximum deflection, which fulfills the requirements of the relevant Hungarian standards [1] and [2]. It has to be mentioned that this loading test was not the first loading of the structure, therefore no large residual deformations were expected before the measurements. During the load testing an intensive temperature increase could be observed, which caused significant additional deformation in the bridge structure. The main part of the measured residual deformations were caused by this temperature increasing effect, thus the residual deformations were developed continuously during the load testing, what is the typical effect of temperature increase. A typical deflection shape can be seen in Fig. 4.

Fig. 4. Typical measured deflection shape.

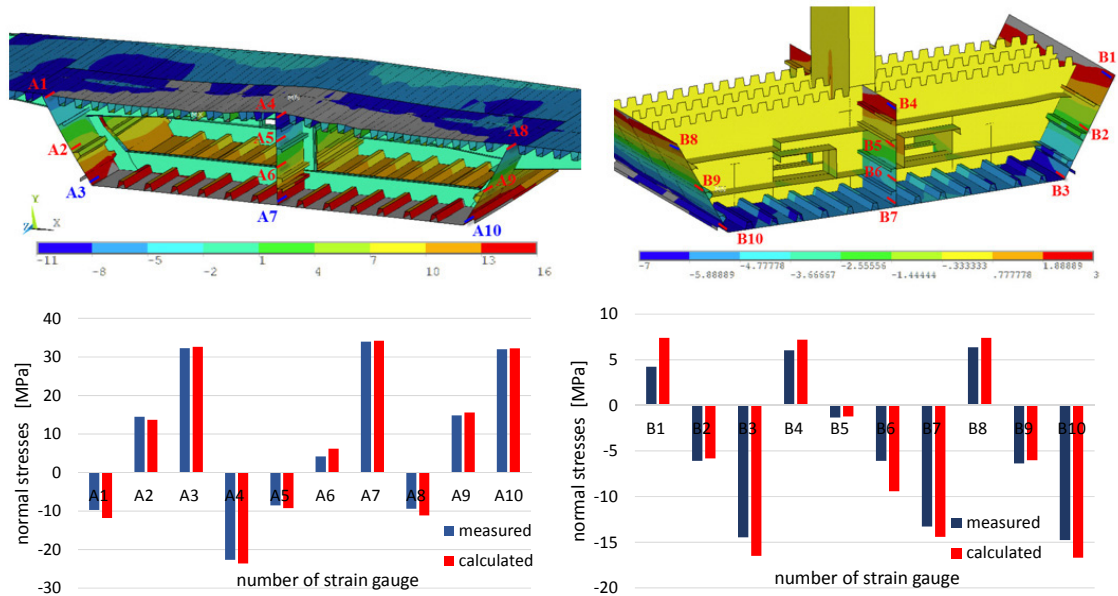
To be able to evaluate the results of the measurements and to check the structural behavior of the superstructure the measured stresses are compared to calculated values. The developed numerical model is a full shell model, with that the comparison of the measured and calculated stresses could be made with large accuracy. Two typical stress distribution diagrams are presented in Fig. 6 for the mid-span and for the internal support region. The diagrams compare the measured and calculated stresses during the test load. The two diagrams in Fig. 6 proves, that a good agreement was found between the measured and calculated values in the main girder and as well as in the cross girders and in the bridge deck system.

Fig. 6. Typical stress distribution diagrams and comparison of measured and calculated stresses.

The measurements proved that the bridge structure behaves as it is supposed in the static calculations and it proves the applicability of the developed FE model and the designed behaviour of the bridge. The measured stresses on the box girder proved that the global static behavior of the bridge under the trams is similar as assumed in the static calculations, the real stress values are very closed to the computed values. However the measured stress extreme values also proved, that the bridge deck system is adequate to the static, stability and fatigue verifications as well under the planned tramway line.

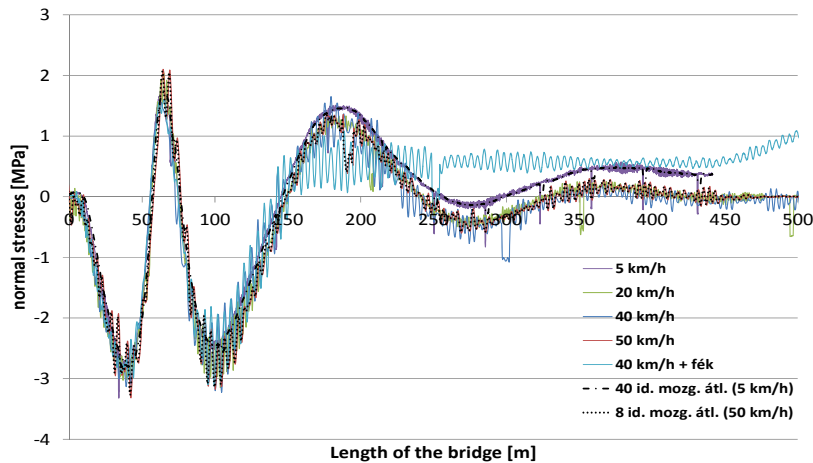
The dynamic test program contained many load cases using 4 trucks and 1 or 2 trams separately. All load cases were applied with different velocities between 5 – 60 km/h, as presented in Table 1. The program has three independent parts. In the first part 4 trucks were moved parallel on the bridge in 5 runs with different velocities (5-20-40 and 50 km/h). The braking and acceleration of the trucks are investigated during the test. In the second and third part 1 or 2 trams were moved on the bridge with different velocities between 5 - 60 km/h and the braking and acceleration of the trams were also tested. The strains during the dynamic loadings were continuously measured on the 109 strain gauges with 50 Hz frequency (which is significantly larger than the eigenfrequency of the structure). A typical measurement result under the dynamic loading can be seen in Fig. 7. The typical vibration in the measured stresses can be clearly seen on the diagram, what is the bases of the dynamic factor determination.

Fig. 7. Typical result of the dynamic loading test.

The largest dynamic factor of the main girder is measured under the loading by the 4 trucks with the velocity of 50 km/h and its value is 1.10. The largest dynamic factor caused by the Combino trams is significantly smaller (1.05). The maximum dynamic factor measured on the cross girders is 1,15 caused by the trucks and 1,06 caused by the trams. The largest dynamic effect is observed on the pilon and in the internal support region. The maximum measured dynamic factor is 1.24 due to the trucks and 1.08 due to the trams. The measurements proved that the trucks give the ultimate loading condition for the dynamic factors, which means that by opening the new tramway line increase in the dynamic effects are not expected on the bridge. Based on the measured results the final conclusion could be drawn, that the trams caused at all the measured locations in all the tested runs significantly smaller dynamic effects than the

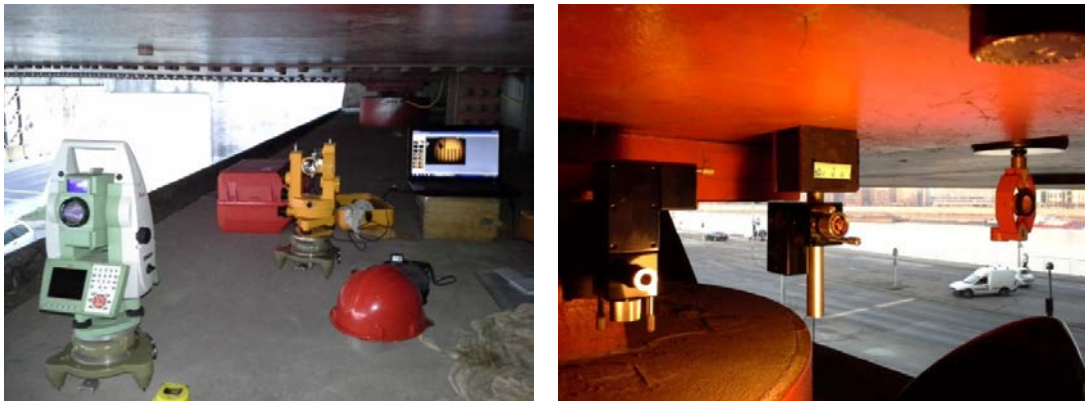
Measurements are also executed at the bearing system of the bridge. The horizontal movement of the bridge superstructure on the bridge abutment was measured. In order to increase the accuracy and confidence of measurements, three independent measurement techniques are applied. The first technique is based upon a total station with automatic target recognition (ATR) function. The instrument is able to automatically track and measure the prism with 10 Hz frequency, the actual frequency of measurements was about 6-7 Hz. The prism was fastened on the bridge superstructure and the total station was set up on the abutment. The distance between the total station and the prism was about 1.9 m, therefore 1 mm displacement corresponded to 109 second rotation. According to the specification of the instrument the accuracy of angle measurement and automatic target recognition together is about ± 1.4 second. It means, that the accuracy of the displacement measurements is about ± 0.01 mm. The arrangement of instruments are shown in Fig. 8.

Fig. 8. Layout of the measuring station: a) theodolite and digital camera, b) laser interferometer.

The second measurement technique is a classical alignment measurement. A piece of a steel tape is placed on the bridge structure along the expected direction of displacement. A digital microscope camera was attached to the telescope of the theodolite, and the view of the telescope was recorded in a digital video film. The video was split into digital images, the frame frequency was 15 fps. As the bridge moved, the image of steel tape moved as well compared to the crosshairs in the diaphragm of the theodolite. Based on the movement of the digital pictures the displacements could be evaluated automatically by digital image processing techniques. For the evaluation process a template matching algorithm of the software OpenCV [4] was used. The accuracy of this measurement method is less than ± 0.01 mm. The third technique is to measure the distance variation of two points by laser interferometer. The reference mirror was recorded during the moving of the bridge. The accuracy of our laser interferometer (Renishaw XL-80) is at least ± 0.001 mm, the frequency of measurements was set to 10 Hz. Our conclusion was that all the three methods could be used effectively, and resulted the same displacement with relative large accuracy.
