Journal of Rock Mechanics and Geotechnical Engineering

Full length article

Monitoring result analyses of high slope of five-step ship lock in the Three Gorges Project

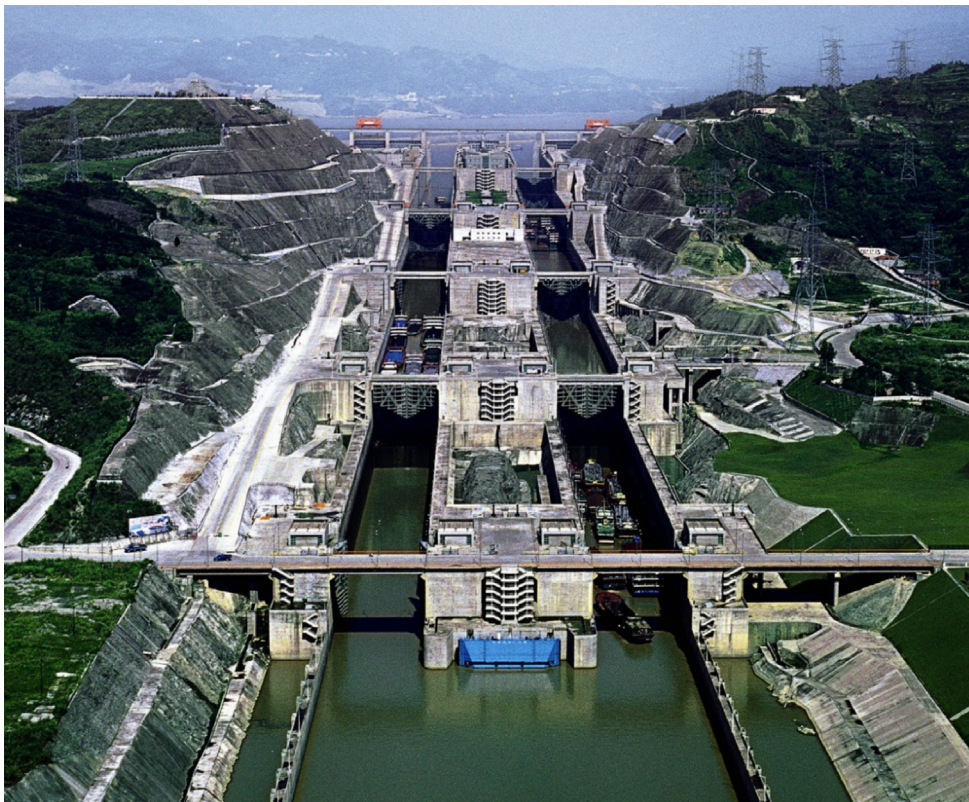
Fig. 2. Photo of the high slope of the double-lane five-step ship lock of the TGP.

addressed and the slopes deformation of these should be strictly controlled in order to satisfy normal operation of the miter gate of the ship lock (Fan, 2004; Fan et al., 2011). The typical section and photo of the lock chamber of the double-lane five-step ship lock is shown in Figs. 1 and 2, respectively.

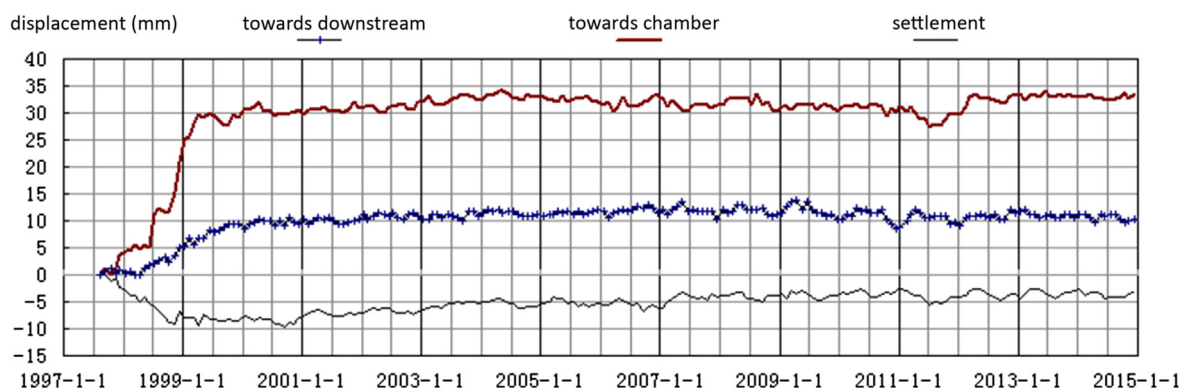
Fig. 3. Displacement of the measuring point TPBM68GP01 at elevation 160 m at the north of central pier top.

complicated deforming behaviors of the central piers. Typical deformation curves of central piers are shown in Fig. 3.

It can be seen from Fig. 3 that there are significant differences in magnitude and direction of displacement along the direction of lock chamber at different parts of the central piers. Most of the monitoring points at the south of the central piers deform towards south and the ones at the north towards north. Between the second and third lock heads, the direction of displacement at some parts of the central piers is the same. In December 2014, the measured displacements of the central piers towards the lock chamber were -19.49 to 33.59 mm and -5.89 to 23.76 mm at the north and south, respectively.

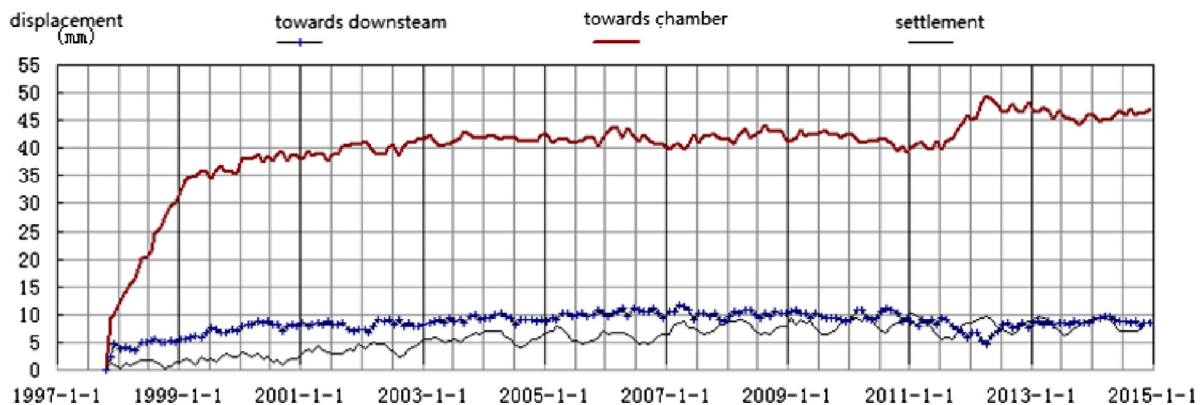
Fig. 4. Displacement of the measuring point TPBM94GP02 at elevation 168 m bench of the south slope.

The south and north slopes mainly deform towards the chamber (the direction of free face), with the horizontal displacement towards the lock chamber much greater than the horizontal and vertical displacements along the direction of water flow. The typical deformation curves of the south slope are shown in Fig. 4.

The horizontal displacements of the north and south slopes towards the lock chamber slightly decrease with reduced elevation. By April 1999 when excavation was completed, the displacements of the north and south slopes towards the lock chamber were 9 – 39 mm and 4 – 53 mm, respectively; and the displacements of the slopes top towards the lock chamber were 11 – 27 mm and 4 – 35 mm, respectively. After that the displacements of the slopes increased slightly. By December 2014, the maximum displacements of the south and north slopes towards the lock chamber were

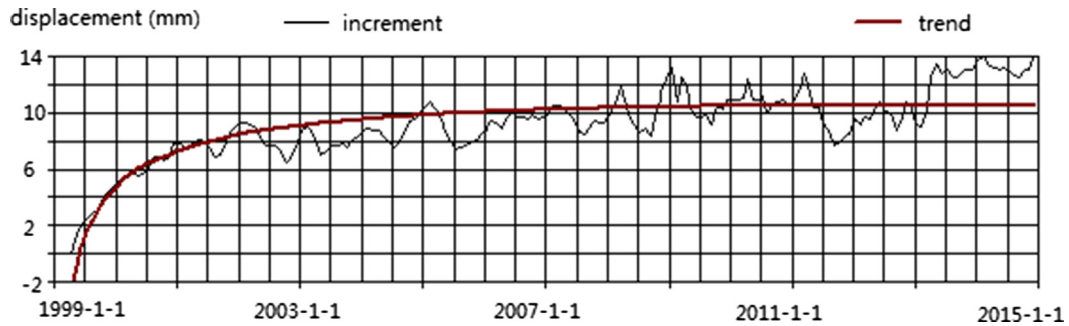
Fig. 5. Trend value of displacement at elevation 139 m on the top of north upright slope at the stake 15+787.

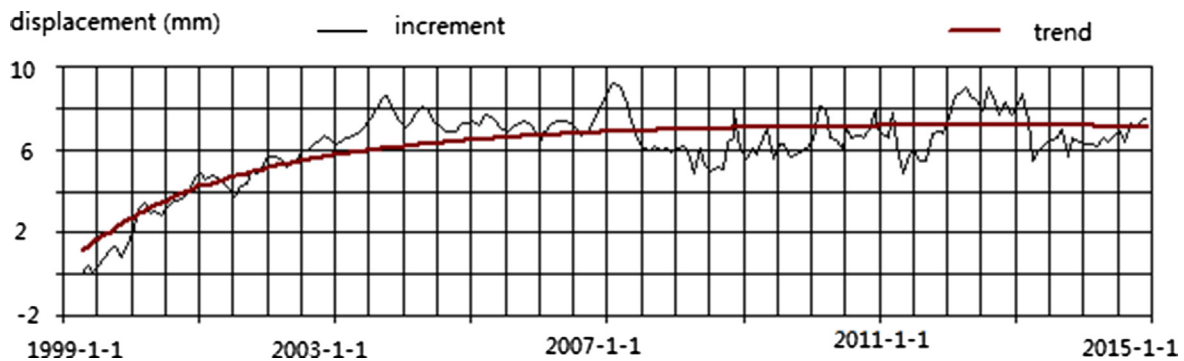
Fig. 6. Trend value of displacement at elevation 155 m on the top of south upright slope at the stake 15+770.

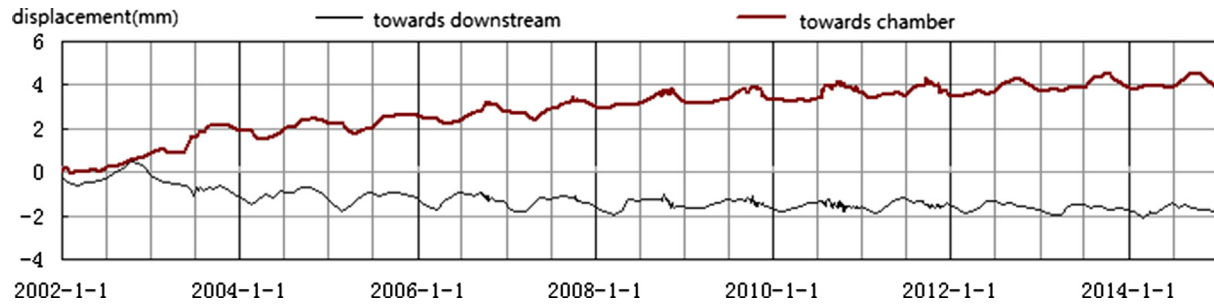
Fig. 7. Correlation curves of horizontal displacement on the top of lock head I.

The normal and inverted plumb lines at each lock head subsequently began to work between September 2001 and August 2002. By the end of December 2014, the measured deformation at lock heads is shown in Table 2, and the typical curves are shown in Fig. 7.

Table 2 and Fig. 7 show that the displacement at the bottom of the lock head is smaller, with the value of –1.5 to 1.5 mm. The displacement at lock head top is –0.83 to 7.27 mm towards the lock chamber, and –3.93 to 7.71 mm towards the downstream direction. The deformation of the lock head does not affect the opening of the miter gate of the ship lock. In contrast, the measured deformations of the 5th and 6th lock heads are slightly greater and change periodically with temperature. This is mainly associated with the characteristic of mixed structure of abutment piers. The annual variation of displacement towards the lock chamber, induced by change of temperature, is approximately within 2 mm. Reservoir impoundment and lock filling and discharge have a slight effect on the displacement of lock head top.

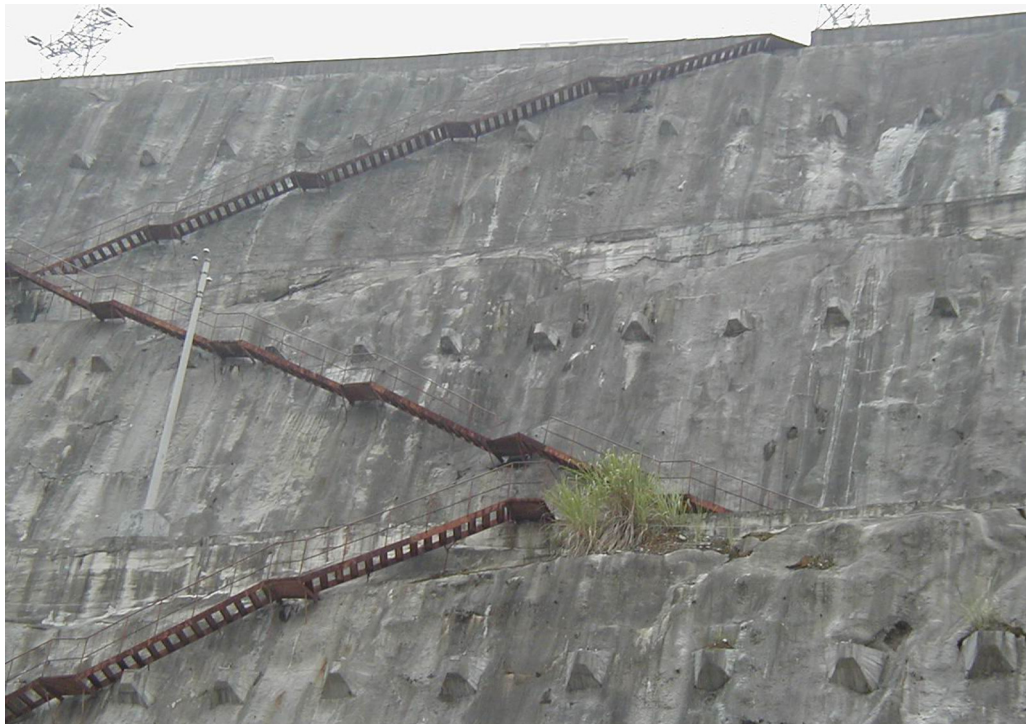
Fig. 8. Photo of anchor cables laid out at the high slope of double-lane five-step ship lock.

of 3000-kN two-ended anchor cables were utilized to reinforce the slopes. In addition, a great number of blocks that have the potential of instability were encountered during excavation of the stage II at the upright slope of the ship lock. To enhance the stability of these blocks, 1309 sets of 3000-kN end anchor cables and 528 of 3000-kN two-ended anchor cables were arranged (Fig. 8).

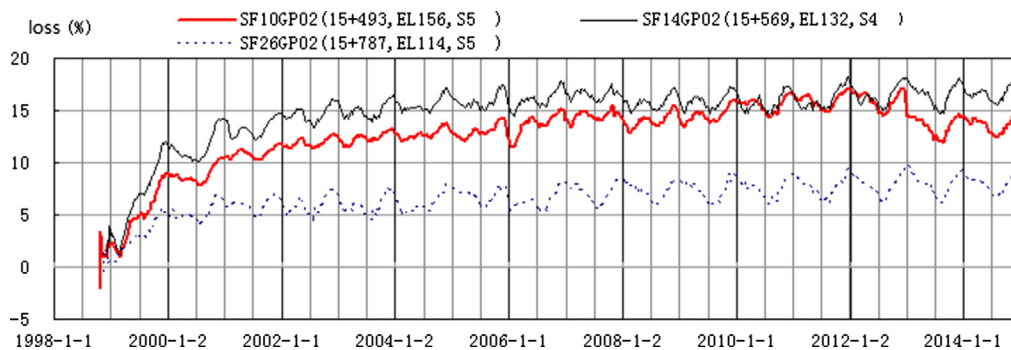
Fig. 9. Process curves of prestress loss after lock-in of 3000-kN anchor cable at the south slope.

One hundred and fifteen anchor cable dynamometers were deployed to observe the long-term prestress state of anchor cables, of which two are bonded anchor cables, and others are unbonded cables. The statistics of prestress loss ratio after anchor cable lock-in is shown in Table 4, and typical process curves are shown in Fig. 9.

As can be seen from Table 4 and Fig. 9, the measured prestress loss after anchor cable lock-in is -0.6% to 6.4%, averaging 2.8%. It was roughly 12.61% in average in December 2014. The change in anchor cable prestress loss is in agreement with the general rules of stress loss obtained in other cases. After one year of installation of the anchor cables, the average prestress loss after cable lock-in was 8%, most of the anchor cables being within 5%. Two years later, the prestress change was slight and almost kept constant, and an annual change of prestress due to the minor effect of temperature can be observed.

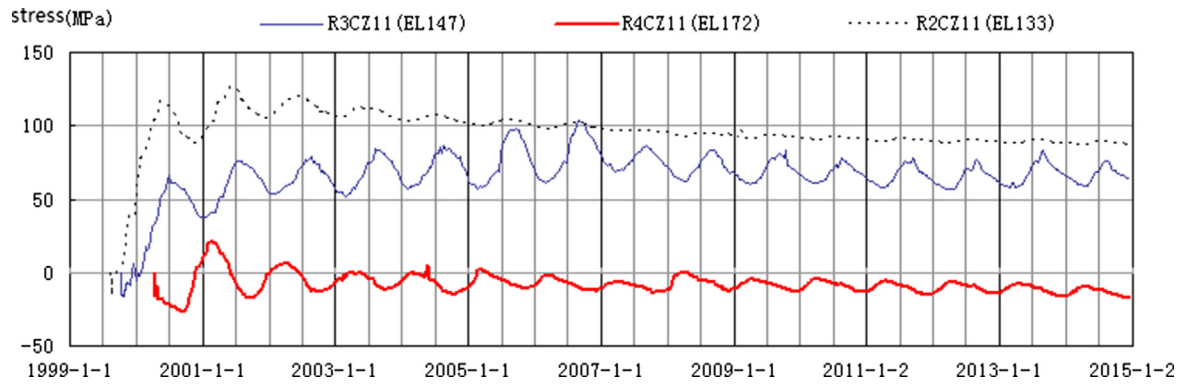
Fig. 10. Stress of high-strength anchor bolt on the north slope of lock head I (R2-4CZ11).

The measured stresses of high-strength anchor bolt at the lock head I are shown in Table 5, and time-history curves of anchor bolt stress are shown in Fig. 10. As can be seen from Table 5 and Fig. 10, the stress measured by 48 stress gages was within 315 MPa in December 2014. The maximum tensile stress recorded by the stress gages was within 150 MPa, except three stress gages, i.e. R4CZ21 (EL. 165.8 m on the north slope of the 2nd lock chamber), R8CZ31 (EL. 152.03 m on the north slope of the 3rd lock chamber), and R1CZS53 (EL. 56.5 m on the south slope of the 5th lock chamber), which had a maximum tensile stress of more than 200 MPa. In presence of the navigation of the ship lock in 2003, filling and discharge of lock chamber had a slight impact on variation of anchor bolt stress. On the whole, the measured stresses of anchor bolt are generally small and far less than the design values of anchor bolts, which indicates that the lining structure of the ship lock is stable.
