Procedia Engineering

Advances in Transportation Geotechnics 3 . The 3rd
International Conference on Transportation Geotechnics
(ICTG 2016)

Remediation of Mud Pumping on a Ballasted Railway Track

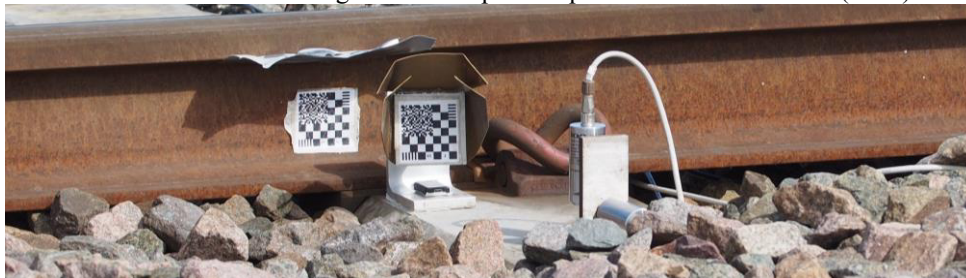
High speed video and digital image correlation (DIC) can be used to obtain track movements (e.g. Bowness *et al.*, 2005, Le Pen *et al.*, 2014 and Murray *et al.*, 2014) as a measurement system complementary to geophones. A target is usually attached to the sleeper end (Figure 3) and videoed. Analysis is carried out using a variant of the DIC technique described by Bhandari *et al.* (2012). The technique involves identifying corresponding patterns in the subsequent images using a normalized cross-correlation algorithm.

Figure 3: Sleeper end with DIC targets on sleeper and rail and a pair of horizontal and vertical geophones.

The use of geophones for determining of sleeper movements as trains pass is well established (e.g. Bowness *et al.*, 2007; Coelho *et al.*, 2011; and Priest *et al.*, 2013). Each geophone is contained within a small cylinder (80 mm height and 30 mm diameter) and is wired to a data logger beside the track (Figures 2b & 3). The geophones are attached to sleepers using glued brackets. Geophones provide a voltage proportional to velocity; the recorded data are converted to displacement by applying the appropriate calibration and integrating. A summary of the data they provide and their interpretation can be found in Le Pen *et al.* (2014).

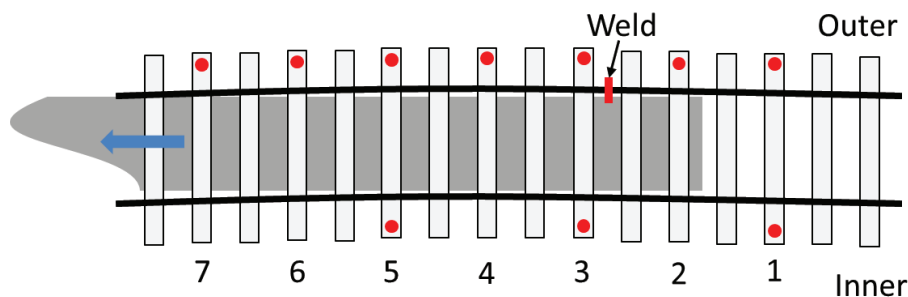
10 vertical and 4 horizontal geophones were placed on 7 alternating sleepers spanning a run of 13 sleepers labelled as shown in Figure 4. The instrumented section of track spans the apparently unaffected track ahead of the wet bed and the major portion of the wet bed prior to renewal.

Figure 4: Site layout prior to renewal showing the approximate extent of the wet bed (in grey) and the vertical geophones (red circles). The arrow indicates the direction of travel.

Figure 4 shows a weld next to sleeper 3. This could have been a potential trigger for the development of the wet bed. However, it was noted that welds were present on the adjacent track where no wet bed was present. Thus although the weld could have been partly responsible for the development of the wet bed, there is no proof of this.

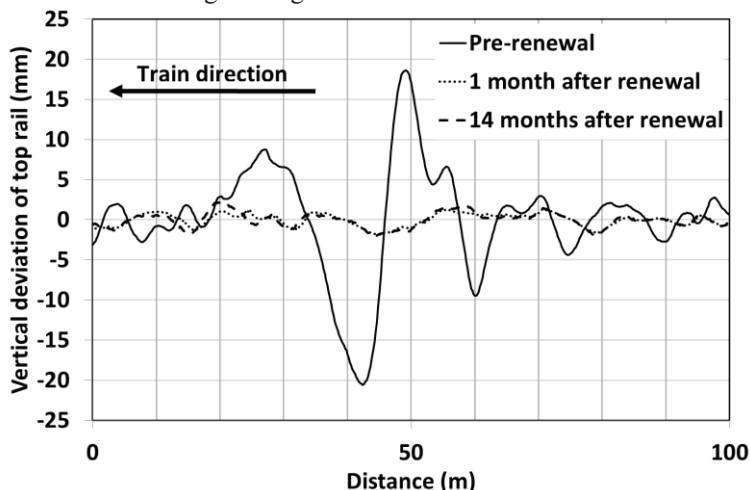
Figure 5 shows TRC vertical loaded geometry data for the outside rail (adjacent to the area between the tracks – known as the ‘six foot’ on UK railways) for a run, prior to and two runs after renewal. As is usual with this type of data, the relative distance along the track for different runs can vary by some tens of metres. The data can be manually aligned, although finding the exact location in relation to track features remains subject to some uncertainty. The pre-renewal data showed the track was performing very poorly and it is clear that the wet bed location lies between 35 and 50 metres. The post-renewal runs show substantial improvement.

Figure 5: TRC data, for the top right rail (from the train) over a 35 m wavelength, pre- and post-renewal.

The TRC data pre-renewal indicates a substantial localized dip of some tens of millimetres compared with the adjacent track (as was apparent visually in Figure 1b). The TRC data represents

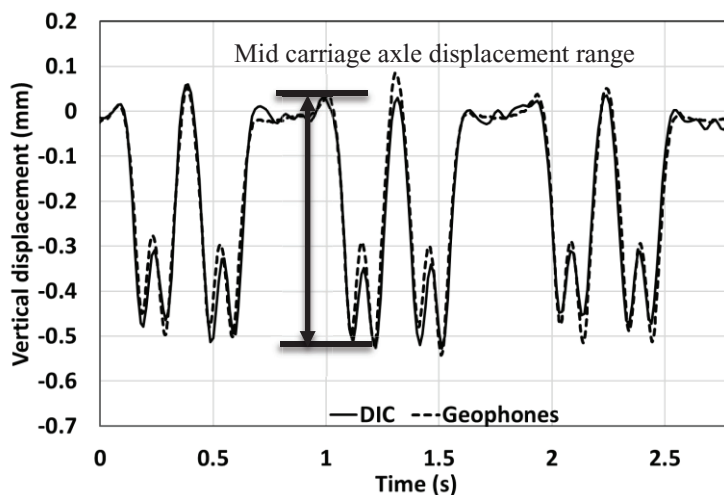
Figure 6 compares the movements of sleeper 1 on the cess side for some middle axles (6 bogies can be identified) of a 6 car Class 171 train, measured using a geophone and DIC after renewal. The geophone data have been migrated to adjust for the relative movement introduced in processing, so that zero is an estimate of the unloaded sleeper level. The DIC data give the correct level directly, provided vibration has not influenced the data. DIC and geophone traces show close agreement. Figure 6 is annotated to show the range of movement from a single axle (used to produce Figure 7).

Figure 6: Post-renewal comparison of DIC and geophone movements for a 6 car 171 on sleeper 1 inside.

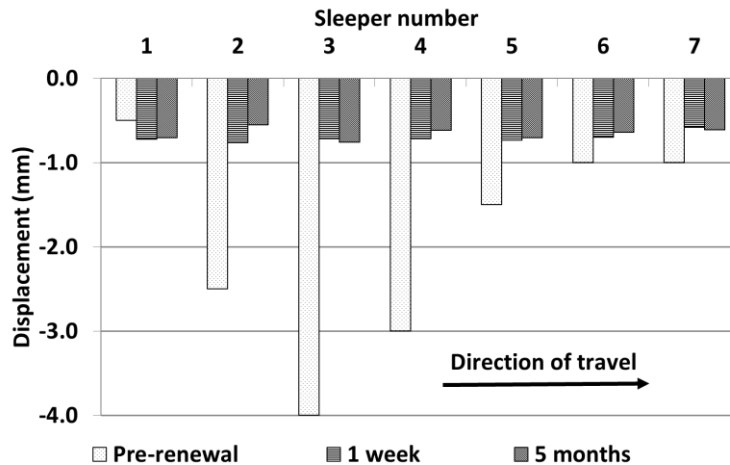
Figure 7 compares the averaged mid-carriage axle displacement ranges obtained from the geophones installed adjacent to the six foot (on the outside of the transition curve). Each bar is the average from at least three train passes. Prior to renewal, sleepers 2, 3, and 4 were performing exceedingly badly and were voided. Sleeper 5 also showed larger displacements than the remaining sleepers. The inner geophones showed similar behaviour. It is apparent that the problem was at its most severe over a localised zone covering just 3 or 4 sleepers with the adjacent sleepers (1, 6 and 7) performing much better. The post-renewal data show that there are no longer any voided sleepers and that the sleeper deflection is much more uniform across the monitored zone. There was little change in displacement between the two post-renewal visits.

Figure 7: Average sleeper vertical deflections for each sleeper across several visits (Class 171)
