# Design, construction and mechanical behavior of relics of complete large Longyou rock caverns carved in argillaceous siltstone ground

**Abstract:** This paper presents a comprehensive summary of data, analyses and findings from the investigations over the past twelve years about the relics of large Longyou rock caverns carved about 2 000 years ago at shallow depths in argillaceous siltstone. The paper presents the typical features associated with the rock caverns. They include structures, large spans, portals, extreme shallow-buried depths, imprints, drainages, inclined ceiling, inclined sidewalls, slender rock pillars, rock staircases, site and strata selections, caving lighting, carving method, and underground construction surveying. They are used to reconstruct and highlight the design and construction methods adopted by the ancients. The paper further demonstrates that the relics of the complete large rock caverns are a consequence of coincidental combinations of ancient human effort and natural factors. The full occupation of water with weak acidity in the large rock caverns with the soft surrounding rocks of weak alkalinity is found to be the main factor ensuring and prese

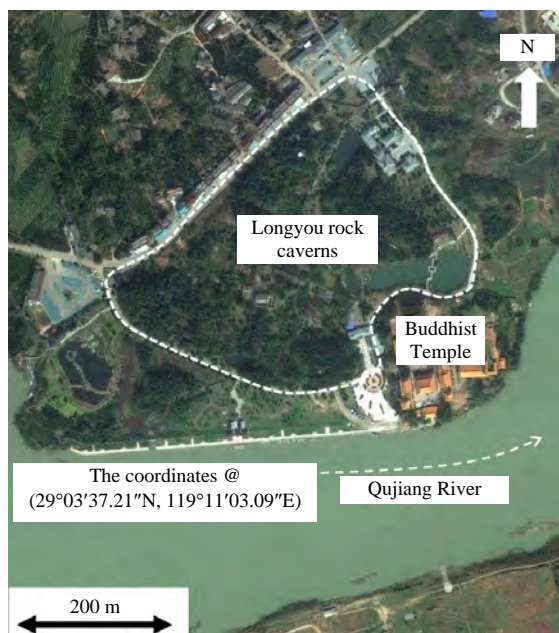
**Fig.2** Longyou rock caverns in a small hill with uneven ground elevations of 47 to 60 m, and comprising argillaceous siltstone of Cretaceous age on northern bank of Qujiang River with elevation of 36 m near Longyou County (drawn on satellite image of Google Map 2011).

The relics of Longyou rock caverns are a group of large rock caverns at shallow depths purely carved in argillaceous siltstone of Cretaceous age by ancient people about 2 000 years ago. They are located in a small hill site on the northern bank of Qujiang River in Longyou County in the middle of Quzhou—Jinhua Basin, Zhejiang Province, East China (Figs.1 and 2).

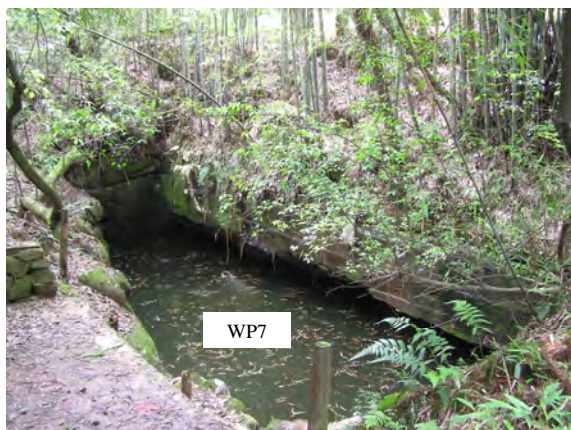
**Fig.3** A small water pool of 12 m long and 2 to 5 m wide for vertical portal of the immersed rock cavern No.7 on the small hill.

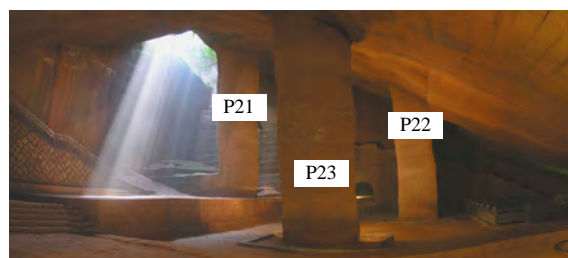
**Fig.4** Unwatered rock cavern No.2 with four rock pillars, one rock staircase, one vertical portal with sunlight and curved imprints on the rock surfaces of sidewalls, three pillars (P21, P22 and P23) and inclined roof in argillaceous siltstone of Cretaceous age.

Of course, they could use sunlight, as shown in Fig.4. However, for the large caverns, the sunlight from their vertical portals is not adequate. This question may be answered by the observation of many small holes in the rock pillars and sidewalls. An example of such small holes is given in Fig.44. It is suspected that each small hole was used for inserting a firebrand on the rock surface. Therefore, firebrands might be used for lighting during the construction.

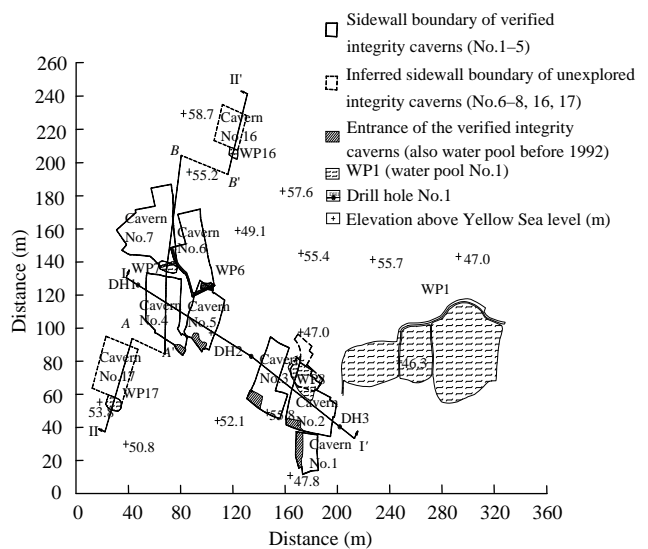
The exact locations and plane areas occupied by the ten complete rock caverns are shown in Fig.6. The five complete caverns No.1–5 were unearthed or unwatered by pumping water out of their small water pools in 1992. The small water pools were actually the vertical portals marked in Fig.5. The other five complete rock caverns No.6–8, 16 and 17 are still occupied with water. Their vertical portals are the small water pools designated with WP6, WP7, WP8, WP16 and WP17, respectively. Except the cavern No.1, the small portal of each cavern is situated on its southern boundary.

**Fig.6** Plan boundaries of ten complete caverns and their vertical portals with small water pools.

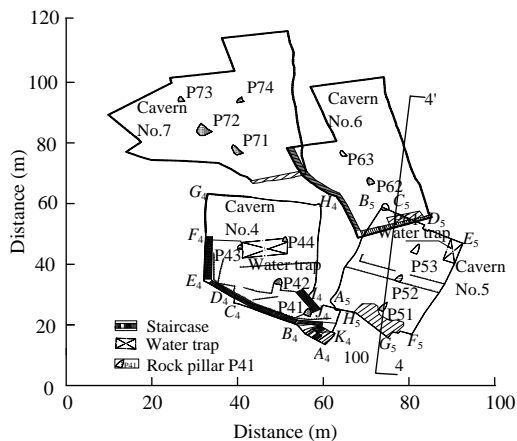
**Fig.17** Plan view of the complete rock caverns No.4-7 showing their staircases, water traps and pillars.

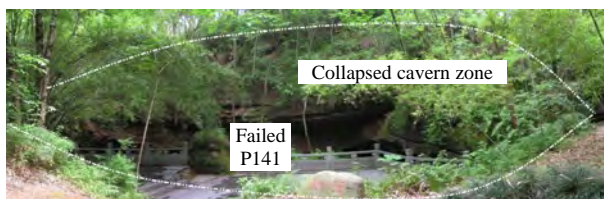
**Fig.34** Site photograph showing the collapsed rock cavern No.14 and its water pool.

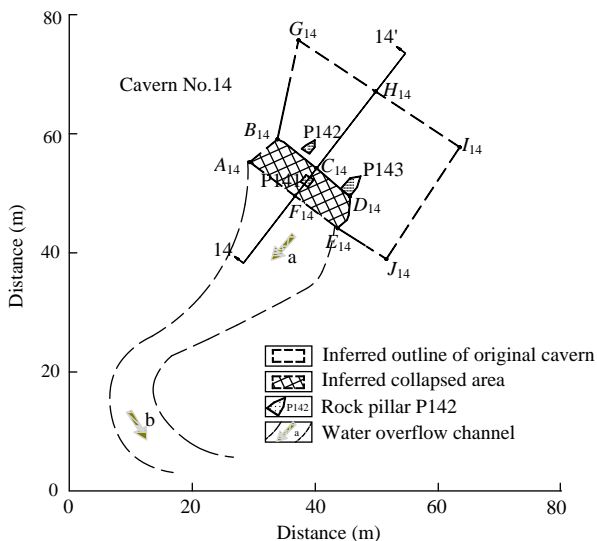
**Fig.35** Plan view of the collapsed rock cavern No.14 showing collapsed portal area (water pool) and pillars.

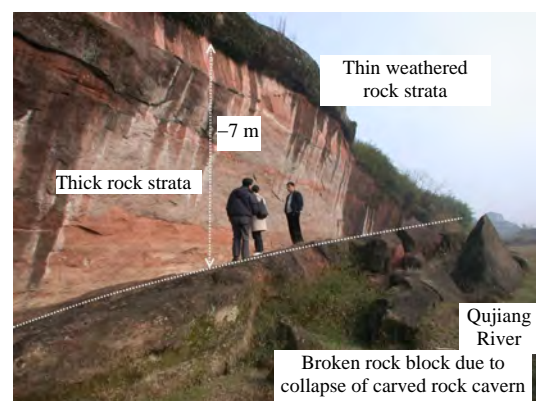
Core samples of borehole investigation indicate that the rock mass thickness is more than 100 m. Field mapping indicates that the rock masses are relatively intact, and they has blocky and integral structures, as shown in Fig.41. The rock strata experienced a very

**Fig.41** Rock mass profile exposed due to collapse of a carved rock cavern on Qujiang River about 3.5 km west to the small hill site.

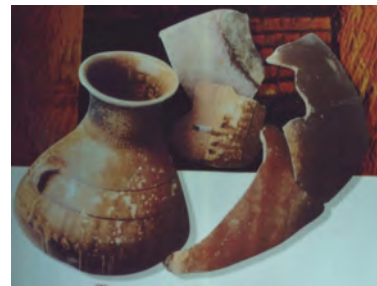
**Fig.42** Two incomplete glazed clay pots unearthed from silt mud in cavern No.2 (courtesy of the Cultural and Tourism Bureau of Longyou County Government).

Thirdly, on October 19, 2001, when cleaning the silt soils in the complete cavern No.2, the workers accidentally found some pieces of glazed clay china. Archaeologists and historians on site put them together and recovered two incomplete glazed clay pots, as shown in Fig.42, and confirmed they were typical clay pots in the Western Han Dynasty of China from 206 B.C. to 23 A.D.. Based on the assumption that they were put into the cavern No.2 two thousand years ago, the rock cavern No.2 would be constructed earlier.

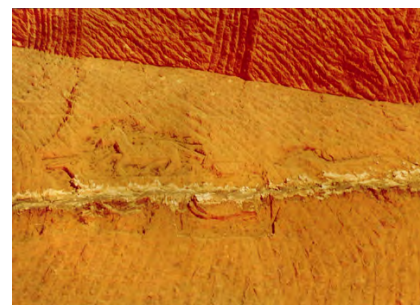
**Fig.43** A relief sculpture of horse, bird and fish carved on the sidewall of the rock cavern No.1.

Furthermore, Fig.43 shows the photograph illustrating a relief sculpture of a horse, a bird and a fish carved on the northern sidewall of the rock cavern No.1. Some archaeologists and historians reasoned and judged that the relief sculpture was carved between 206 B.C. and 589 A.D..

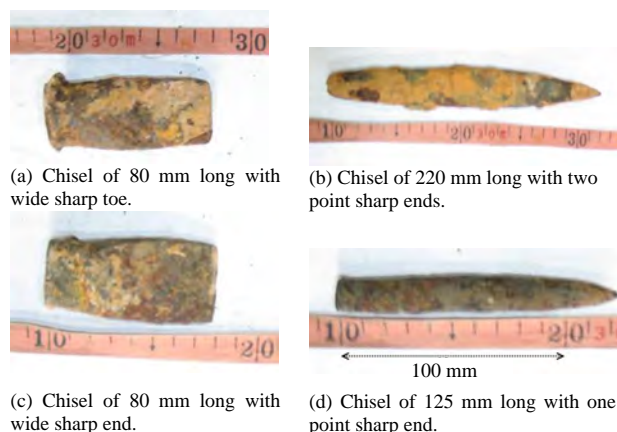
Based on the site investigation, it is highly possible that the cavern was formed by carving rock stones from top to bottom and layer by layer. The tools might be short chisels with different sizes. Figure 45 shows four short chisels unearthed in the rock caverns No.1 and 5. They are made of steel. It is also guessed that the hammers were made of hard woods.

**Fig.45** Relics of four short steel chisels unearthed in rock caverns No.1 and 5.

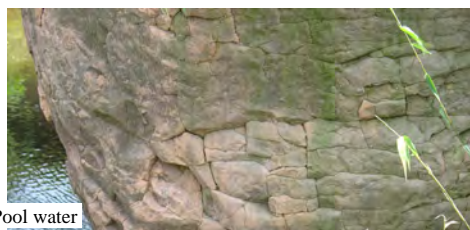
**Fig.48** Severely weathered rock surface with blocky cracks exposed above water.
