Chinese Nursing Research

Original article

A peripherally inserted central vein catheter fractured and slid into the right pulmonary artery: A case report

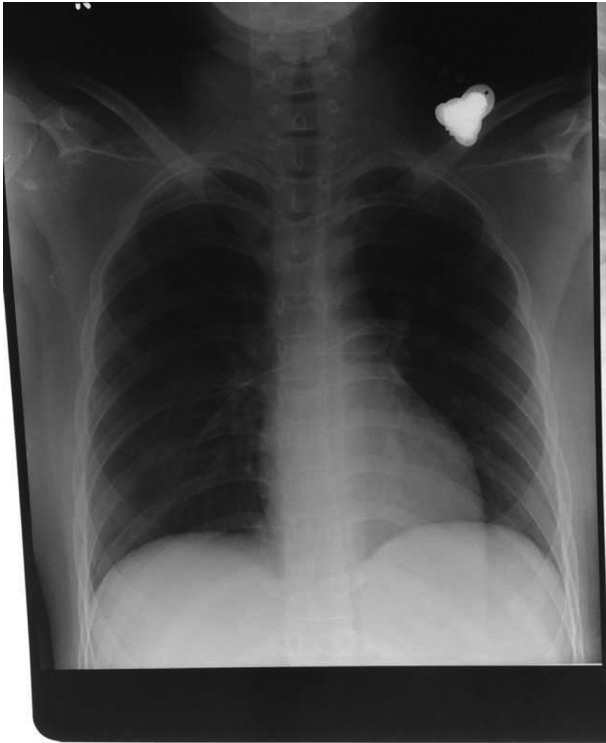
Fig. 1. Chest radiograph demonstrating the fractured PICC fragment lodged in the right pulmonary artery.

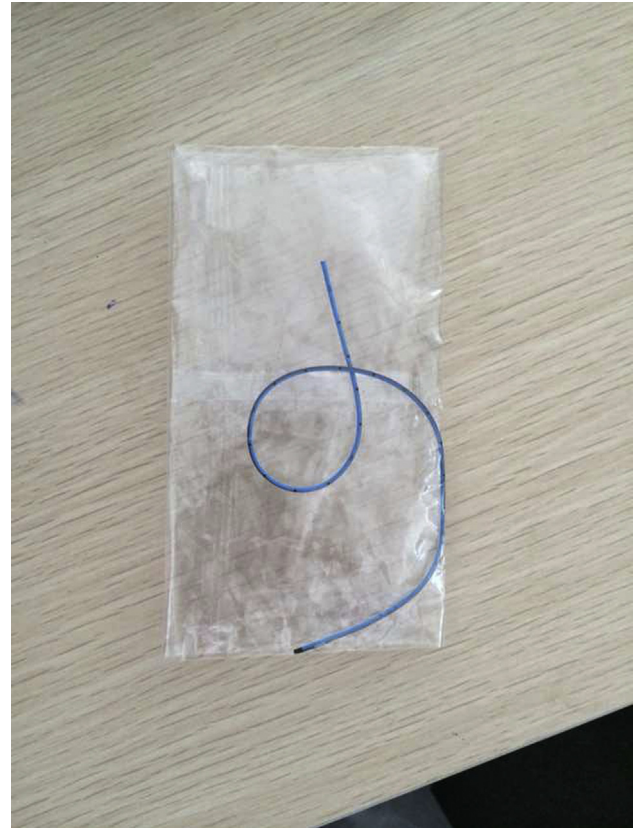
Fig. 3. Removal of the fractured PICC fragment from the inferior vena cava using a snare pull.

the right branch of the pulmonary artery. Next, the PICC was wrapped using a 'pig tail pipe' and dragged into the inferior vena cava; the PICC fragment was subsequently pulled out using a snare pull (Fig. 2). The introducer sheath (Fig. 3) was removed, and local oppression haemostasis was applied for 6 h.

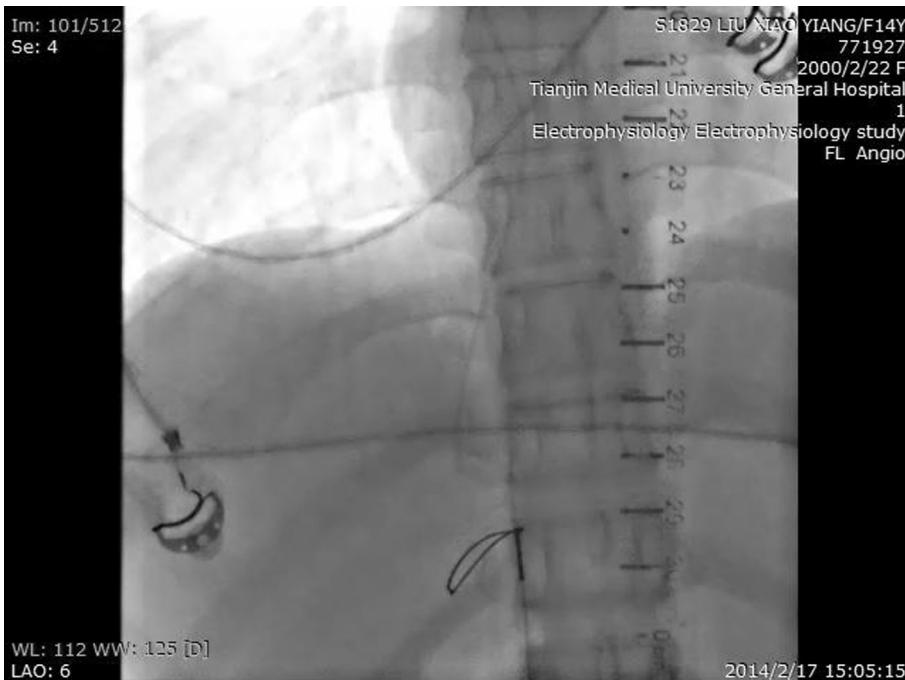
Fig. 2. PICC fragment retrieved from the right pulmonary artery.
