“Conservation of Architectural Heritage, CAH” 23-27 November 2015, Luxor

Using contingency valuation approaches to assess sustainable cultural heritage tourism use and conservation of the outstanding universal values (OUV) at Great Zimbabwe World Heritage Site in Zimbabwe**Nyasha A. Gurira^{a*} - Patrick Ngulube^b**^{a*} Midlands State University Department of Archaeology, Cultural Heritage and Museum Studies, P. Bag 9055, Gweru, Zimbabwe^{b*} School of Interdisciplinary Research and Postgraduate Studies, University of South Africa, P. O Box 392, UNISA, 0003

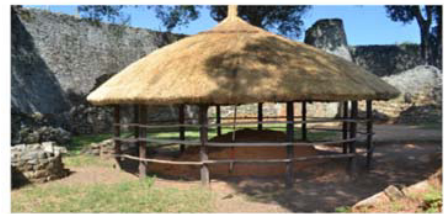
The researcher also carried out observations of the state of conservation for dhaka/dagga structures which also contribute to the overall OUV of the WHS. Efforts by the NMMZ conserve the structures include thatching and the use of back filling. According to the curator Archaeology at the WHS conservation of these structures is problematic as there is little knowledge about their composition and this impedes reconstruction. Dhaka/dagga structures at Great enclosure show evidence of conservation efforts with the structures newly roofed. At the hill complex the Dhaka structures are still under threat as some remain exposed with very little to nothing being done in regards to their conservation. Figure 1 and 2 depict the dhaka/dagga structures at the hill complex and at the Great enclosure. Overall conservation of dhaka structures is still a grey area at Great Zimbabwe with little research being done to try and ensure adequate conservation. According to the curators, the conservation centre is not functional as experiments to determine interventions are not being conducted due to financial challenges. Funding for research projects is limited with conservation getting only a 26% allocation from the tourism use at the site.

Figure 1: An exposed hut floor in the Hill Complex

Figure 2: A roofed hut structure at the Great enclosure

The conservation of *dhaka/dagga* structures in Zimbabwe in general still possess major problems where very little is known in regards to the chemical composition of the *dhaka/dagga* which limits the ability of the responsible authority towards conservation actions were backfilling and thatching become more plausible solutions. At GZWHS these efforts towards conservation are apparent. Lack of knowledge on *dhaka* structure conservation has left the institution with very few options but to allow nature to slowly take course with little to no research in the area. Though the institution has a budget for research, according to interviews conducted only \$5500 was used for research in 2014. This low use also indicates that research is an area that is lagging behind in the institution yet is key to feeding into the conservation agenda. There is a need to incentivize staff to carry out research projects that aid the conservation of the WHS. The use of the conservation centre is limited in terms of research or experiments done at the WHS, though the original focus at the centre was that it was to enable experimentation on conservation aspects. There is definitely a need to enhance conservation efforts for *dhaka/dagga* structures. A potential avenue for research is tapping into the local knowledge on the construction of *dhaka/dagga* structures combined with experimentation so to ascertain chemical composition. The conservation centre is in fact that right place for this type of research hence the need to resuscitate activities at the centre.
