**Procedia
Engineering**www.elsevier.com/locate/procediaWorld Multidisciplinary Civil Engineering-Architecture-Urban Planning Symposium 2016,
WMCAUS 2016

Construction History as a Part of Assessment of Heritage Buildings

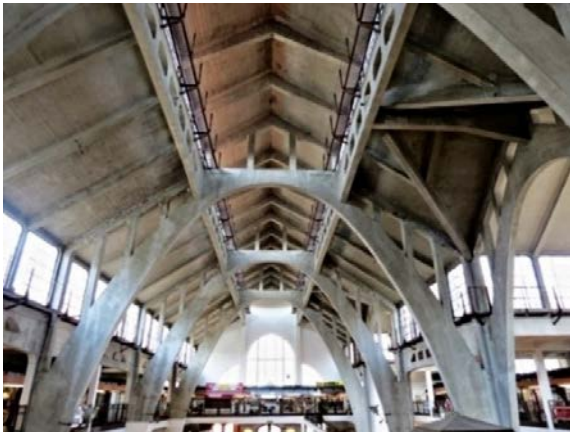
Figure 2. View of the main structural arches.

The main load-bearing structure consists of 6 parabolic arches made of reinforced concrete (Figs 1 & 2) with a total height of 20.80 meters, spaced every 12.00 m. These arches are connected on two levels by castellated reinforced concrete beams (Fig. 3). Smaller, but very similar arches, were designed in three transverse aisles. In addition, stiffening of the overall structure was assured by the reinforced concrete gallery, located at the first floor level and extending around the entire hall. The roof was made of prefabricated reinforced concrete slabs (Fig. 3), with cork as thermal insulation, and covered by ceramic tiles. Due to the high groundwater level, situated above the bottom of the basement, the foundation has been formed as a reinforced concrete slab having a thickness of 50 cm, monolithically connected to the walls of the basement. As a result of such a solution these elements created a waterproof basin without dilatation. Its tightness was assured by insulation of 2 bonded layers made of felt and asphalt, derived 20 cm above the maximum level of the groundwater.

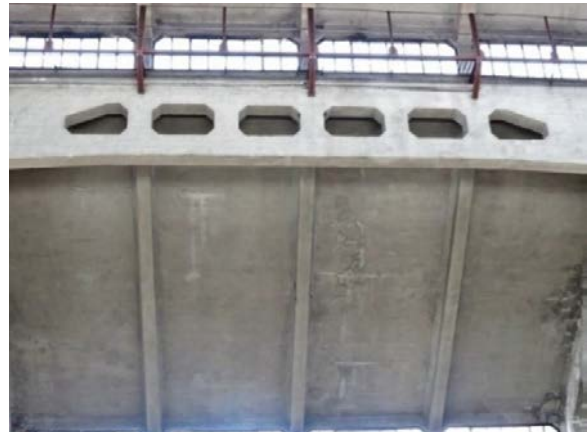
Figure 3. View of the castellated stiffening beams.

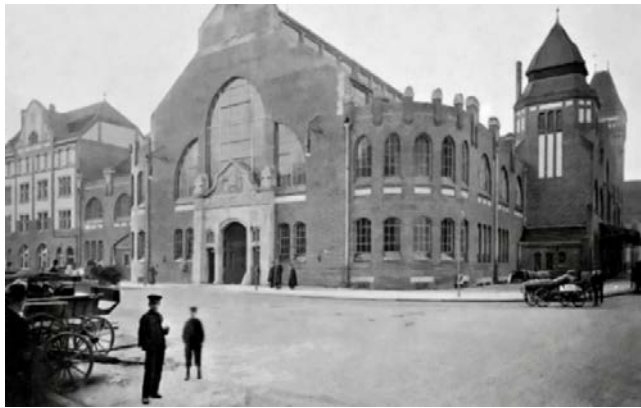
Figure 6. View of the rear façade in 1909, A. Pilcher [14].

The considered market hall was built in the first decade of the twentieth century (Fig. 6) and during operation time it was subjected to all kinds of minor refurbishment, primarily pertaining to elements of finishing (years 1936-1938). The first important structural intervention took place after World War II in order to repair some minor damage caused by the war. A fragment of the roof was reconstructed and a section of the reinforced concrete ceiling above the basement was replaced by a segmental ceiling on steel beams.

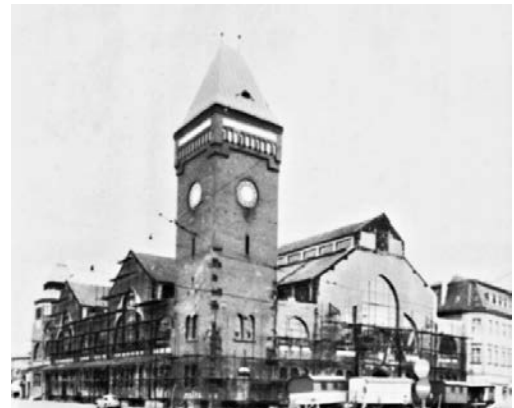
Figure 7. View of the front façade during repair works in 1980-83, [14].

It was only in 1971-73 and 1979-1982 when the expert reports and the modernization design were prepared. In the period from 1980 to 1983 the building was subjected to a major repair (Fig. 7). These works certainly had a positive impact on the current technical condition of the building.
