Soils and Foundations

The impact of the 2011 Tohoku earthquake tsunami disaster and implications to the reconstruction

Shunichi Koshimura^{a,*}, Satomi Hayashi^b, Hideomi Gokon^b

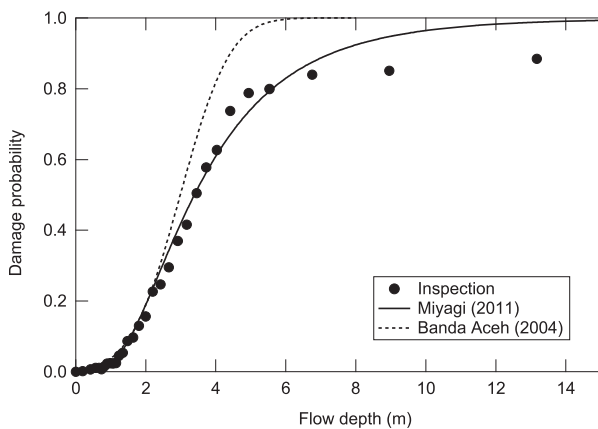
Fig. 4. Tsunami fragility curves for structural destruction (washed-away). The solid line is obtained from Miyagi Prefecture (2011 event) and the dashed one is from Banda Aceh, Indonesia (2004 Indian Ocean tsunami) (Koshimura et al., 2009a).

Taking the above procedure, the tsunami fragility curve is preliminary obtained as shown in Fig. 4. The fragility curve shown in the figure indicates the damage probabilities of structural destruction equivalent to the flow depth. Structures in Miyagi Prefecture were especially vulnerable when the local flow depth exceeded 2 m, and 6 m flow depth would totally cause total devastation. The plot of Fig. 4 also includes the tsunami fragility curve in Banda Aceh, Indonesia for a comparison (Koshimura et al., 2009a). The fragility curve from Banda Aceh was obtained by integration of satellite image interpretation and the numerical analysis of tsunami inundation. Interestingly, these two curves show a similar characteristic when the flow depth is less than 2 m, and structures in Banda Aceh are more vulnerable when the maxim flow depth is higher than 3 m. However, we have not yet identified how this difference has occurred. The major structure types in Banda Aceh were low-rise wooden house, timber construction, and non-engineered RC construction which is lightly reinforced (Koshimura et al., 2009a), and all of the structural types in the tsunami affected area were included in Banda Aceh tsunami fragility curve. Further analysis is required to characterize the fragility curves by considering structural type, structural age and urban configurations. In both cases, we can

preliminarily conclude that over 2 m tsunami flow depth may devastate the houses and buildings and this fact leads to a lesson to determine the land use plan (zoning) which considers the effect of coastal protection.

evaluate if these plans really work for future disaster reduction. For instance, based on the findings regarding the structural vulnerability (see Fig. 4), Sendai city determined a reconstruction plan (Sendai city, 2011) to reduce the tsunami flow depth less than 2 m in the populated area with a conceptual image of multiple coastal protection (Fig. 12(a)). A significant feature of the Sendai city's reconstruction plan is integrating several coastal protection facilities such as seawalls, coastal forests, park (artificial hill) and elevated roads to minimize the potential losses. Fig. 12(b) indicates the plan view of the multiple protection of Sendai city with a 7.2 m seawall and river dike and 6 m elevated prefectural road.

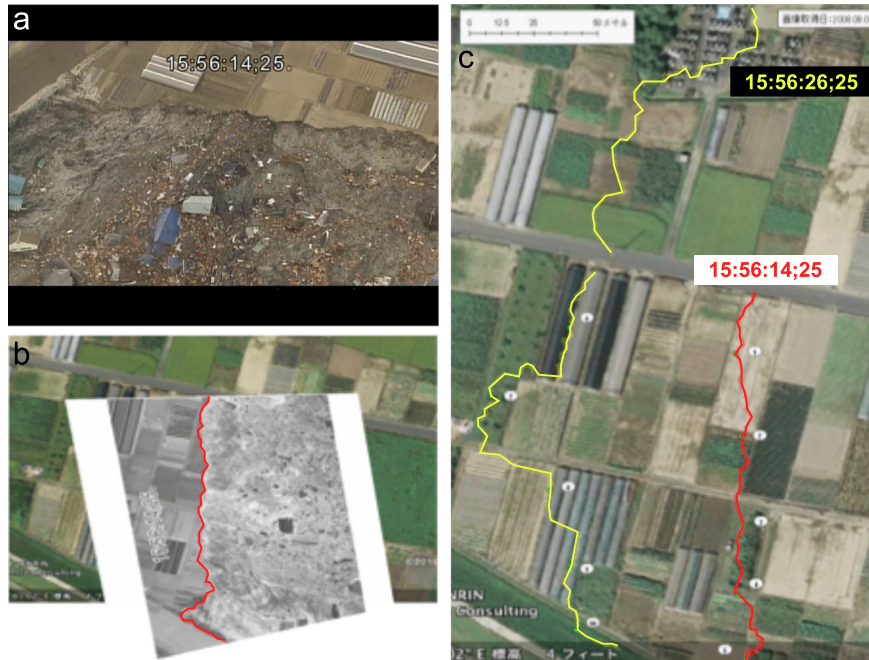
Fig. 6. Procedure of capturing tsunami front from the video. (a) A frame divided from the original video at 15:56:14 (Hours:Minutes:Seconds, 11 March 2011, JST). (b) Result of projective transformation of the captured image. (c) Result of mapping tsunami front captured from the video.

Fig. 6 shows the procedure for mapping tsunami front (Hayashi and Koshimura, 2013). First, we divide the continuously recorded video into an individual frame. Then the video frames are calibrated and rectified by 2-D projective transformation as defined by Eqs. (2) and (3), with ground control points which could be identified in pre-event Google map and image:

As shown in Fig. 6(c), the time series of tsunami wave front on land was obtained. When the distance between two tsunami front lines is divided by the time, the “tsunami front velocity” can be estimated. In addition, when we focus on the movement of floating objects in the video, the “tsunami flow velocity” can be identified.

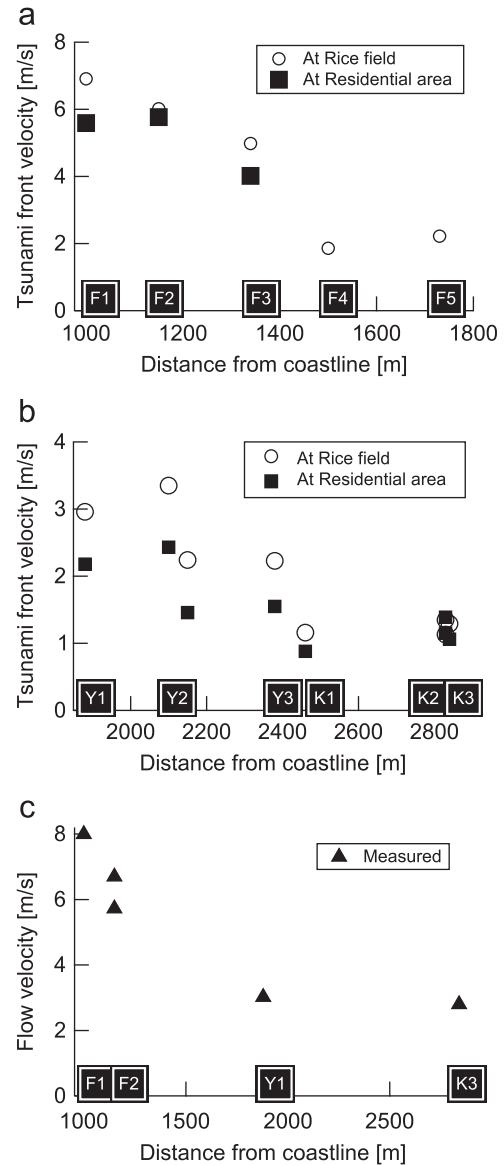
Fig. 8. The result by the tsunami front and flow velocity measurements. (a) Tsunami front velocities in Fujitsuka (the north of Natori river). The tsunami front and the flow velocities were measured in the rice field and residential areas, and the results are plotted with regard to the distances from the coastline. (b) Tsunami front velocities in Yuriage and Kozukahara. (c) The tsunami flow velocities. The annotations F1–F5 (Fujitsuka), Y1–Y3 (Yuriage), and K1–K3 (Kozuhara) indicate the areas where the video images were taken (see Fig. 5(b)).

Fig. 7 is the mapping result regarding the sequence of the 2011 tsunami front on Sendai plain and the result of measuring the tsunami front velocity. The result of measurement is summarized in Table 2 and Fig. 8. Table 2 indicates the comparison of the present result with that of EERI reconnaissance team (Chock et al., 2012), and both are very consistent. From Fig. 8, the tsunami front and flow velocities reached approximately 8 m/s within 1 km inland from the shoreline, and they decreased as penetrating more into inland. And we also found that the tsunami front velocities were affected by the existence of the structures which reduce the speed of inland tsunami penetration.

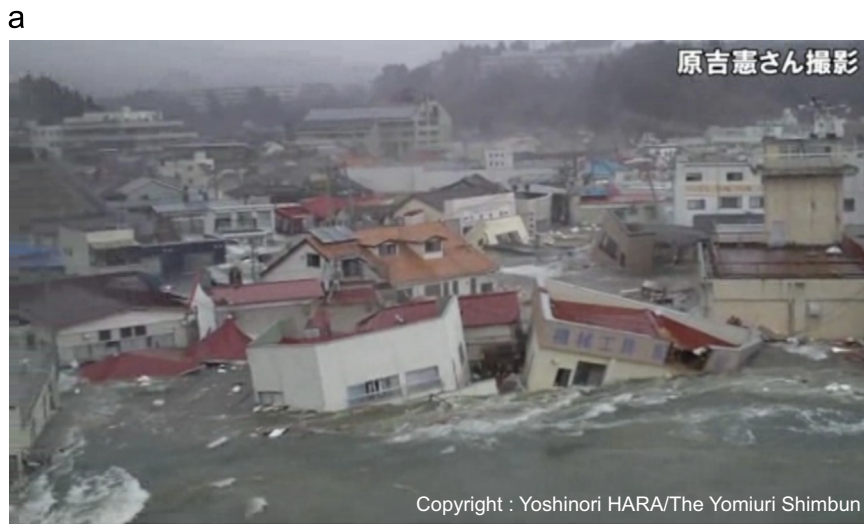
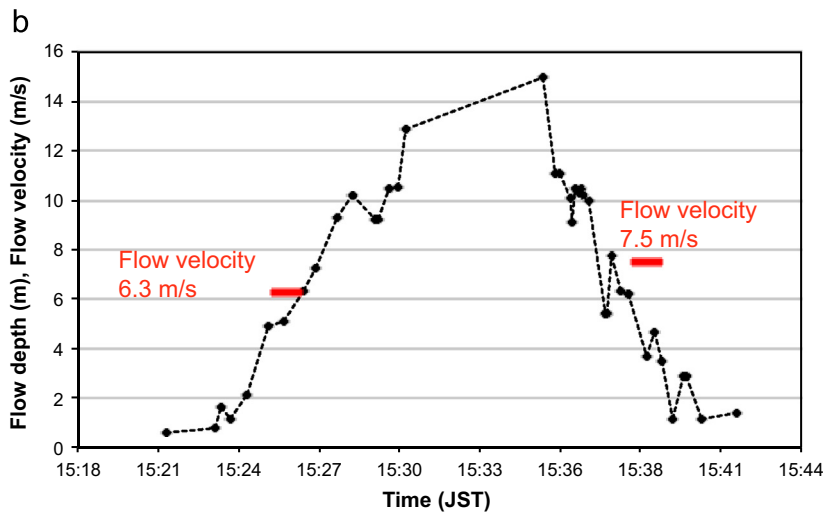
Fig. 10. (a) A snapshot from the survivor video (Yomiuri Shinbun, 2011) capturing the moment that the houses were washed away (approximately at 15:25 JST) (Yomiuri Shinbun, 2011). (b) Time series of tsunami flow depth and flow velocities interpreted by the video.

the height of the water level on withstanding buildings in the video (Fig. 10(b)). Also focusing on the movement of drifting objects, the flow velocity was estimated at the moment when the houses were washed away. As a result, the flow velocity of the tsunami inundation was estimated as 6.3 m/s at the flow depth of approximately 5 m. Using this hydrodynamic

features, the tsunami force was roughly estimated as 100 kN/m, the drag force acting on a wall per unit width.
