Procedia Engineering 114 (2015) 862 – 869

1st International Conference on Structural Integrity

Experimental characterization of the in-plane and out-of-plane behaviour of infill masonry walls

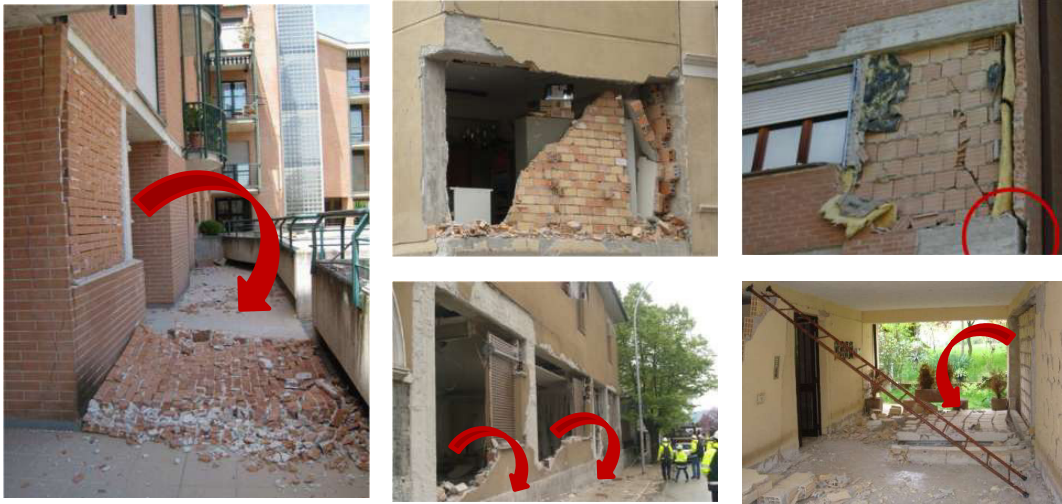
Fig. 1. IM walls out-of-plane collapses when subjected to earthquakes.

In fact, the contribution of the IM walls to the building's seismic performance can be favorable or not, depending on a large series of uncertain phenomena, detailing aspects, mechanical properties, and others. The infills out-of-plane behaviour was observed as one of the most important critical failures of such type of non-structural elements [4, 5], as observed in Fig. 1. A few major factors causing out-of-plane instability and poor performance are the reduced support-width on RC beams and/or slabs,

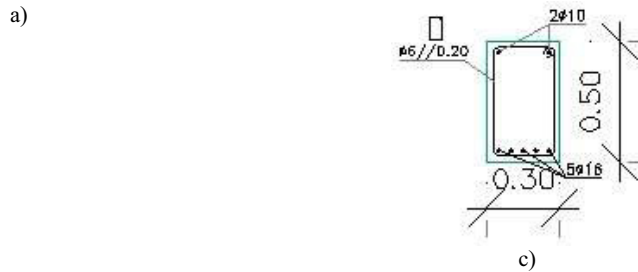
Fig. 2. Infilled RC frame specimen dimensions a) general dimensions b) columns and b) beams dimensions and reinforcement detailing.

The present experimental campaign comprised three out-of-plane tests of full-scale infilled RC frames, two of them without previous in-plane damage and one with previous in-plane damage. The general dimensions of the specimens were selected as 4.80x3.30m² and the cross sections of RC columns and beams are 0.30x0.30m² and 0.30x0.50m², respectively, which are representative of those existing in the Portuguese building stock [6]. Fig. 2 shows the RC infilled frame geometry, as well as the corresponding columns and beams dimensions and reinforcement detailing.

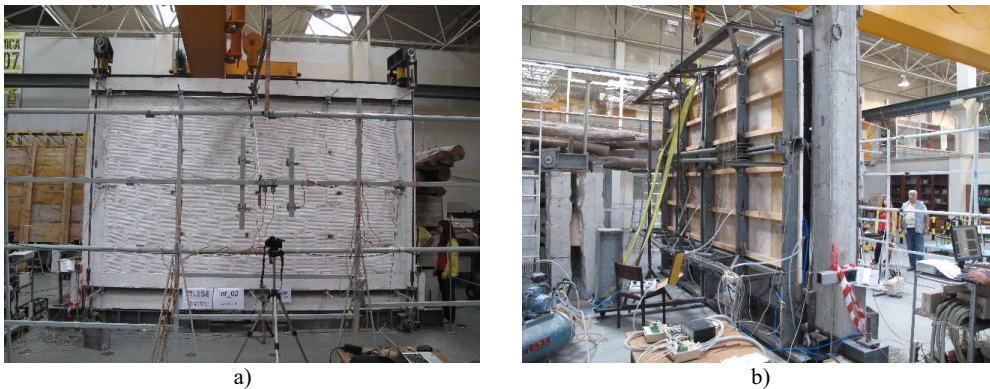
Fig. 4. General view of the experimental test setup a) Front view b) Lateral view.

The out-of-plane test consisted on the application of a uniformly distributed surface load through a system composed by seven nylon airbags, reacting against a self-equilibrated steel structure, as shown in Fig. 3 and Fig. 4.

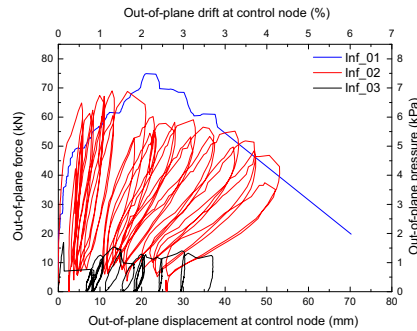
Fig. 7. Out-of-plane force-displacement test results: Global results.

Fig. 6c, respectively. For a better comparison between the tests, Fig. 7 includes all the global force-displacement test results. From the result analysis, the following main observations can be drawn:

- The maximum strength was almost 4 times higher for tests without previous in-plane damage (Inf_01 and Inf_02) and for higher out-of-plane drift values. For Inf_01 and Inf_02 tests the maximum strength occurs at out-of-plane drift values between 1.5-2%, while for the Inf_03 test it occurs at 0.25% drift value;

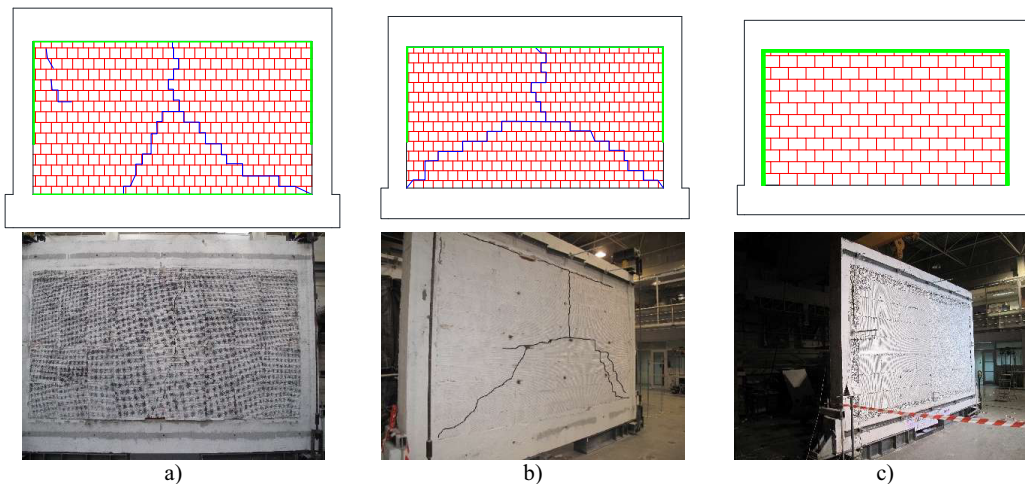
Fig. 8 – Final cracking pattern and pictures for the three out-of-plane tests: a) Inf_01, b) Inf_02 and c) Inf_03.

Aiming at a detailed observation of the damage evolution during the experimental tests within the present work testing campaign, each test was stopped at the end of the last cycle of each displacement level in order to highlight and register new cracks and/or the evolution of existing ones. Visual observation of the damage evolution during the tests yielded the information described in the following paragraphs. The final damage patterns of all tests are presented in Fig. 8, showing several differences between tests with and without previous in-plane damage. The final cracking shape of the Inf_01 was vertical, with detachment between the infill panel and the surrounding RC frame in the top and bottom joints, as shown in Fig. 8a. However, the Inf_02 test exhibited a trilinear cracking pattern with deformation concentrated in the mid-point of the wall, with slight cracking in the top joint, as illustrated in Fig. 8b. Finally, it was found that no cracking pattern occurred in the middle of the IM wall Inf_03, which is related with the observed detachment between the infill panel and the surrounding top beam and columns, evidencing typical rigid body behaviour (Fig. 8c).

The failure modes observed in each of the tests reveals different out-of-plane behaviour of the IM walls with and without previous in-plane damages. The tests in original IM walls (Inf_01 and Inf_02) showed vertical cracking, with detachment between the infill panel and the surrounding RC frame in the top and bottom joints. In the Inf_02 wall a trilinear cracking was observed with concentrated deformation in the middle point of the wall, with slight cracking in the top joint. For the test with previous in-plane damage only the detachment was observed between the infill panel and the surrounding top beam and columns, and typical rigid body behaviour was found
