Nuclear Engineering and Technology

Original Article

A Failure Estimation Method of Steel Pipe Elbows under In-plane Cyclic Loading

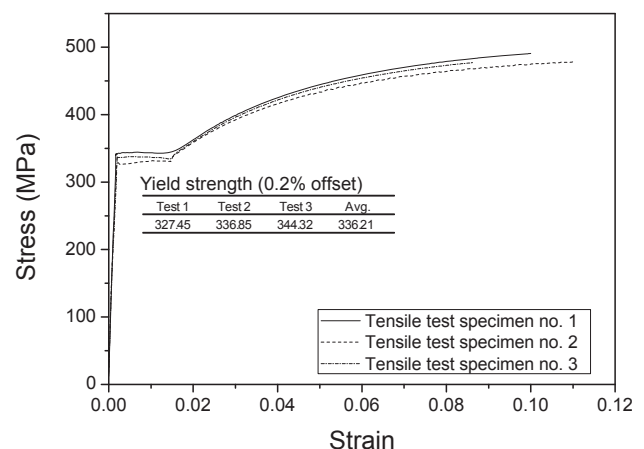
Fig. 3 – Stress-strain relationship of material.

Here, ϵ_{eng} and ϵ_{true} mean engineering stress and true stress, respectively. As shown in Fig. 3, material properties of test coupons were almost the same. Therefore, variations by material properties can be ignored in the in-plane cyclic loading tests.

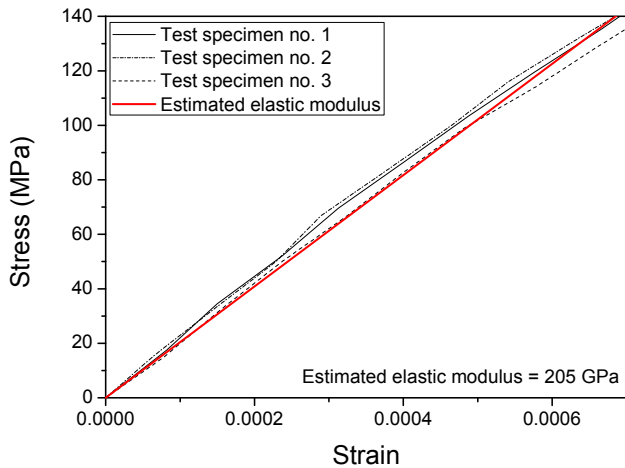
Fig. 4 – Elastic modulus of test specimen.

A representative trend line of elastic behavior area in a stress-strain curve was estimated by the least squares method with coupon tests data, as shown in Fig. 4. The representative elastic coefficient of specimens can be calculated by Eq. (4).

Therefore, the representative elastic coefficient for the specimens in this study can be assumed as 205 GPa.

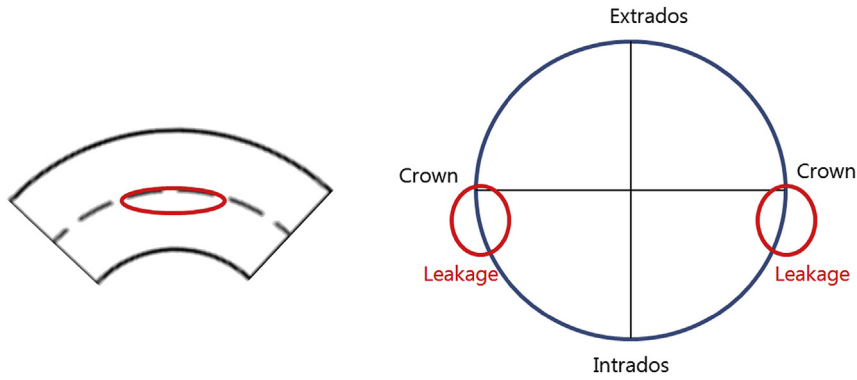
Fig. 7 – Leakage point of specimen.

The relationship between displacement and force is shown in Fig. 6. The locations and numbers of cycles for leakage are shown in Fig. 7 and Table 5. The crack (rupture) occurred near the crown of the elbow and grew up in the axial direction. The initiation and propagation of the crack were in agreement with a previous study by Mizuno et al [6].

A leakage due to in-plane cyclic loading occurred on the crown or near the crown in the intrados direction; cracks (ruptures) grew in the axial direction.

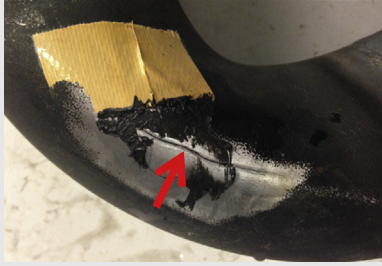
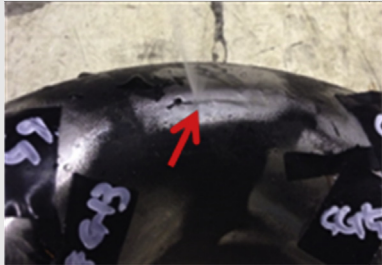
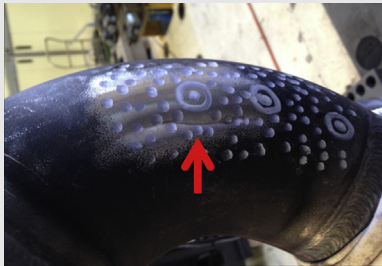
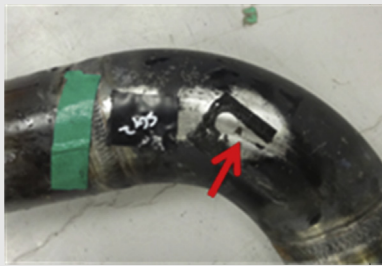
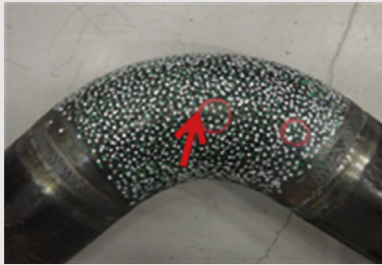
| Loading amplitude (mm) | Number of specimen | Internal pressure (MPa) | Leakage location | Leakage cycles |
|---|---|---|--|---|
| ±60 | 6 | 3 | | 6, 6, 8, 8, 8, 8 |
| ±70 | 5 | 3 | | 4, 5, 5, 4, 6 |
| ±80 | 7 | 3 | | 5, 4, 4, 5, 4, 4, 5 |
| ±90 | 5 | 3 | | 4, 4, 4, 4, 4 |
| ±100 | 5 | 3 | | 4, 3, 4, 4, 3 |

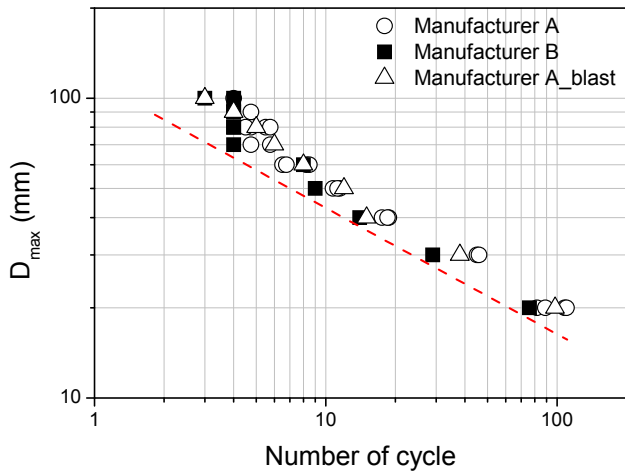
Fig. 8 – Fatigue curve for maximum induced displacement.

Fatigue curve for maximum induced displacement decreases exponentially as the number of cycles increases, as shown in Fig. 8. Here ○, ■, and △ are Manufacturer A, Manufacturer B, and blasting specimens, respectively.

The loading amplitude exponentially decreased as the number of cycles increased.

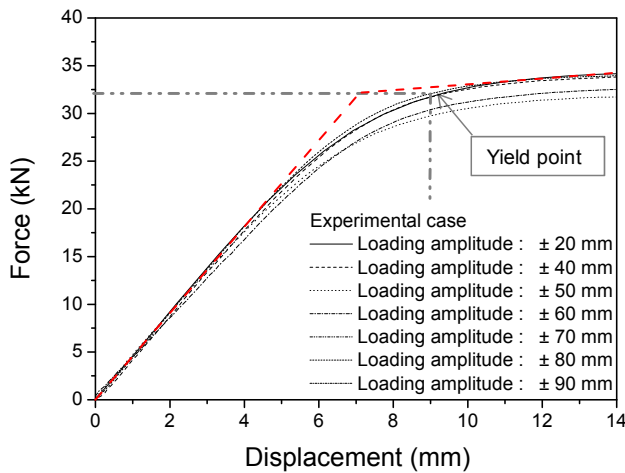
Fig. 9 – Yield point of specimen.

According to Jelka's [8] research, yield force can be considered as the force at the intersection point of the linear area regression line and the plastic area tangent line. Also, yield displacement can be considered as the displacement corresponding to the evaluated yield force. Therefore, the maximum yield force and yield displacement from the experiment in this study are 32 kN and 9 mm, respectively, as shown in Fig. 9.

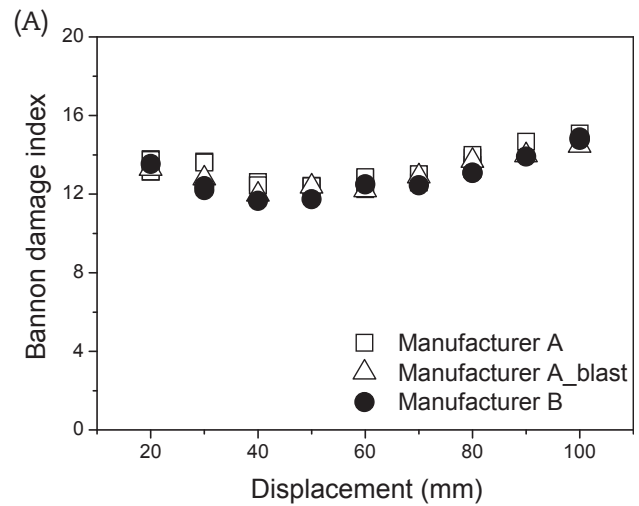
Fig. 10 – Damage index for piping elbow. (A) Damage index: individual. (B) Damage index: mean value of each loading amplitude.

Calculated damage indexes by Eq. (4) and statistical data are shown in Fig. 10 and Table 6, respectively. The individual damage index of each specimen is shown in Fig. 10A and the means of damage indexes against loading amplitude are shown in Fig. 10B.

The maximum and the minimum damage indexes from each test are 15.08 and 11.65, respectively. Also, mean and median values of each damage index are 13.17 and 13.07, respectively. Log-normal standard deviation and covariance

of each damage index are calculated as 0.028 and 0.065. Meanwhile, mean value and log-normal standard deviation of the mean damage index against loading amplitude from Fig. 10B are 13.17 and 0.027, respectively. These values are similar to those from individual results.

Therefore, mean value or median value can be used for a representative value because the log-normal standard deviation is small enough. Also, it is possible to quantitatively estimate or predict the failure of the pipe elbow with the representative value of damage index recommended in this paper.
