# Periprosthetic leak and rupture after endovascular repair of abdominal aortic aneurysm: The significance of device design for long-term results

Kirsten Krohg-Sørensen, MD, PhD, Magne Brekke, MD, Anders Drolsum, MD, and Knut Kvernebo, MD, PhD, *Oslo, Norway*

We present a case of abdominal aortic aneurysm treated with an endovascular bifurcated aortic graft in which a periprosthetic leak caused by a tear in the polyester prosthesis appeared between 9 and 12 months after surgery. The tear appeared adjacent to a suture breakage that caused separation of two struts of the nitinol wire framework in the body of the stent graft. The leak was sealed with insertion of a new endovascular tube graft into the body of the bifurcation. Eight months later, the patient had a nonfatal rupture of the abdominal aortic aneurysm because detachment of the second limb from the bifurcation caused a new major periprosthetic leak. According to the manufacturer of this device, suture breakage with separation of metal components is commonly seen, but perforation of the polyester prosthesis caused by movement of the metal stent against the fabric has not been reported. It is likely that this occurred in our

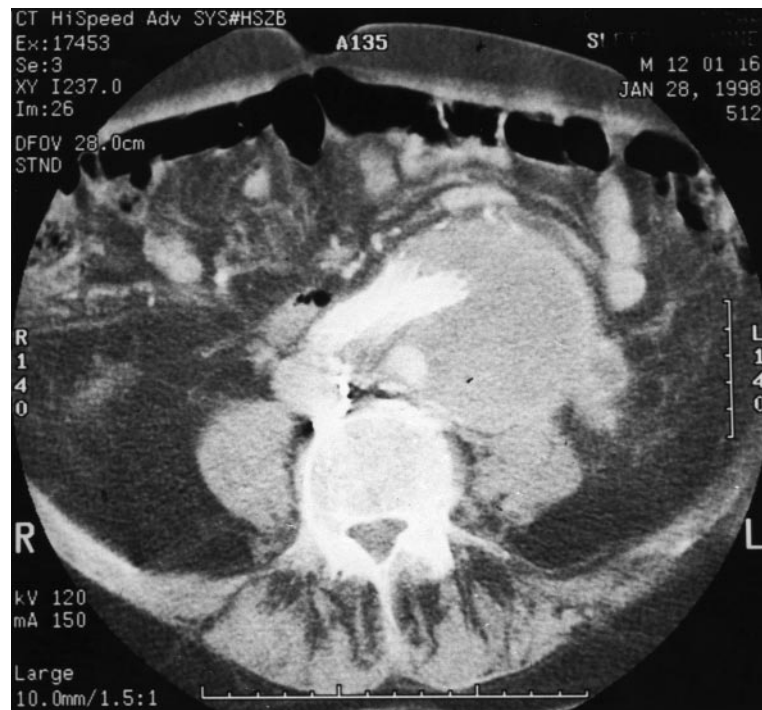
**Fig 4.** Computed tomographic scan 3 months after embolization of lumbar arteries with back-flow. There is still small backflow from right lumbar artery through coils.

results showed a small contrast filling close to the coils in the right lumbar artery (Fig 4). A possible increasing angulation of the stent graft was noted, but the aneurysm size was unchanged (80 mm). CDS results showed retrograde flow in the lumbar artery, reversing in diastole. Further observation for 3 months was planned, followed by repeated CT angiography and CDS.

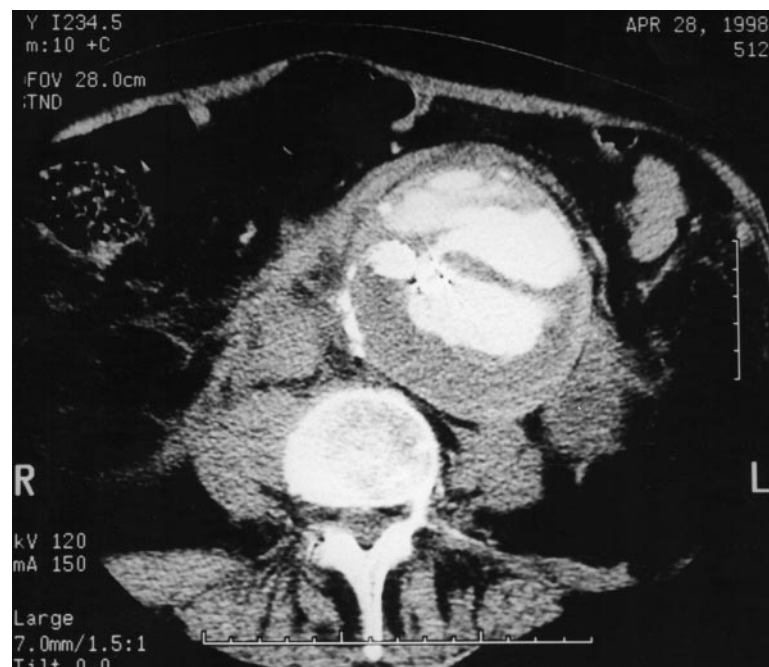
**Fig 5.** Computed tomographic scan after 20 months. Periprosthetic leak is related to connection between second limb and bifurcation. Size of aneurysm has increased to 100 mm, and there is rupture with retroperitoneal hematoma.

back pain, hemodynamically stable but without palpable pulse in the left groin. CT scanning results showed a large endoleak from the connection between the second limb and the bifurcation, diameter increase from 80 to 100 mm, and rupture with hematoma in the retroperitoneum (Fig 5). Conventional surgical repair with a tube graft was performed without complication after explantation of the endovascular graft. The aorta initially was crossclamped above the renal arteries, and after the stent graft was removed, the clamp was
