XIIIth International Scientific and Engineering Conference “HERVICON-2011”

## Balancing With the Presence of a Rub

During commissioning of a cogeneration plant the air cooled generator can not be run up to synchronization speed because of high 1X vibration during startup. Several attempts were done by the commissioning team to balance the rotor but proven ineffective. Article presents the vibration analysis performed by GE MDS Engineer. As a result of the analysis it was concluded the high levels of synchronous vibration are caused by thermally induced bow because of rub in the new type of seals installed in generator casing. The seals were removed for test and the generator was started successfully. The next part of the article discusses the differences between Newkirk and Morton type thermally induced bows as they can be observed in the machinery diagnostics during field analysis

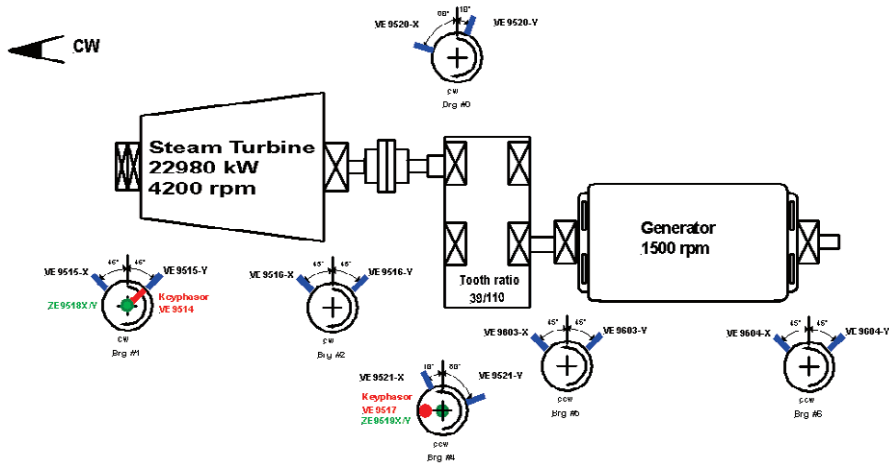
Fig. 1. Machine train layout

Machine train as shown in figure 1 consists of Steam Turbine driven, Gearbox and Generator. The air cooled generator is coming from another site where, according to maintenance data it was running with low vibration levels. Because of damages caused by shortcut in the stator the rotor was in overhauled and later it was installed in current location. During the overhaul no works were done on the rotor so balancing condition should be unchanged.

Each of the machine train's bearing is monitored by displacement transducers mounted on the machine casing in a plane (XY) perpendicular to the rotor axis of the machine to observe radial motion of the shaft. The XY pairs of non-contacting proximity probes are mounted at 45-degrees left (Y-probe) and 45-

degree right (X-probe). The machine train layout is shown in figure 1. The driver shaft rotates clockwise, when viewed from the driver to the driven. The driven machine shaft rotates counter clockwise.

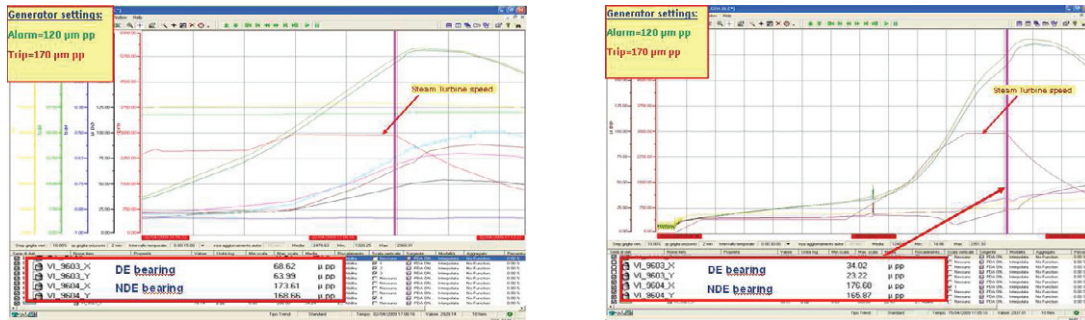
During each startup very high vibration levels on the DE and NDE bearings of the generator was noticed and synchronization speed couldn't be reached. Several attempts were done by the commissioning team to balance the rotor but proven ineffective. DCS data from the customer on figure 2 show two different attempts.

Fig. 2. Customer data showing high vibrations on generator bearings while trying to reach nominal speed. Data show two attempts to reach synchronization speed within two weeks

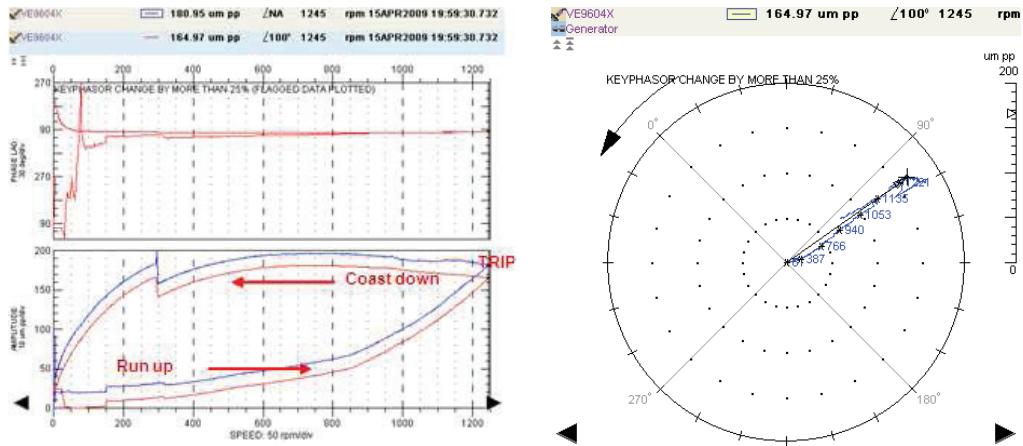
- An hysteresis between run up and coast down is noticed on the Bode plots figure 3: during coast down the vibration level observed is much higher than during the run up and the shape of coast down

- Though the critical speeds were unknown no phase change of 180° during speed up was observed suggesting no critical was crossed

Fig. 3. Direct and 1X Bode plots with 1X polar plot for NDE generator bearings during run up and coast down after a trip because of high vibrations

The DCS trends are showing only overall vibration trends so diagnostic system need to be used to obtain more informative characteristics. A first set of vibration data was recorded using ADRE 408 DSPi (Dynamic Signal Processing Instrument) connected to vibration signals from the existing Bentley Nevada's 3500 Series vibration monitor system. During the coast down the vibration level exceeded the vibration level observed while running up. Synchronization speed couldn't be reached. The following facts can be observed from analysis of the data as in figure 3.

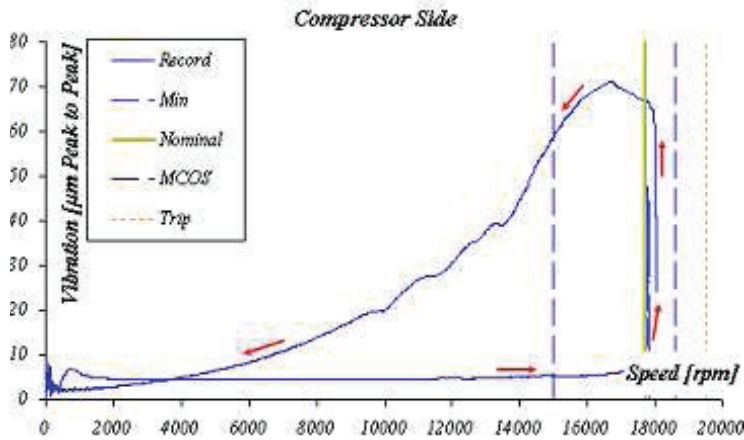
characteristics is unusual. Indeed for a speed below the first resonance the shape of the 1X amplitude versus the speed should be parabolic as shown on figure 4 where typical Bode plot of a rotor system is described

Fig. 4. Vibration hysteresis in Bode plot. Typical behavior for a spiral vibration [1]

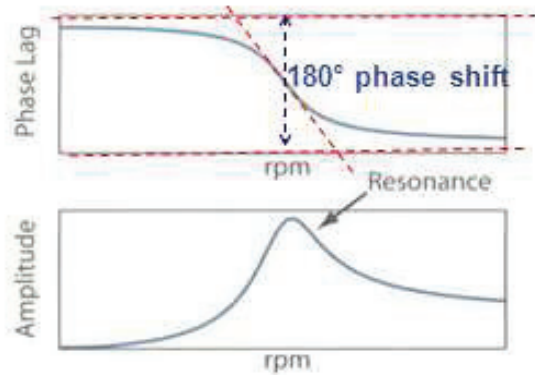
Figure 5 shows Bode plot showing resonance of an ideal single mass rotor system (Jeffcott rotor). The upper plot shows the phase lag versus rotor speed. The lower plot shows the amplitude of vibration versus rotor speed. When rotor speed nears the rotor system natural frequency the amplitude of vibration increases and a phase shift of 180° occurs. As the rotor speed passes beyond the natural frequency the amplitude decreases

Fig. 5. Bode plot of an ideal rotor system [2]

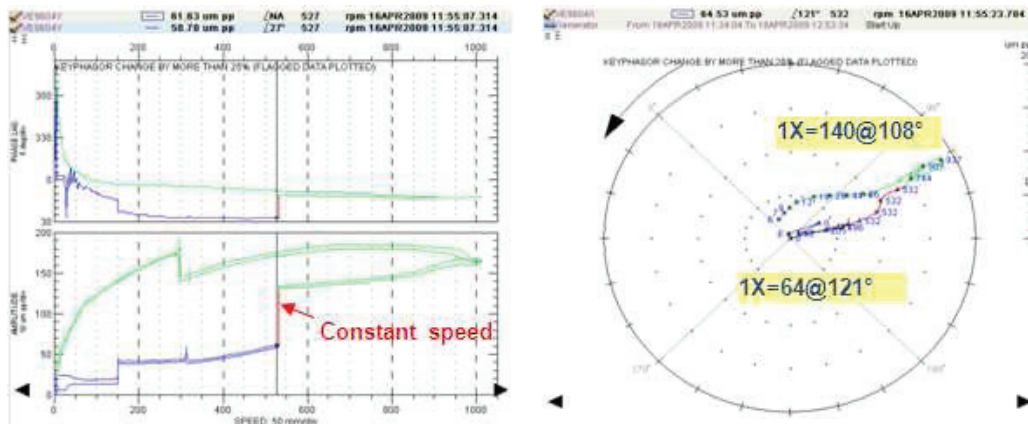
The Bode plots and polar plots on figure 6 shows the vibration level is increasing at constant speed suggesting something else rather than response to unbalance. If during run up thermal bending occurs at a particular speed the thermal unbalance will result in an increase of synchronous rotor vibration. A quick reversal of speed (because of a trip for example) will result in a hysteresis loop (see figure 4) because of the time constants associated with the thermal phenomenon. Polar plots on figure 5 and trend plot on figure 7 show those changes in amplitude and phase while the speed is constant

Fig. 6. Direct and 1X Bode plots with 1X polar plots for NDE generator bearings during run up/coast down with a step at 500 rpm showing vibration increase and phase change

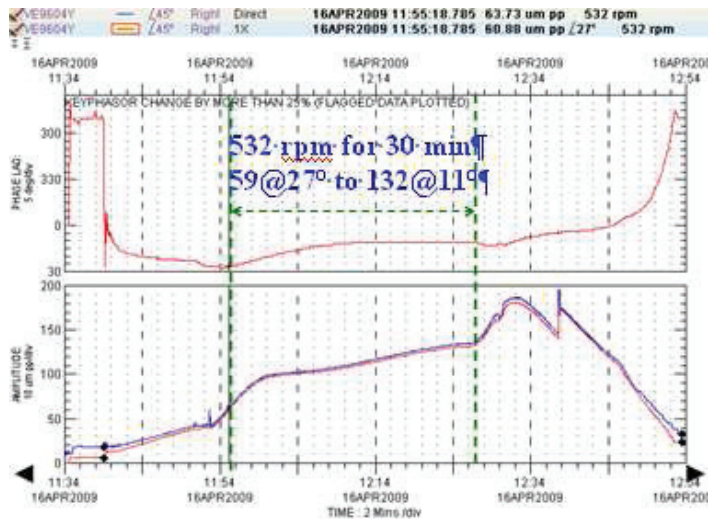
Once the machine dropped below a certain speed (100rpm) the vibration levels decreased rapidly indicating that if there would have been any residual unbalance this would have been still noticeable. This abrupt-speed related absence of vibration is also suggesting the problem isn't a balance related phenomenon. Below this speed 1X forces because of thermal unbalance drop because the contact disappear and 1X vibration go back to “no bow” response

Fig. 7. Direct and 1X trend plots for NDE generator bearings during run up/coast down with a step at 500 rpm showing vibration increase and phase change

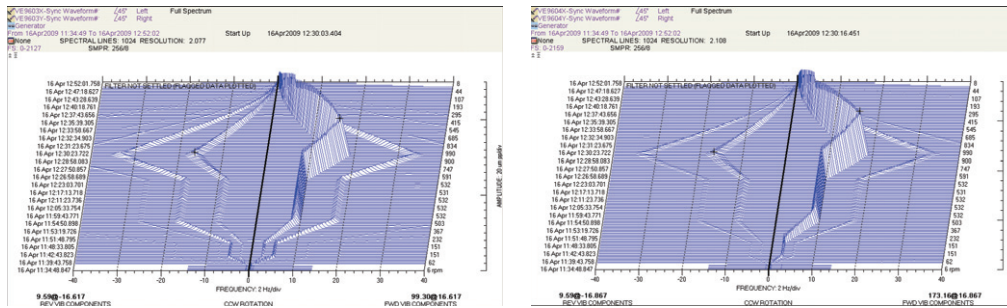
The shaft movement is composed of 1X (shaft rotative speed) vibration frequencies (see full waterfall plots figure 8). Even as the turbine is coasting down the vibration level remains with a dominant 1X forward component

Fig. 8. Full Waterfall plot of DE and NDE generator bearings showing dominant 1X forward vibration component (circular orbit)

The Full spectrum is a tool that allows the user to examine the shape and precession of an orbit at any frequency with the measure frequency range. The relative magnitude of the forward and reverse components can be used to determine orbit shapes as well as precession. Most forcing functions applied to rotating machinery are acting with or in the same direction as rotor rotation. Rotor to stationary part rubs are example of forces applied to the rotor opposite to the direction of rotation. This type of force can introduce precession forces and reverse precession orbital motion.

The presence of reverse components in the full spectrum plot does not always imply that reverse precession forces are present. For example, a mass unbalance force on the rotor with an anisotropic bearing stiffness; e.g. elliptical bearings. The response of the system at the plane of measurement will yield an elliptical orbit. The full spectrum plot will define the orbit shape with a display of reverse and forward components at the rotor frequency (1X). However, this does not imply that forward and reverse forcing functions are present. Mass unbalance (centrifugal force) is an integral part of the rotor geometry and produces only a forward direction force

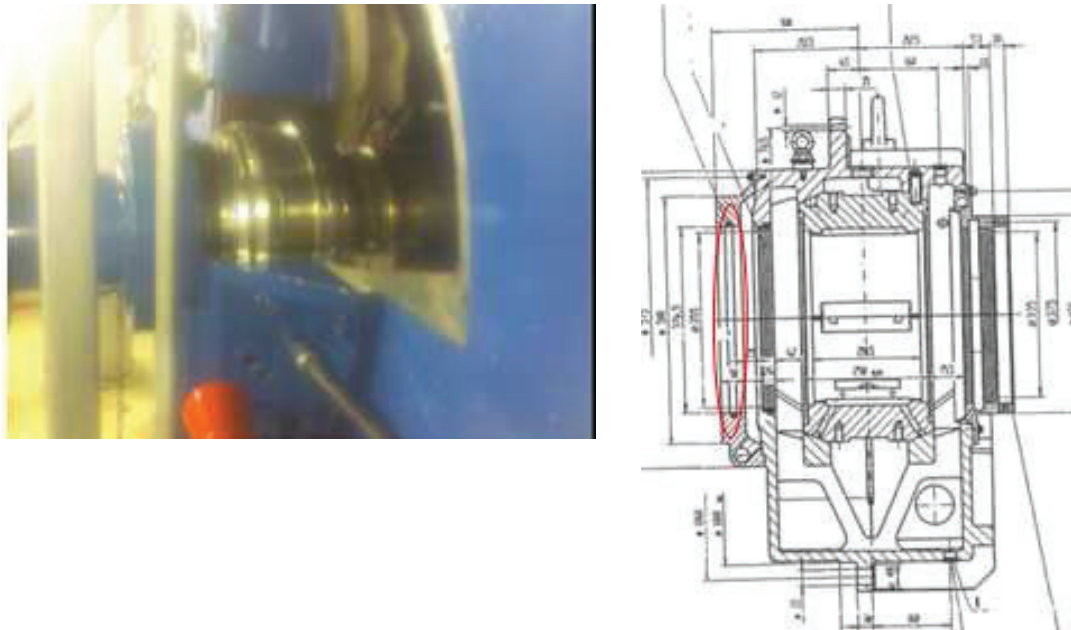
Conclusion of the analysis of the data showed that it wasn't a balancing issue but rather a rub. The localization of the rub can be predicted from analysis of machine design. In generators the clearances are big when compared to fluid machines so the typical localization of rub are machine seals (air seals in the housing) or the bearing oil seals. An inspection of the NDE and DE bearings of the generator showed the machine seals had indeed sustained a heavy rub. Corresponding marks were found on the shaft. Picture on figure 10 shows the seals as they were found after opening the bearings

To prevent leakage to the inside of the machine due to negative pressure or high air velocity, the housing has an integrated air or machine seal. Floating labyrinth seals catch and divert oil mist and vapors away from the rotating shaft.

Fig. 10. Picture and drawing showing seals details on generator bearings (air cooled generator)

Decision was then made to run the unit again without those air seals to confirm diagnostics. figure 9 shows the difference in vibration level before the issue and after the issue confirming the rub on the machine seals. The machine could then be started up to full speed no load with no vibration issue

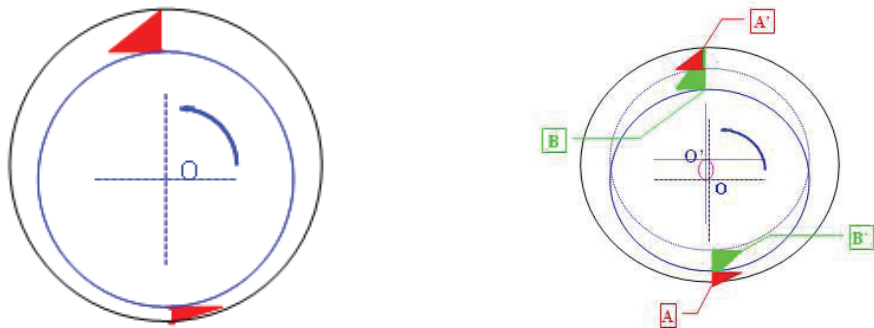
The Morton effect occurs when the journal is executing a synchronous orbit around the bearing center. Because of the load the center of the shaft isn't at the center of the bearing. If there is no vibration all the points on the journal surface will follow the same way: there is no area exposed to a different oil thickness.

In case of a synchronous vibration the motion of the center of the shaft will be an orbit and will move from O to O' for a rotation of 180°.

A will move to A' and B to B'. A will always be at minimum oil thickness than B. In other words it is always the same point on the shaft which is subject to maximum (A) friction and minimum friction (B).

Thus this difference will lead to temperature gradient across the journal and a hot spot will occur.

Fig. 11. Drawing showing motion of the center of the shaft when moving from O to O'

Some corrective actions for Morton effect can be: limit the “design” speed, reduce of overhung moments, change bearing clearances, reduce bearing length, change bearing type or geometry, increase specific bearing loading and eccentricity, change shaft material, change lubrication oil viscosity or increase oil flow.

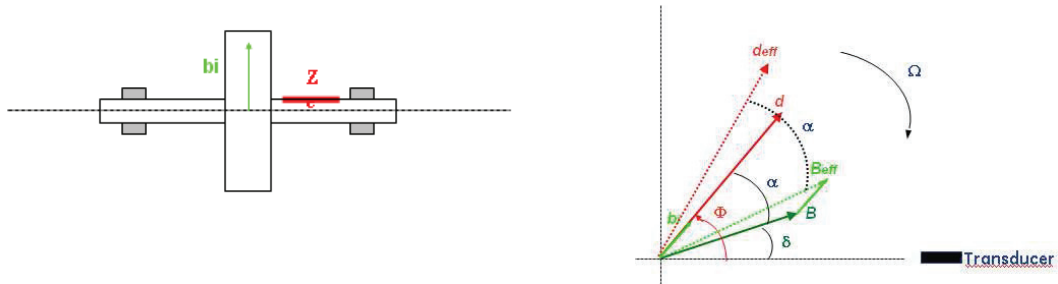
In the following two models (in between bearing and overhung configuration) will be studied. For the case of a rub in between bearings the hot spot location could be a seal between both bearings. Because of the thermal expansion of shaft material at the point of run contact (local heating) the shaft bows and gravity center of the shaft moves in the direction of the hot spot angular position.

Fig. 13. In between bearing configuration

Initial unbalance **B** causes the response **d** located at angle  $\alpha$  lagging the initial unbalance location. In this case the center of gravity is shifted in the same direction of the displacement and we have a new unbalance **bi** that will be added (vector adding) to the initial unbalance to create a final unbalance **Beff**. In fact we are adding bowing at the point of contact **F**. It is assumed that the additional “unbalance” is small when compared to original one. So the angle of the resultant unbalance moved slightly in opposite direction to rotation. So the response **deff** is moved from the same angle if the speed and the stiffness didn't change ( if stiffness changes, which is likely to happen, then there would be a new phase lag). The phase lag is increasing and the rotation direction of the 1X vector is reversed.

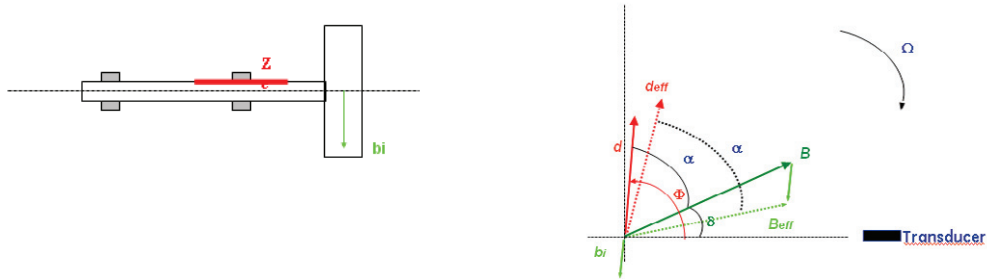
In the case of overhung configuration the Hot Spot could be a seal between both bearings or the bearing itself. Practically speaking... What can be rubbing in bearing? Light rubbing... It also can be only seal.. Because of the thermal effect the gravity center of the overhung moves in the direction opposite of the generatrice where the hot spot is located. The same method as before will give us a new response that is moving in the same direction of rotation of the shaft.

Fig. 14. Overhung configuration

Because of the initial unbalance  $\mathbf{B}$  we have a response  $\mathbf{d}$  located at  $\alpha$  degree lagging. In this case the center of gravity is shifted in the opposite direction of the displacement and we have a new unbalance  $\mathbf{bi}$  that will be added to the initial unbalance  $\mathbf{B}$  to create a final unbalance  $\mathbf{B_{eff}}$  (same direction of rotation). The phase lag is decreasing and the rotation direction of the 1X vector is forward.
