Remote sensing analysis of riparian vegetation response to desert marsh restoration in the Mexican Highlands

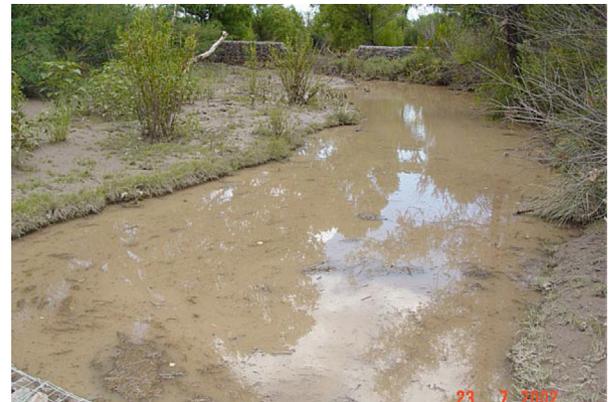
Fig. 2. Photo taken in 2002 of gabions at Cienega San Bernardino, in Sonora, Mexico, “shows two gabions: one at the bottom left, and one at the center top. They work together to slow the flow of run-off water and to catch silt.” (CLO, 2014).

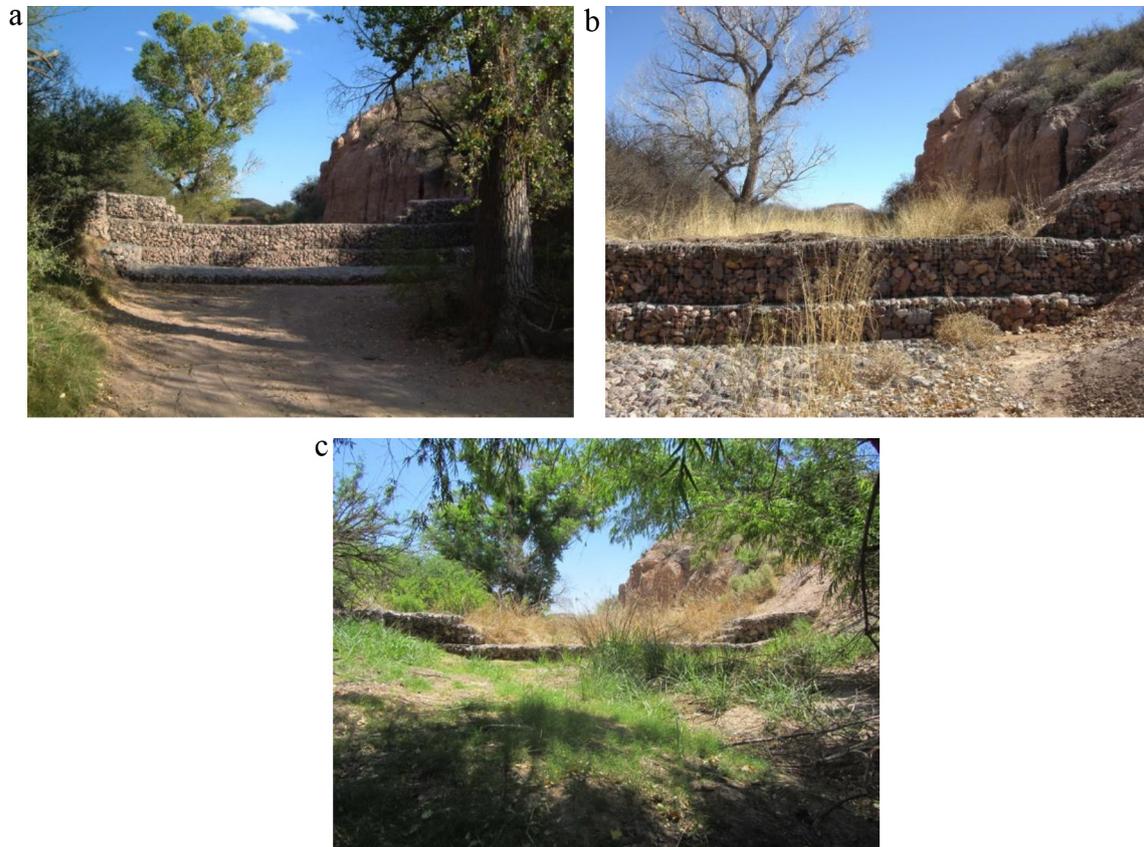
Fig. 10. Pictures taken at RS-3, along Hay Hollow. (a) Photo taken on 27 October 2001, immediately following gabion construction – the spillway, in the center, is 2 m above the streambed (by Josiah Austin). (b) Photo demonstrates considerable sediment deposition below the gabion and grasses (*Sorghum halepense*) protruding behind the gabion indicate the upper side has large filled with sediment on 1 September 2004 (by Mark Austin). Note that the cottonwood tree on the left of the photograph (a) had died and fell before this was taken. (c) Photo taken on 12 June 2011 shows sedimentation and associated changes in the vegetation has continued (by RL Minckley).

Gabions accumulated substantial amounts of sediment and often did so rapidly (Fig. 10a–c). Fig. 10a, taken just as the gabion was completed, shows there is more than 2 m from the spillway to the streambed. In 2004, the bottom layer of the gabion and above is covered with stream deposited sediment. Plants emerging over the top of the spillway indicate that the upstream side has filled with sediment nearly completely. In Fig. 10c, taken in 2012, little of the gabion remains exposed on the downstream side, and the channel width is much reduced relative to that seen in the 2004

photograph. The native grass, *Sacaton wrightii*, has established in front of the dam and much of the ground cover in the channel is bermudagrass (*C. dactylon*).

halepense) and Bermudagrass (*Cynodon dactylon*) greatly expanded (Figs. 10 and 11). Young age classes of tree species, not present before gabions were constructed, are now common. Furthermore, aquatic plant species are present throughout the river. Many of these changes are due to decreased erosive effects of floods, one consequence of greater vegetation in the water channel. The exact contribution of gabions to vegetation changes is complicated because cattle were also removed within 5 years before gabion construction began on both SBNWR and CLO (Minckley, 2013). Cattle removal is a passive form of restoration that nevertheless has substantial effects on ecosystems; Hadley (1977) estimated that
