Case report

Fracture of an uncemented tantalum patellar component

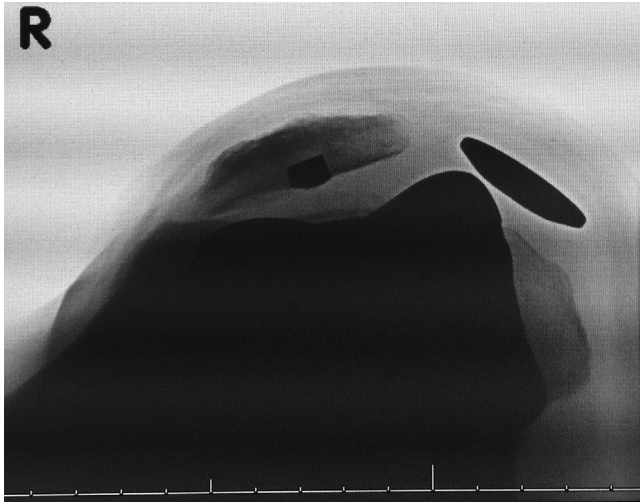
Anteroposterior, lateral, and sunrise radiographs were obtained in the emergency department (Fig. 1). On the sunrise view, there was a metallic density in the medial joint gutter and remnant metallic density in the native patella consistent with a broken

Figure 1. Initial radiograph showing fractured patellar component dislocated to medial joint.

single-peg tantalum patellar component (Zimmer NexGen; Zimmer Inc., Warsaw, IN).

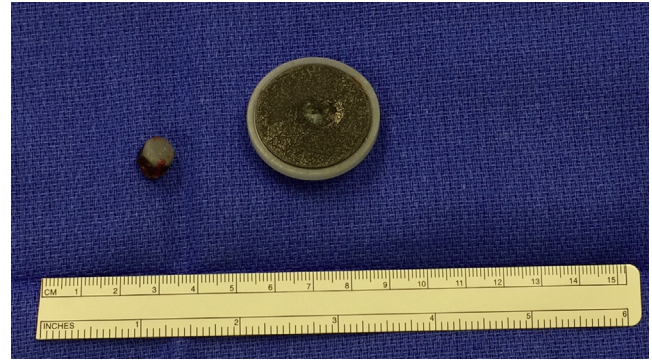
Figure 3. Fractured patellar component ex situ.

With the use of a tourniquet, the patient's previous anterior incision was used. The knee joint was then aspirated, with the finding of 700 nucleated cells, with 51% lymphocytes on differential. An Insall-type medial arthrotomy [1] and a synovectomy were performed (Fig. 2). The patella plate, sitting free in the medial gutter, was removed. A 15-mm superficial scratch was noted in the anteromedial aspect of the femoral component, in a location that did not articulate with the polyethylene. The femoral and tibial components were well fixed, well positioned (no malrotation on direct inspection), and otherwise not damaged. The patella was everted, the single-tantalum peg was removed with a fine-nose rongeur, and fibrous tissue overlying the remnant patella was aggressively debrided to expose healthy bone (Figs. 2 and 3).

Fracture of porous-peg metal-backed [4, 8, 9] and all-polyethylene [10-12] patellar components have been reported. To our knowledge, this is the first report of fracture of this single-peg, metal-backed tantalum uncemented patellar component. This fracture was not associated with a traumatic event, at only 3 years of implantation in a relatively low-demand patient. We presume that the theoretical mode of failure was lack of bone ingrowth into the tantalum patella baseplate, some ingrowth or fixation of the hexagonal tantalum peg, and a fatigue fracture of the peg at the peg-plate junction. As pointed out by Unger and Duggan [13] in their series, it can be challenging to completely seat the undersurface of the patella against the host bone, and therefore, only the peg is in close contact with the bone leading

to increased stress across the peg, with micromotion leading to a weakening of the peg contributing to the mode of failure. Until there are further reports of the longer-term success of this single-peg tantalum patella component, we recommend against the use of this prosthesis and agree with the recommendations of Unger and Duggan to use an all-poly cemented patellar component [13].

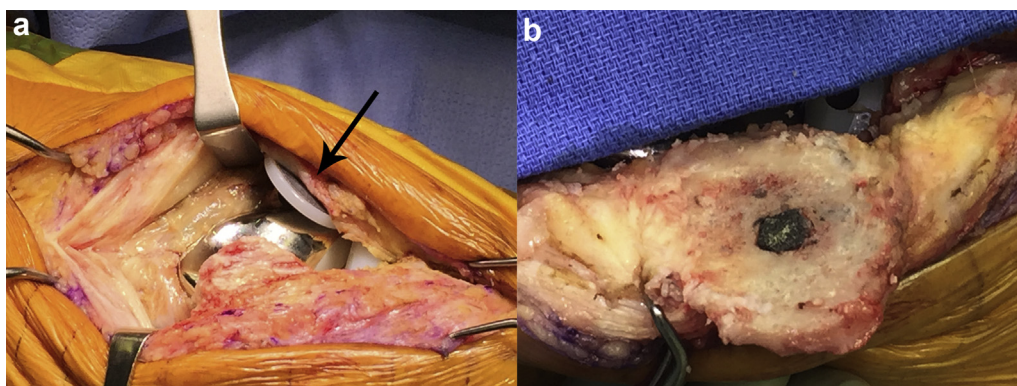
Figure 2. (a) Arthroscopy of knee showing fractured component (arrow) in medial gutter and (b) showing patellar component peg in situ.

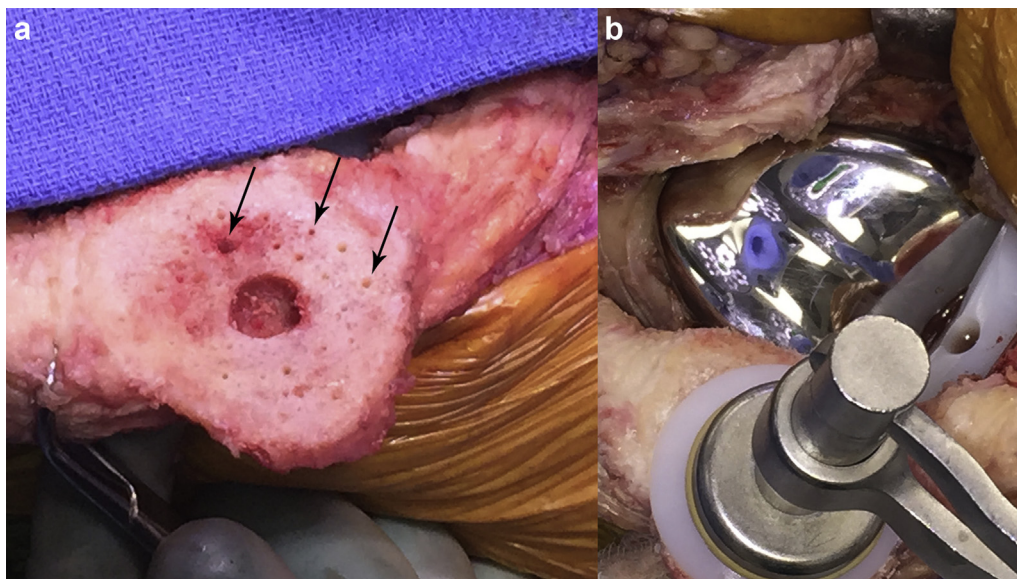
Figure 4. (a) Preparation of patella (arrow shows trephinations) for cemented component and (b) pressing of polyethylene patellar component into prepared patella.

The patella was prepared including a pencil-tip burr to trephinate the bone surface, and a 38-mm all-polyethylene 3-peg component was cemented into the patella (Fig. 4). The wound was copiously irrigated, and periarticular anesthetic infiltration and layered wound closure were performed.
