Case study

Electrolytic corrosion of water pipeline system in the remote distance from stray currents—Case study

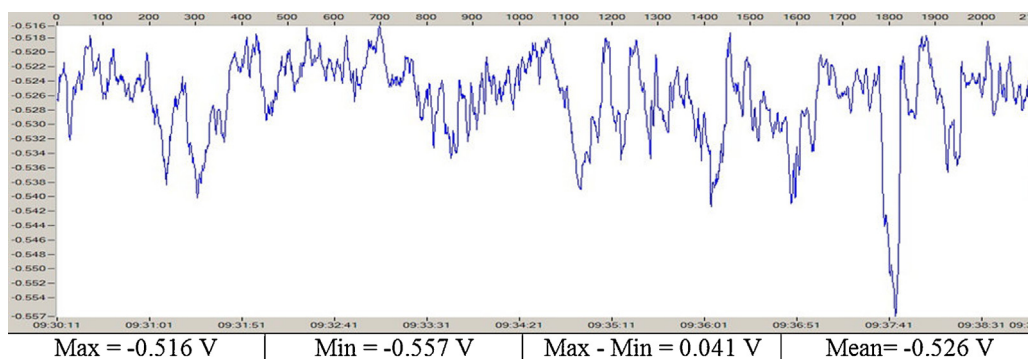
Results of potential measurements of pipeline at the place of corrosion damage are presented in Fig. 7.

In the graph dynamic random changes in the value of registered potential are visible. The nature of potential changes is the same as in the vicinity of railway and tramway. So, the measurement results indicate the influence of stray currents from electric traction, despite considerable distance from the tram and rail. Of course, the fact of presence of potential changes is not a proof of stray current corrosion [22], but they indicate the likelihood of this type of corrosion.

According to Table 1 in the standard EN 50162 [23] acceptable potential shift of a pipeline as a result of stray current influence is equal to only 20 mV. Whereas the potential change of investigated pipeline was 41 mV (Fig. 7). This indicates the harmful effects of stray currents on the pipeline.

The mean value of pipeline potential at this point in time of measurements was equal to -0.526V . This value is approximately 300mV more positive than at the cathodic zone in the vicinity of pipeline crossing under railways and tram (Figs. 3 and 4). The obtained results of the measurements indicate that the test site is the anodic zone of stray currents interference.

Fig. 7. Changes in potential at the place of corrosion damage.

Due to the very large distance from the place of damage to the rails, application of polarized electrical drainage would not make sense. In the region of the point of failure it is necessary to eliminate the phenomenon of leakage currents flow from the pipeline to the ground through the interface metal/electrolyte and this can be achieved by other methods. The simplest of these is the use of the earthing electrode [23], buried near the pipeline and connected to the pipeline by cable. Such a low resistance grounding has protective effect in the form of directing stray currents out-flow from pipeline to the soil through this electrode instead of pipeline coating defects. Most preferably, the electrode made of magnesium is used, because it can function as a earthing electrode for stray currents and as a source of cathodic protection current (as an galvanic anode [26]). The values of the potential of pipeline as well as their changes shown in Fig. 7 indicates that the use of magnesium sacrificial anodes can provide effective protection against electrolytic corrosion.
