**Procedia
Engineering**www.elsevier.com/locate/procedia**XXV Polish – Russian – Slovak Seminar “Theoretical Foundation of Civil Engineering”****GPR application – non-destructive technology for verification of thicknesses of newly paved roads in Slovakia****Martin Pitoňák^{a*}, Ján Filipovsky^b**^a*Researcher Faculty of Civil Engineering, Žilina, Slovakia*^b*Country manager, Roadscanners Central Europe, Prague, Czech republic***Abstract**

This manuscript focuses on survey results of R2 motorway bypass in Žiar nad Hronom, Slovakia. The survey was carried out in December 2014 by Roadscanners Central Europe, s.r.o. Non-destructive testing technology of ground penetrating radar complemented by 2D laser scanner and 3D accelerometer was applied. The purpose of this survey was to determine the layer thicknesses used in building new road and compare them to the designed structure. Total length of the measured section was 5.2 km. The outputs of the survey includes calculation and interpretation of roughness (accelerometer data), IRI parameters and cross fall (laser scanner and accelerometer data). Results were presented in the form of longitudinal profiles, GIS views and statistical data o

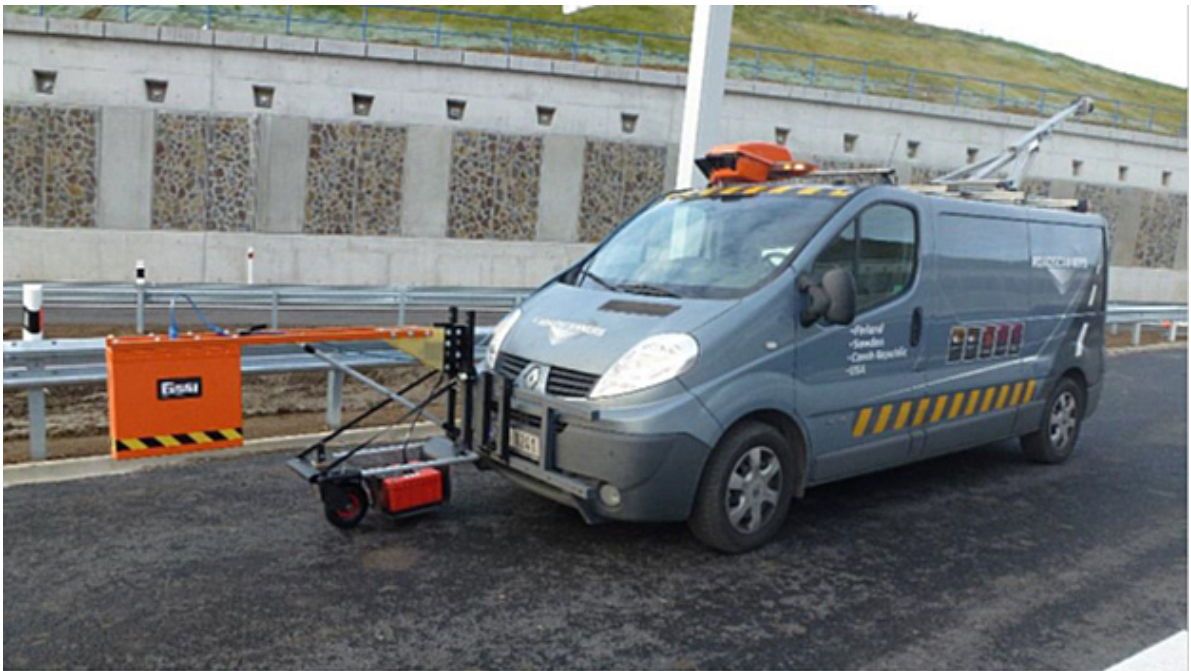
Data were collected by Road Doctor Survey Vehicle (RDSV) unit developed by Roadscanners (Fig. 2). This unit collects all data needed for quality control of the pavement. The RDSV unit follows the idea of modern sensor fusion with several sensors measuring different parameters. RDSV system consists of 1) Ground Penetrating Radar (GPR) unit equipped with air-coupled “horn” antenna of 2 GHz frequency to survey dielectric value of asphalt surface and 400 MHz ground-coupled antenna to survey unbound base layers 2) Road Doctor CamLink system allowing digital video data collection during survey 3) 3D accelerometer mounted to the back axle of the vehicle was used to measure pavement roughness, cross fall and IRI values and 4) 2D laser scanner technique mounted on the roof of the vehicle enabled measurement of surface shape, rut depths and ditch depths.

Fig. 2. Road Doctor Survey Vehicle used in the project data collection. The system consists of 1. GPR system with 2.0 GHz horn antenna and 400 MHz ground coupled antenna, 2. CamLink System for digital video recording, 3. 3D accelerometer and 4. 2D laser scanner.

3 m. Due to need for a close contact to the surface, the antenna requires lower survey speed, in this case constant speed of 60 km/h. Ground penetrating radar (GPR) data was collected using a GSSI SIR-30 unit with two antennas, 2 GHz air-coupled and 400 MHz ground-coupled antennas (item 1 Fig. 2)

The CamLink video-logging system was installed on the van roof (item 2 Fig. 2). The GPS device model used for positioning was an APD Communications INCA 2. All of the data was linked to GPS using Road Doctor™ CamLink software. One video camera in a CamLink box was used in the survey in order to record the view of the road.

Accelerometer is a device that measures acceleration forces (item 3 Fig. 2). Acceleration is the second derivative of position. When a car drives over a road with roughness, the roughness produces accelerations to the car tire. Bigger amplitude and shorter wavelength of the roughness produces larger acceleration. In other words, severe damages of the road produce large accelerations. Together with GPS-positioning system the measured accelerations can be positioned on the road. The accelerations also depend of the driving speed, so a constant driving speed on the whole section is desirable. Acceleration measurements were carried out using Xsens MTi-G accelerometer and integrated GPS-receiver. The accelerometer was attached to the back axle next to the right tire, so that the suspension of the car does not affect the measured accelerations. During the measurements MTi-G measured accelerations at a frequency of 100 Hz (100 times per second). A constant driving speed of 60 km/h was pursued in order to achieve the best possible data quality.

In this project the data collection was carried out using a SICK LMS151 laser scanner (item 4 Fig. 2). The laser scanner was mounted to the back of the survey van.

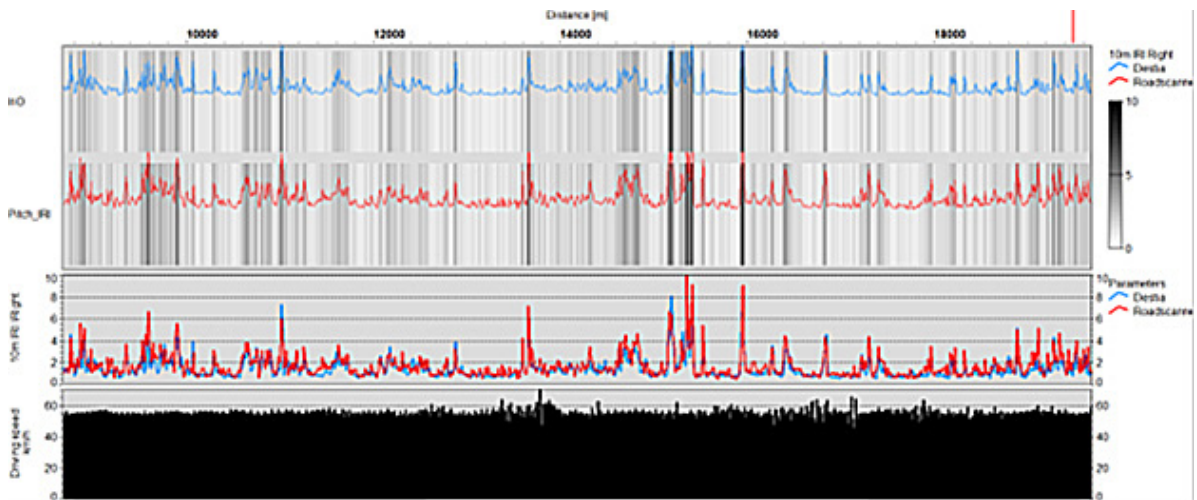
The results from Roadscanners' RD LS-3DAcc system and standard profilometer system, were correlated in network level measurements in Azerbaijan. The features were well defined but the value levels were shifted. The levels were matched using a correction formula:

$$\text{IRI} = (1.335 * \text{IRI}_{\text{roadscanners}}) + 1.1408$$

After using the correction the R^2 was 0,807.

Fig. 4. IRI values measured using standard profilometer and Roadscanners' Pitch method (In Finland).

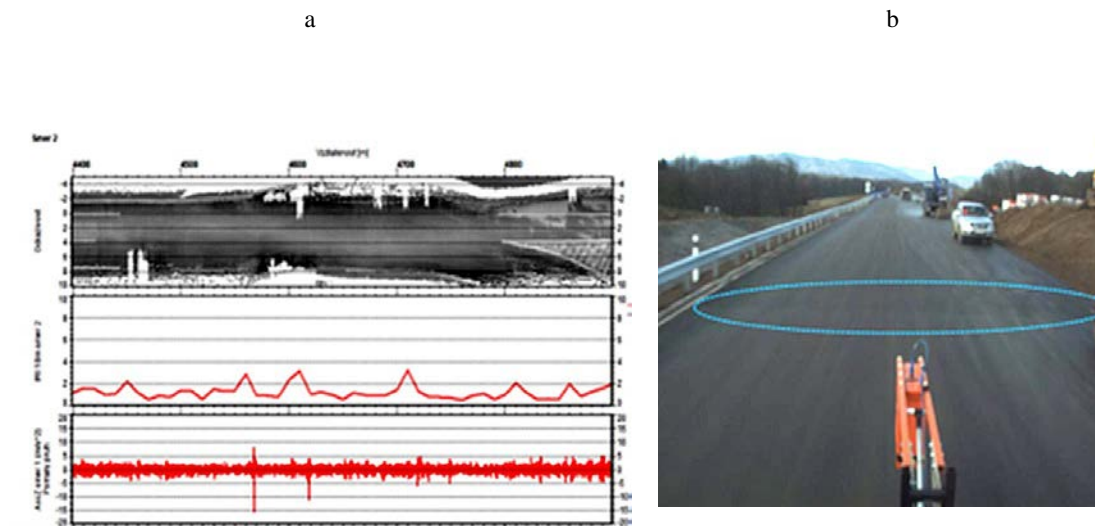
10m IRI and vertical acceleration values were reviewed from accelerometer and gyroscope data. The road surface appears mostly even. The highest values were caused by bridges and especially their construction joints, some minor peaks were also caused by pavement joints. One reason for some minor unevenness could be dirt on the road that was visible during measurement (Fig. 8).

Fig. 8. Minor peak in IRI 10 m value caused by pavement joint, slow lane, direction 2

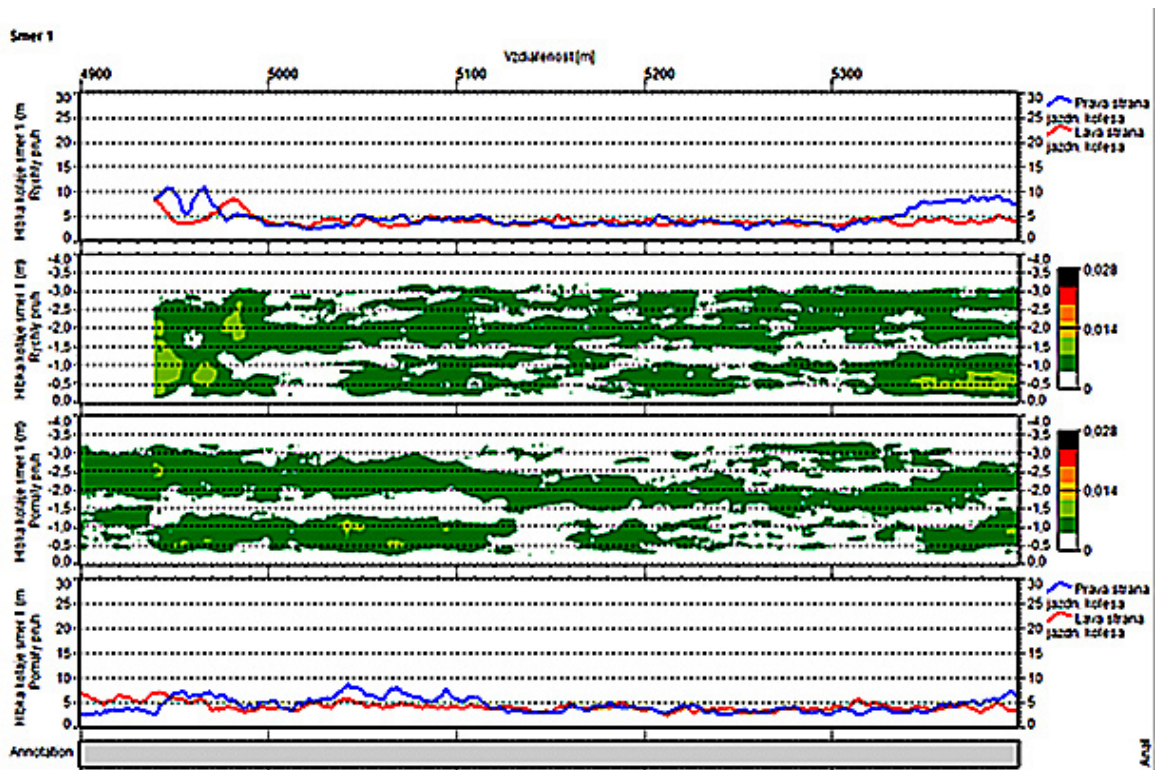
Despite the rutting measurements were also disturbed by cars and construction machines blocking the driving path in many places (in these places the rutting measurements show higher value than actual), in places where the survey vehicle could drive normally on the lane, rutting values are generally quite low.

Fig. 10. Interpretation of rut depths in direction 1, slow and fast lane
