IJCV Heart & Vasculature

Third CoreValve™ insertion for treatment of a severe paravalvular leak after a failed valve-in-valve procedure

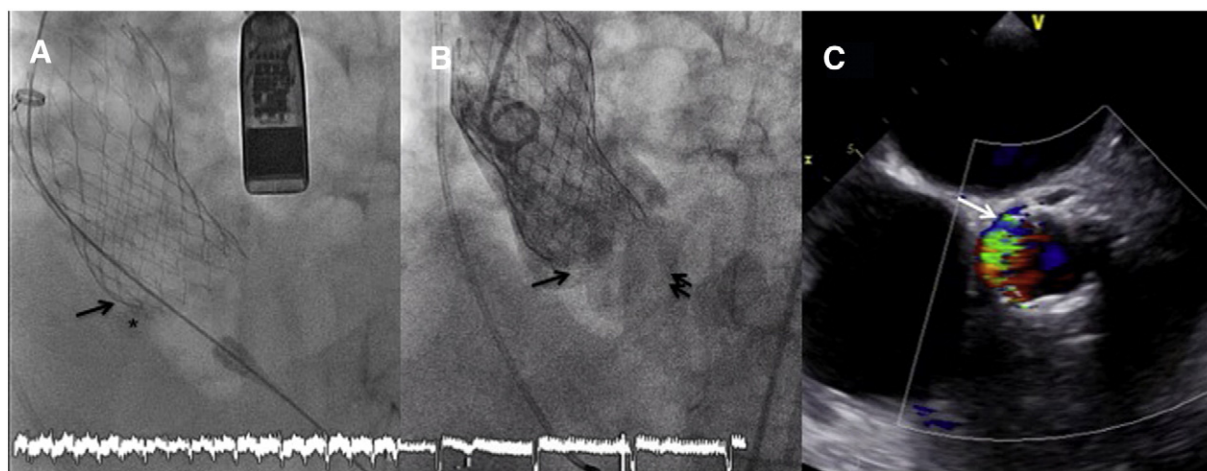
Fig. 1. (A) Bulky calcification in non-coronary sinus (asterisk) where the valve frame is deformed. (B) Partial dislodgement of the TAV (arrow) and presence of severe aortic regurgitation (double arrow). (C) TEE monitoring showing severe paravalvular regurgitation located in non-coronary sinus and occupying almost 50% of the circumference.

the full release of the valve, we observed that the frame had popped out and it was partially located above the leaflets (Fig. 1A). Severe paravalvular regurgitation (PVR) was noted (Fig. 1B and C). The decision was to proceed with a new 31 mm CoreValve, valve-in-valve technique. The second valve was deployed in a deeper position

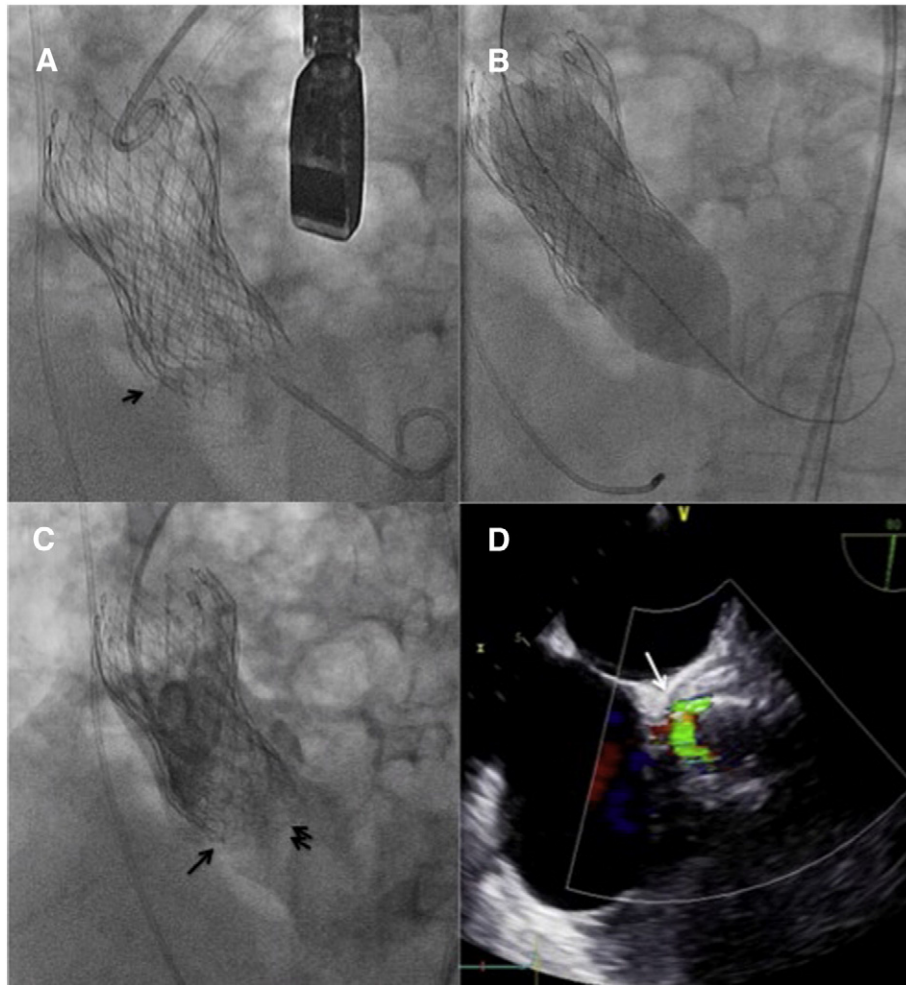
Fig. 2. (A) Second TAV implanted below the previous one. We can observe that the lower part is below the calcium landmark (arrow), but the valve frame is not fully expanded. (B) Balloon postdilatation trying to fully expand the valve frame. (C) After postdilatation, the valve slipped again in the severe calcification and was again partially dislodged (arrow) leading to a severe regurgitation (double arrow). (D) Severe PVL by TEE monitoring.

(6–8 mm) to ensure full coverage of the leak. The deployment was correct, however still severe PVR was noted (Fig. 2A). We decide to perform a balloon postdilatation with a NuCLEUS™ (NuMED Inc.) 28 mm balloon to improve the expansion of the valve structure. Interestingly, after the inflation, we realized that again the valve frame had slipped in the bulky calcification and the valve was partially dislodged (Fig. 2B, C and D). After considering different alternatives to solve the

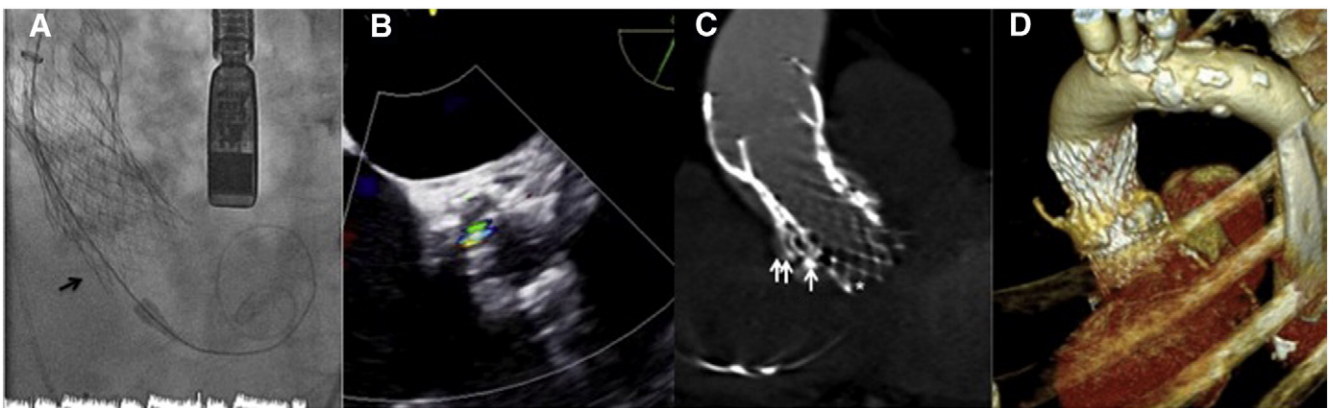
Fig. 3. (A) Implant of third TAV far below the previous ones (arrow). (B) Only traces of aortic regurgitation were seen in TEE imaging. (C) CT scan performed 1 year after the procedure demonstrating the three valves in place (asterisk, arrow and double arrow). (D) A 3D CT scan rendering reconstruction with the three valves and demonstrating the patency of both coronary arteries.

PVR after a valve-in-valve procedure, we finally decided to implant a third valve. Subsequently, we deployed a 29 mm CoreValve deep in the left ventricular outflow tract (8–10 mm), and after complete release, a new angiogram and TEE monitoring showed complete disappearance of the PVR (Fig. 3A and B). A CT scan at 1-year follow-up showed the position of valve frames and the patency of both coronary arteries (Fig. 3C and D).
